Curiosity Mars rover crosses rugged plateau

April 28 2016

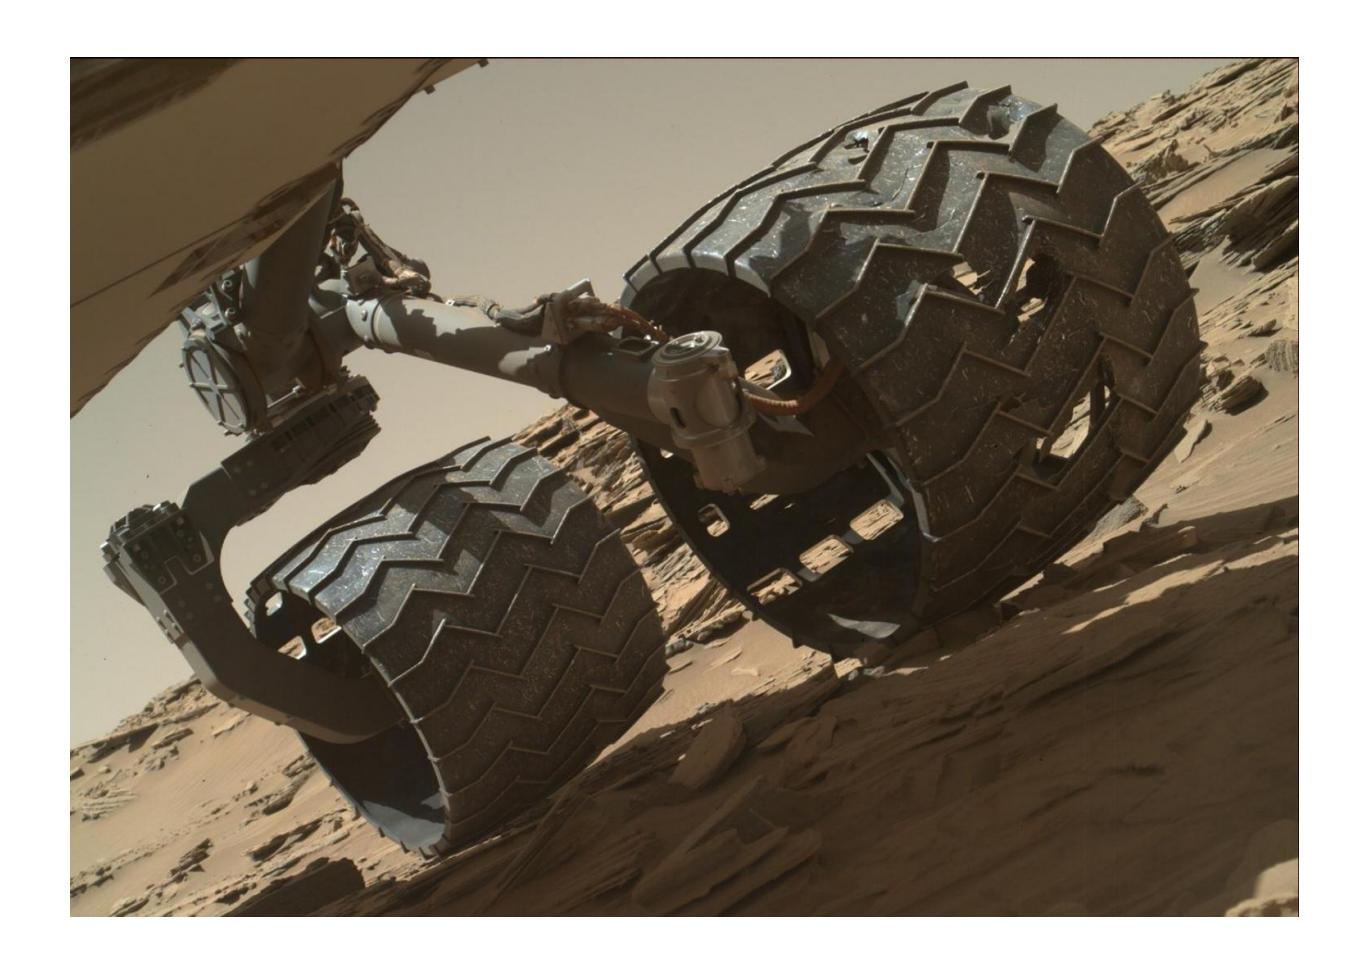
The team operating NASA's Curiosity Mars rover uses the MAHLI camera on the rover's arm to check the condition of the wheels at routine intervals. Credit: NASA/JPL-Caltech/MSSS

The roughness of the terrain on the plateau raised concern that driving on it could be especially damaging to Curiosity's <u>wheels</u>, as was terrain Curiosity crossed before reaching the base of Mount Sharp. Holes and tears in the rover's aluminum wheels became noticeable in 2013. The rover team responded by adjusting the long-term traverse route, revising how local terrain is assessed and refining how drives are planned. Extensive Earth-based testing provided insight into wheel longevity.

The rover team closely monitors wear and tear on Curiosity's six wheels. "We carefully inspect and trend the condition of the wheels," said Steve Lee, Curiosity's deputy project manager at NASA's Jet Propulsion Laboratory, Pasadena, California. "Cracks and punctures have been gradually accumulating at the pace we anticipated, based on testing we performed at JPL. Given our longevity projections, I am confident these wheels will get us to the destinations on Mount Sharp that have been in our plans since before landing."

Inspection of the wheels after crossing most of the Naukluft Plateau has indicated that, while the terrain presented challenges for navigation, driving across it did not accelerate damage to the wheels.

Each of Curiosity's six wheels is about 20 inches (50 centimeters) in diameter and 16 inches (40 centimeters) wide, milled out of solid aluminum. Most of the wheel's circumference is a metallic skin that is about half the thickness of a U.S. dime. Nineteen zigzag-shaped treads, called grousers, extend about a quarter inch (three-fourths of a

centimeter) outward from the skin of each wheel. The grousers bear much of the rover's weight and provide most of the traction and ability to traverse over uneven terrain.

The holes seen in the wheels so far perforate only the skin. Wheelmonitoring images obtained every 547 yards (500 meters) have not yet shown any grouser breaks on Curiosity. Earth-based testing examined long-term wear characteristics and the amount of damage a rover wheel can sustain before losing its usefulness for driving. The tests indicate that when three grousers on a wheel have broken, that wheel has reached about 60 percent of its useful mileage.

At a current odometry of 7.9 miles (12.7 kilometers) since its August 2012 landing, Curiosity's wheels are projected to have more than enough life remaining to investigate the hematite, clay and sulfate units ahead, even in the unlikely case that up to three grousers break soon. The driving distance to the start of the sulfate-rich layers is roughly 4.7 miles (7.5 kilometers) from the rover's current location.
