Thin-film solar cells: How defects appear and disappear in CIGSe cells

April 22 2016

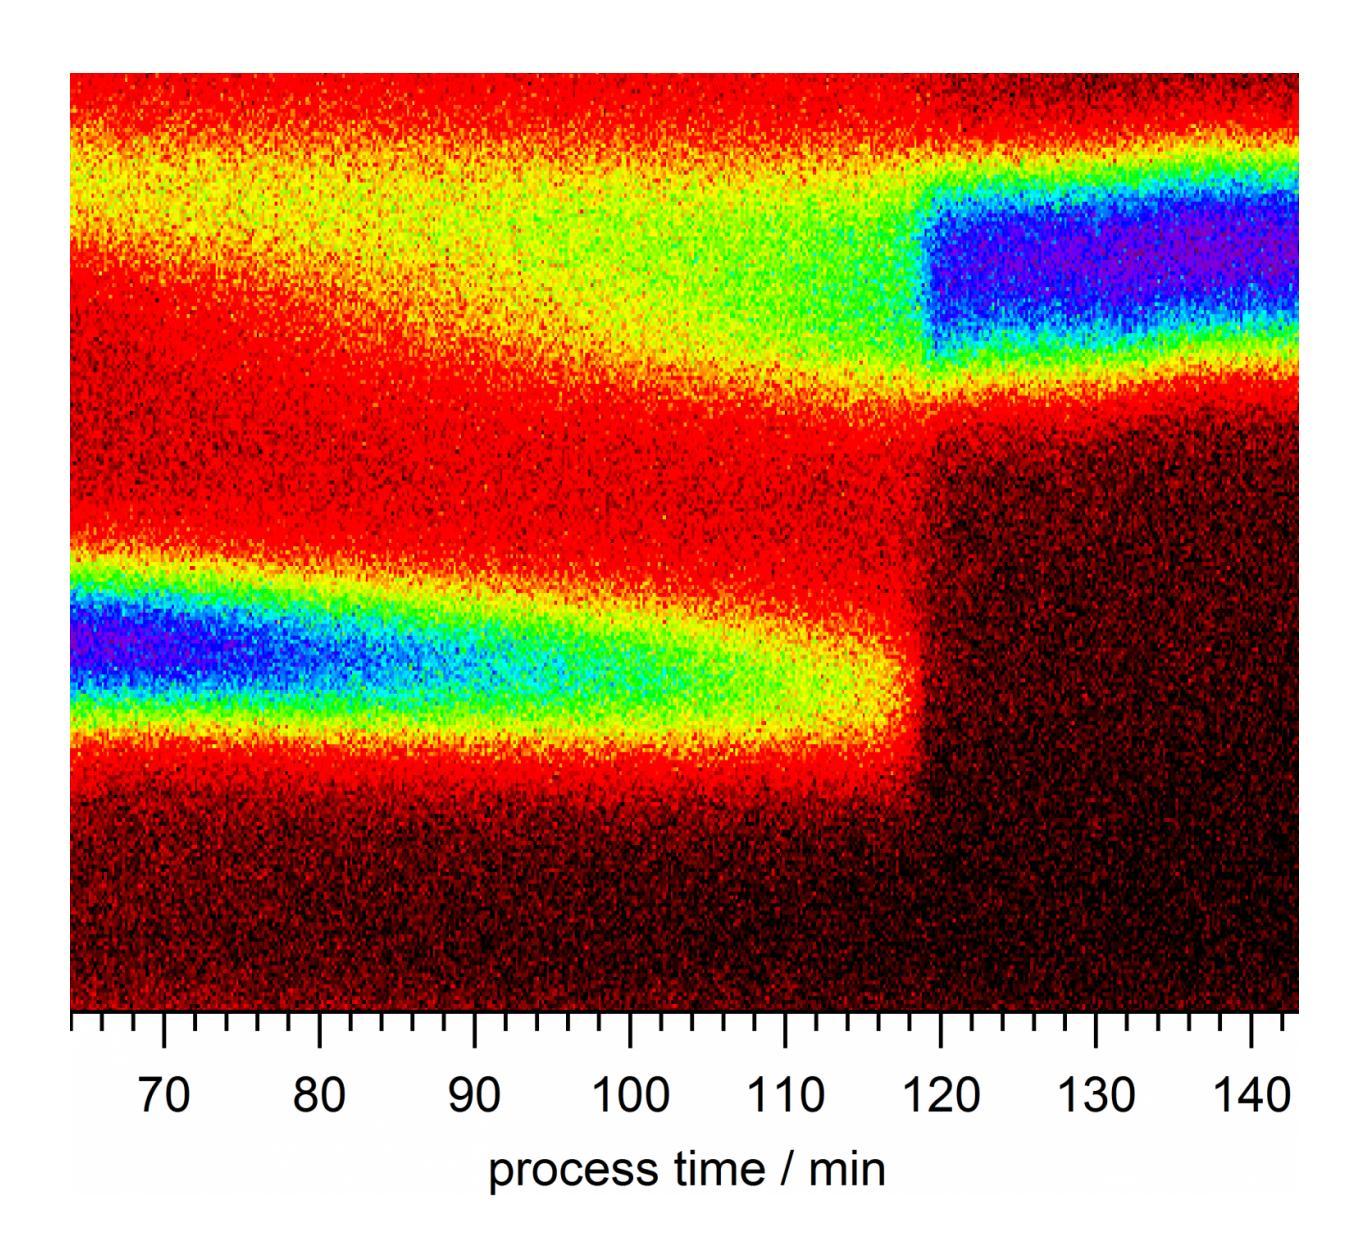
The data (photon energies over time) show defects (lower signal) which disappear after 120 minutes. This happens at the transition from the copper-poor

phase to the copper-rich one. Credit: HZB

chalcopyrite form there. The concentration of copper only reaches the correct value over the course of this second step. The prior copper-poor phase is characterised by numerous defects within the crystal. The defects increasingly disappear with the addition of copper and selenium. If more copper and selenium atoms are added after reaching the "right" ratio, then these two elements no longer fit into the existing crystal matrix and deposit themselves as copper and selenium grains in and on the polycrystalline CIGSe layer. This is actually problematic, since the grains must be removed afterwards. Nevertheless, they apparently have an important function in reducing the defects to near zero, as the current work shows.

Dr. Roland Mainz and his colleagues at HZB were able to observe the changes to the film structure during deposition using X-ray diffraction at the EDDI beamline of BESSY II - in real time. At the same time, they were able to use X-ray fluorescence to analyse the elemental composition of the thin-film layer as it grew. Simultaneous observation with two methods enabled them to obtain a new insight: "The annihilation of the defects takes place very rapidly - just prior to the excess copper-selenium grains being deposited on the surface of the CIGSe film and the film entering the copper-rich phase. So far, we had only understood the copper-rich phase as being important for the growth of the grains. Now we know that it also plays an important role in the elimination of the defects", explains Mainz.
