New understanding of plasma arc damage in nuclear reactors

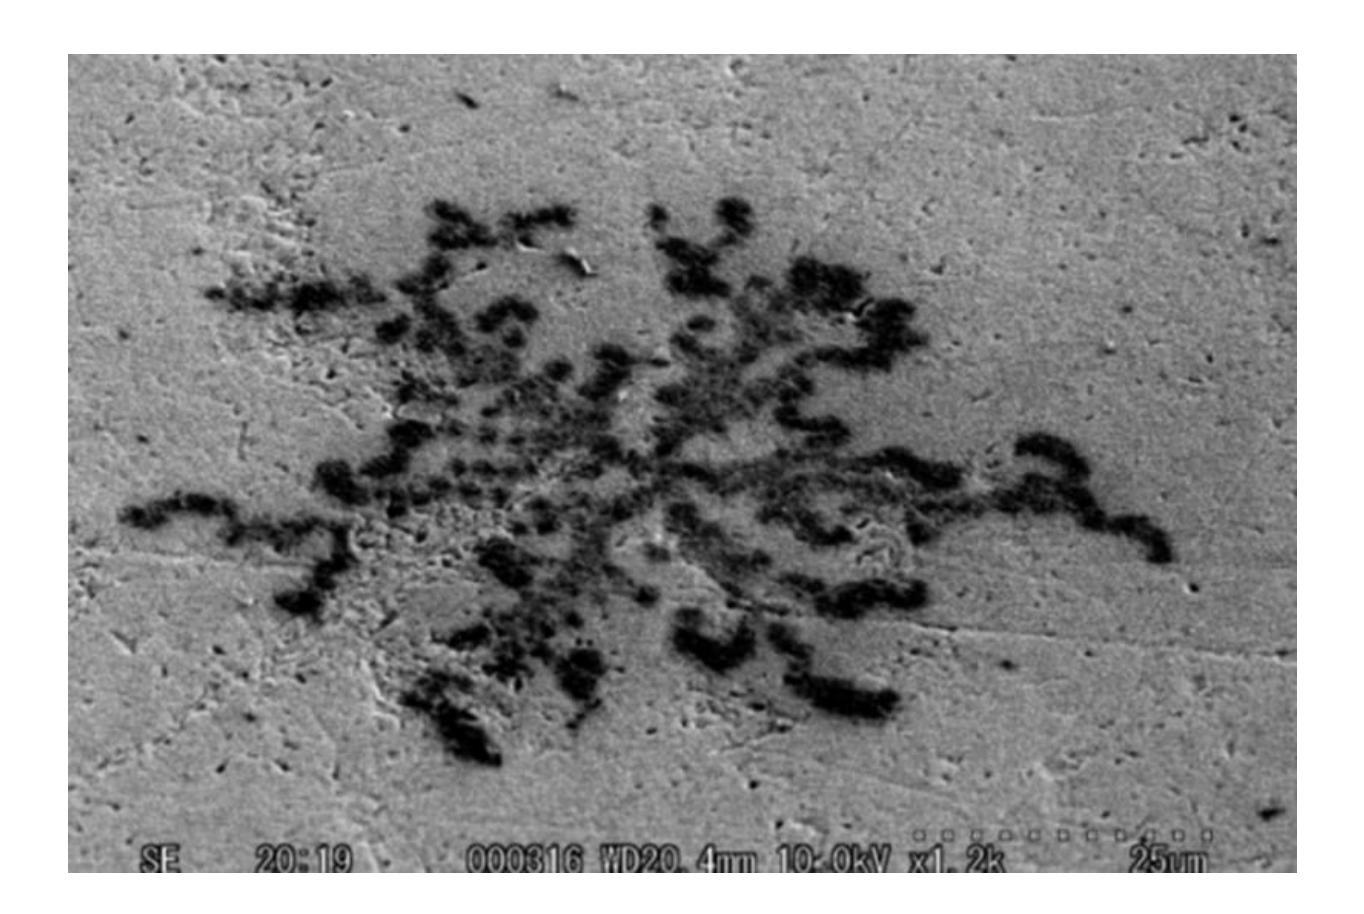
Snowflake-shaped crater at a nanostructured tungsten surface after rupture. Credit: National Research Nuclear University

Department of Plasma Physics employee Dmitriy Sinelnikov, while studying initiation of the arc striking, found craters on tungsten nanoundercoat from arcs, which look like snowflakes. This data will advance understanding of the mechanism of arc striking and lead to their prevention.

The reason for this change, as the electronic microscope measurements

show, is these snowflake-shaped craters. Craters of that type have not been observed on the metal surface before.

"As we can assume, the craters are traces of the arc, which appeared in a microrupture. Isolated traces are visible in the structure of the snowflake craters from cathode spots, barely distinguished on other materials," Dmitriy Sinelnikov said. "So apart from the outer beauty, snowflake craters can help better understand the mechanism of the arc movement along the surface."
