## Making sense of failure in light-harvesting semiconductors

September 8 2016

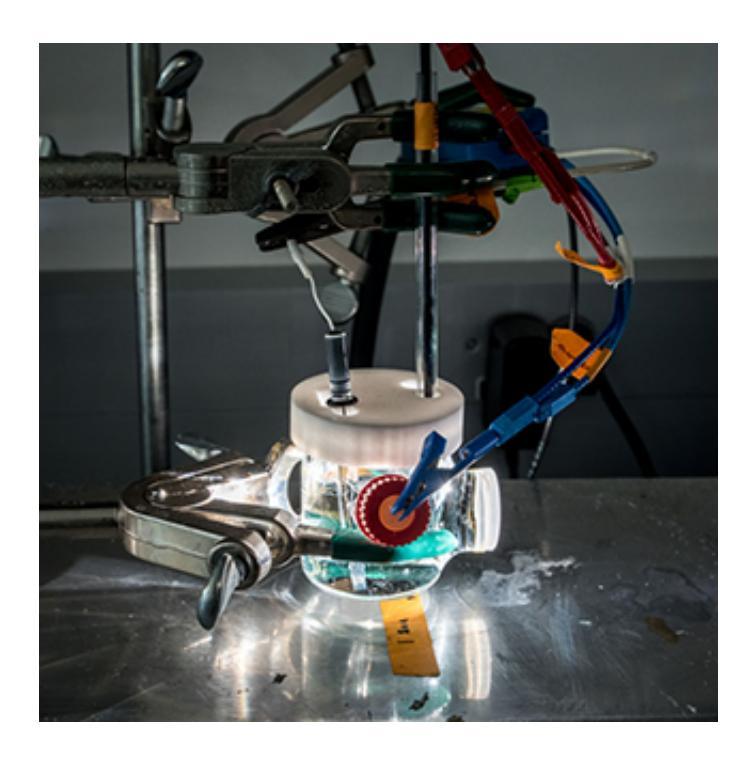
A solar simulator illuminates a photoelectrochemical cell that contains a bismuth vanadate thin-film electrode to harvest light. Credit: Joint Center for Artificial Photosynthesis and Paul Mueller (Lawrence Berkeley National Laboratory)
