Mars rover Opportunity on walkabout near rim

June 23 2017, by Guy Webster

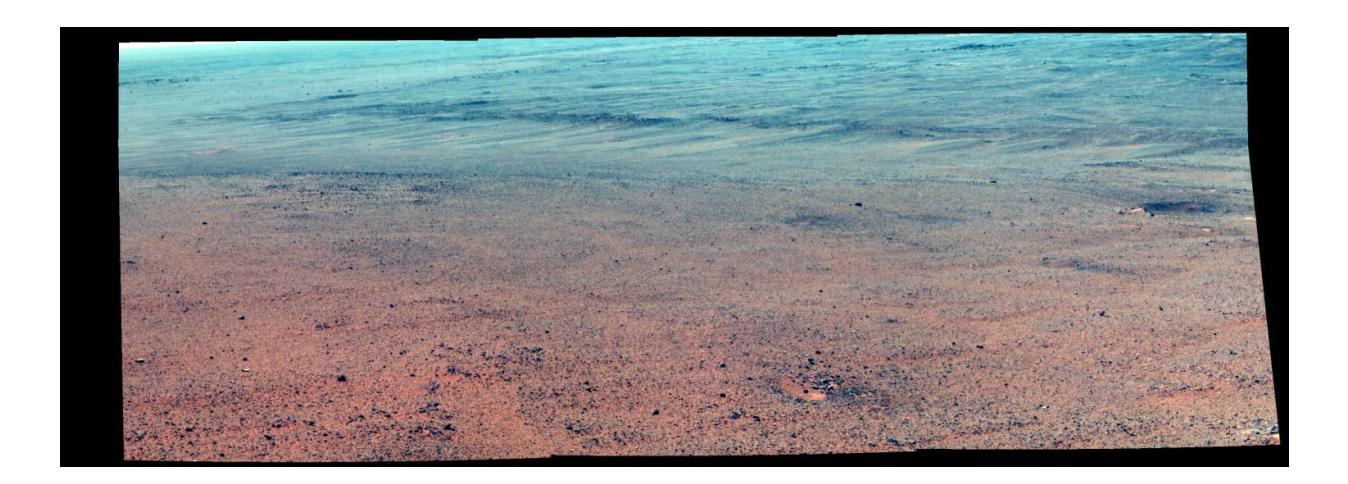
The Pancam on NASA's Mars Exploration Rover Opportunity took the component images of this enhanced-color scene during the mission's "walkabout" survey of an area just above the top of "Perseverance Valley," in preparation for driving down the valley. Credit: NASA/JPL-Caltech/Cornell/Arizona State Univ.

A portion of the crest at the top of Perseverance Valley has a broad notch. Just west of that, elongated patches of rocks line the sides of a slightly depressed, east-west swath of ground, which might have been a drainage channel billions of years ago.
