Engineers use replica to pinpoint California dam repairs

June 26 2017, by Brady Mccombs

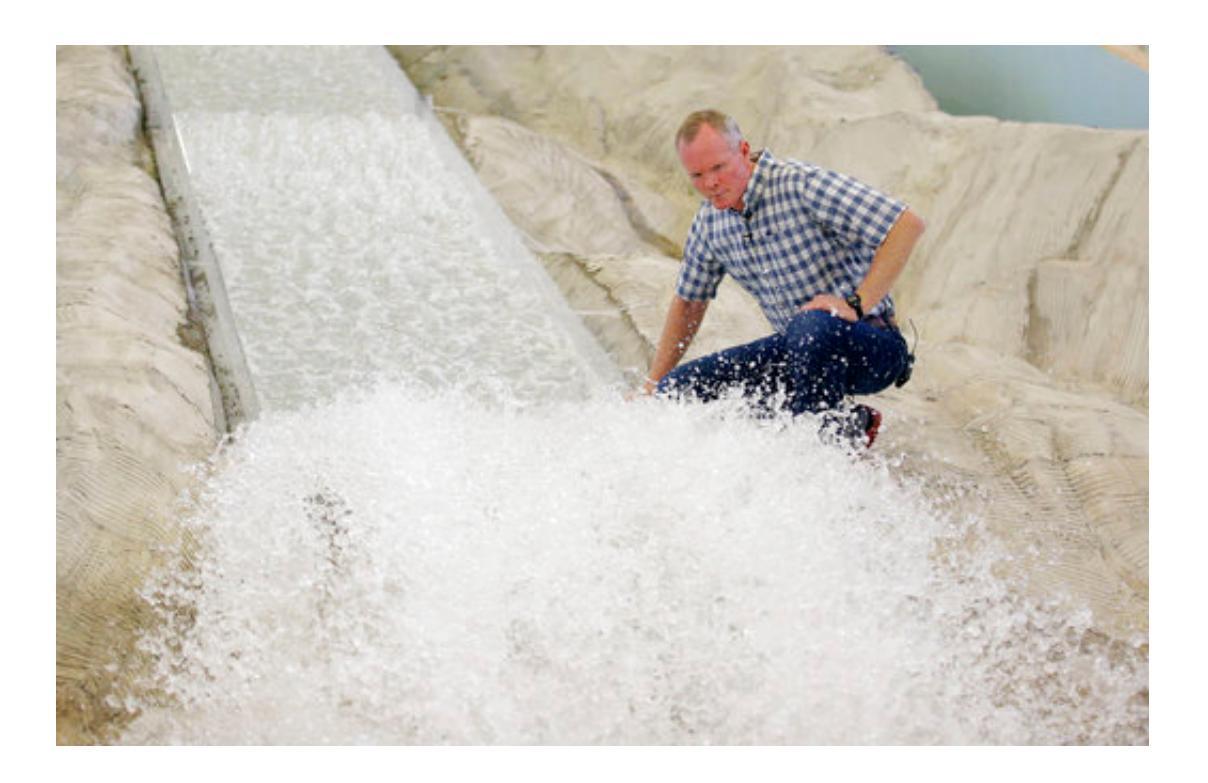
In this Friday, June 16, 2017, photo, hydraulic engineering professor Michael Johnson looks at the water flow on a replica of the Oroville Dam spillway at Utah State University's Water Research Laboratory, in Logan, Utah. California water officials are relying on key hydrology tests being performed on the replica of the spillway to pinpoint what repairs will work best at the tallest dam in the U.S for a spillway that was torn apart in February. (AP Photo/Rick Bowmer)

The sound of rushing water is deafening as Utah State University hydraulics engineering professor Michael Johnson kneels in front of a replica of an Oroville Dam spillway the size of a small house to examine one of two channels that run the width of the spillway to allow air into the water to prevent bubble formations that can damage the concrete spillway of the real dam.

The new channels, called aerators, are one of the key features in the proposed \$300 million spillway reconstruction set to be completed by November—when winter rains and snow will once again increase the flow of water into the lake above the dam.

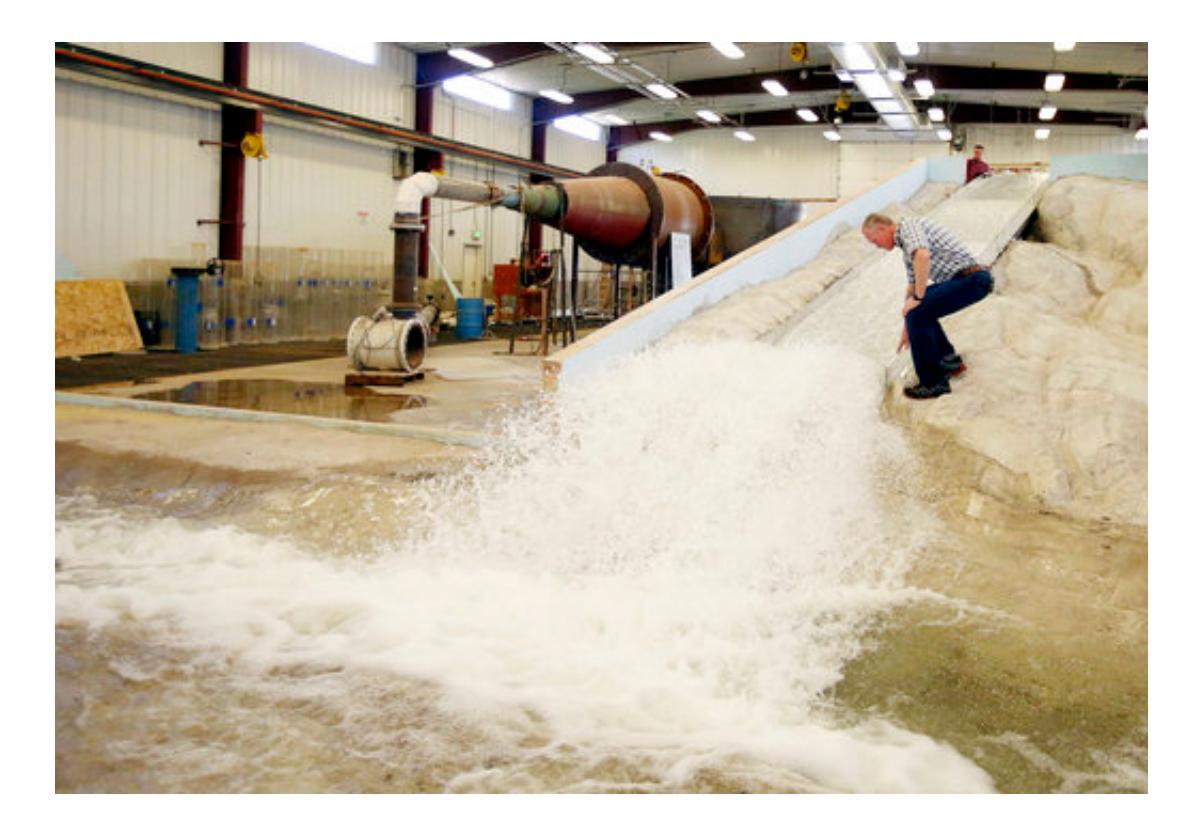
In this Friday, June 16, 2017, photo, hydraulic engineering professor Michael Johnson looks at the water flow on a replica of the Oroville Dam spillway at Utah State University's Water Research Laboratory, in Logan, Utah. California water officials are relying on key hydrology tests being performed on the replica of the spillway to pinpoint what repairs will work best at the tallest dam in the U.S for a spillway that was torn apart in February. (AP Photo/Rick Bowmer)

Besides confirming that the channels to aerate water going down the spillway would ease pressure on the spillway, the Utah testing has determined that an adjustment to a curve about halfway down the spillway would only slightly improve its effectiveness. The idea was to make the curve more gradual near a steep part of the spillway where it caved in and left a gaping hole the size of a football field in the concrete chute.

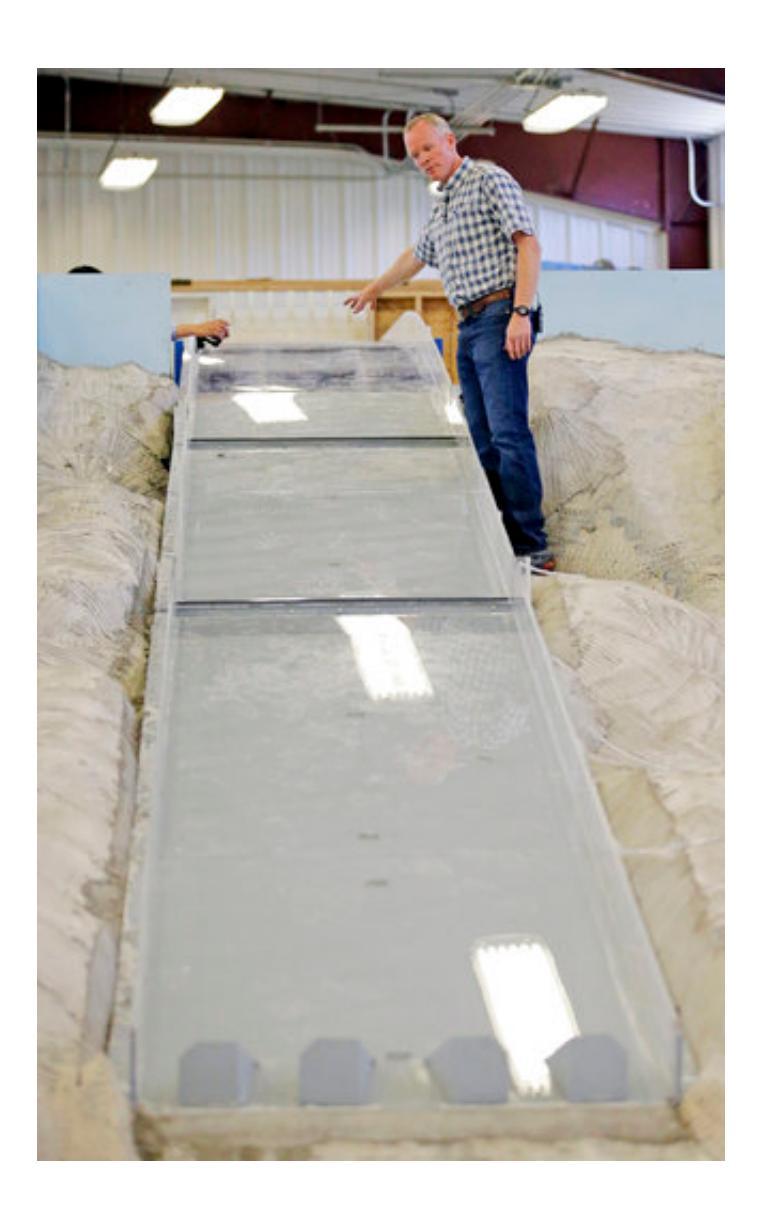
In this Friday, June 16, 2017, photo, hydraulic engineering professor Michael Johnson talks to reporters about the replica of the Oroville Dam spillway at Utah State University's Water Research Laboratory, in Logan, Utah. California water officials are relying on key hydrology tests being performed on the replica of the

spillway to pinpoint what repairs will work best at the tallest dam in the U.S for a spillway that was torn apart in February. (AP Photo/Rick Bowmer)

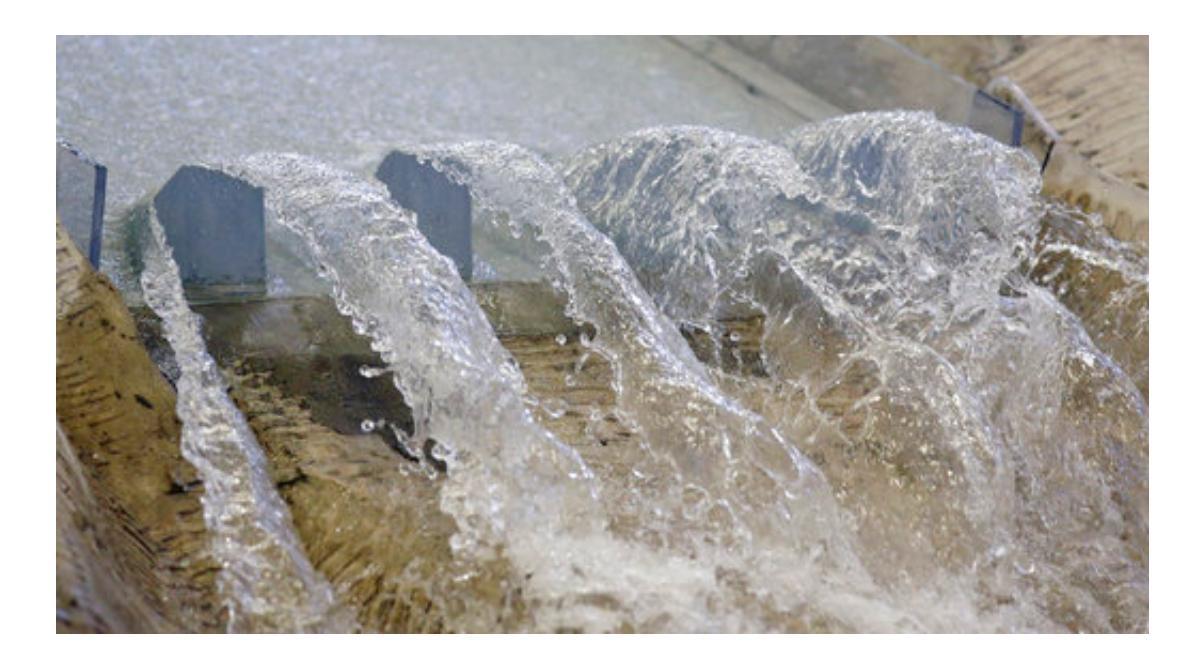
In this Friday, June 16, 2017, photo, water flows from a replica of the Oroville Dam spillway at Utah State University's Water Research Laboratory, in Logan, Utah. California water officials are relying on key hydrology tests being performed on the replica of the spillway to pinpoint what repairs will work best at the tallest dam in the U.S for a spillway that was torn apart in February. (AP Photo/Rick Bowmer)

Each simulation of the 100-foot (30-meter) long replica that took 40 days to build begins when a crew member slowly opens a large steering wheel like valve that sends water screaming down a chute modeled after the spillway and crashing into blocks that disperse it and send it in waves to a replica of the river. Johnson almost has to shout for his team to hear him above the noise of the water mimicking a flood.

The hydrologists calculate the velocity of the water, track how much air is being absorbed in the water and document what they see in weekly reports to California authorities.

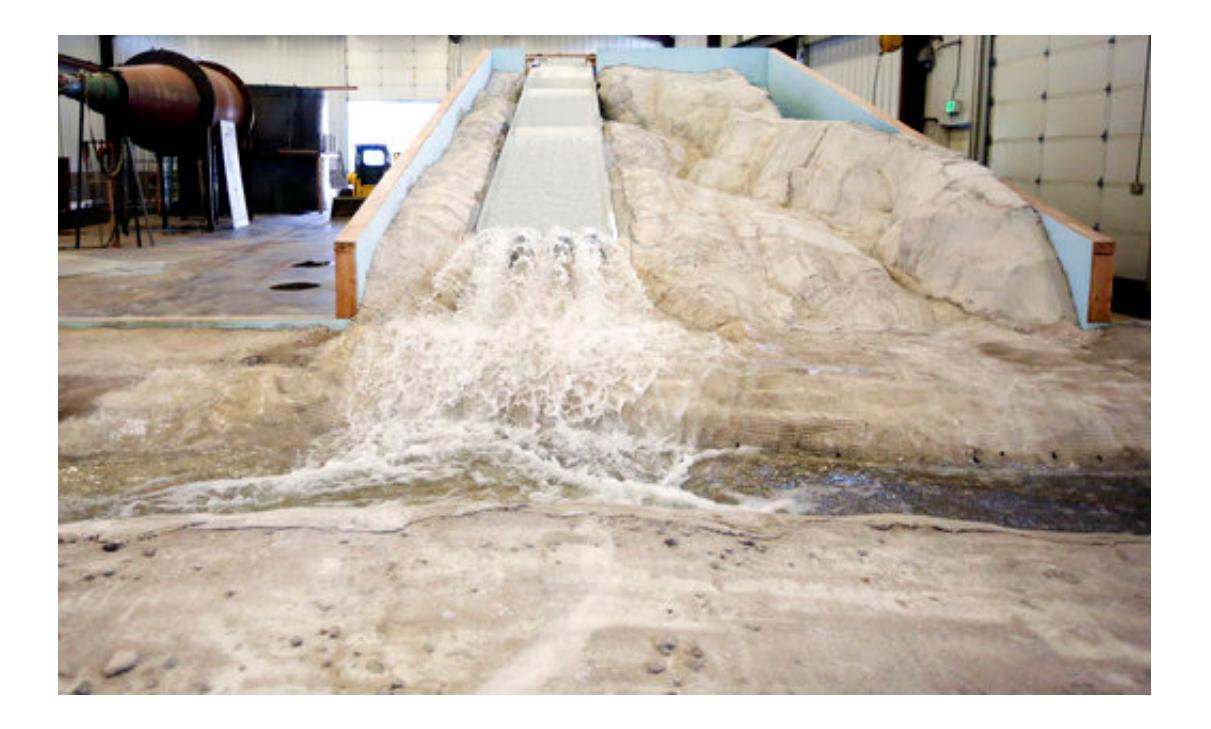
In this Friday, June 16, 2017, photo, water flows from a replica of the Oroville Dam spillway at Utah State University's Water Research Laboratory, in Logan, Utah. California water officials are relying on key hydrology tests being performed on the replica of the spillway to pinpoint what repairs will work best at the tallest dam in the U.S for a spillway that was torn apart in February. (AP Photo/Rick Bowmer)
