## Melted nuclear fuel seen inside second Fukushima reactor

January 19 2018, by Mari Yamaguchi

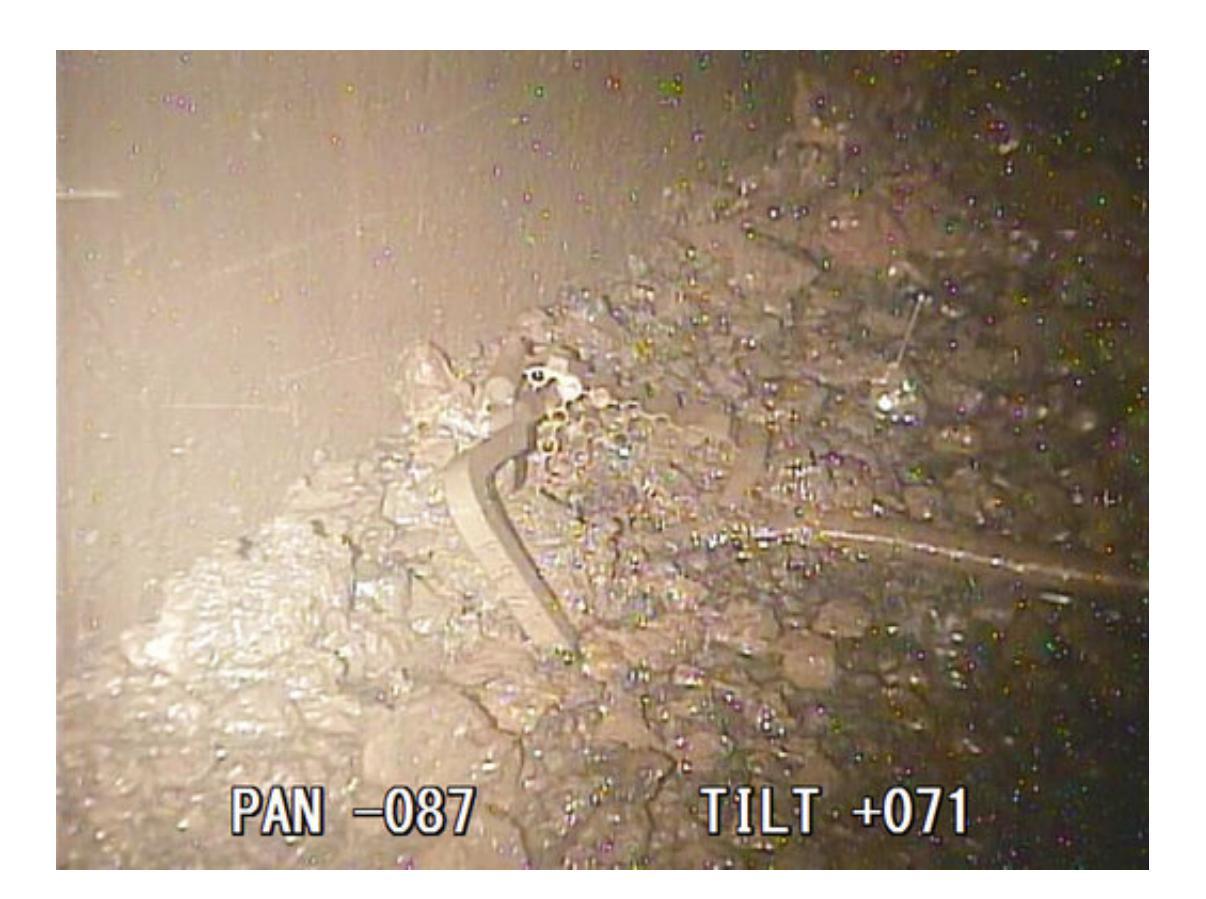
A photo taken by a robotic probe provided by the International Research Institute for Nuclear Decommissioning, Friday, Jan. 19, 2018, shows a part of what is believed to be the handle of the fuel rods container and melted fuel in small lumps scattered on a structure below the Fukushima reactor core. The operator of the crippled Fukushima nuclear plant says a long telescopic pipe carrying a camera has captured images of some melted fuel inside one of the three reactors, a crucial information for the decades-long cleanup. (International Research Institute for Nuclear Decommissioning via AP)

The images from Friday's probe show was what is believed to be a stainless steel handle of a case containing bundles of fuel rods sitting on a pile of pebble-shaped and clayish substances, in a sign the rods melted and breached the bottom of the core. The deposits seemed to be scattered in a wide area around the pedestal, the main structure that sits underneath the core.

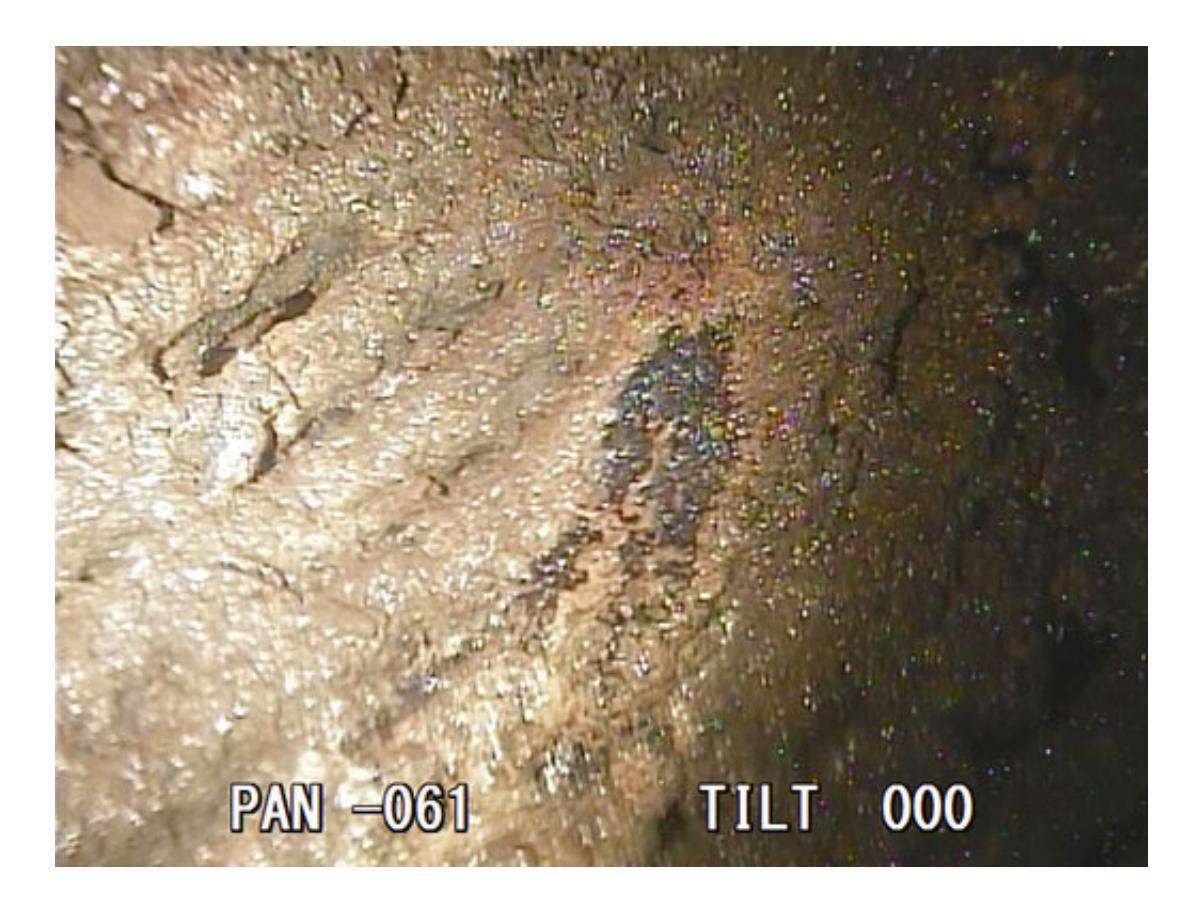
A photo taken by a robotic probe provided by the International Research Institute for Nuclear Decommissioning, Friday, Jan. 19, 2018, shows part of a grated platform that broke and fell from a structure below the core of Unit 2 reactor's primary containment vessel coated with what could be melted fuel or structure inside the Fukushima nuclear plant. The operator of the crippled Fukushima nuclear plant says a long telescopic pipe carrying a camera has captured images of some melted fuel inside one of the three reactors, a crucial information for the decades-long cleanup. (International Research Institute for Nuclear Decommissioning via AP)
