## **Permafrost in continuous motion**

## January 25 2018, by Peter Rüegg

ETH researchers have identified a rock glacier in canton Valais that is degrading and moving very quickly. Fortunately, it does not present an immediate threat to people and infrastructure.

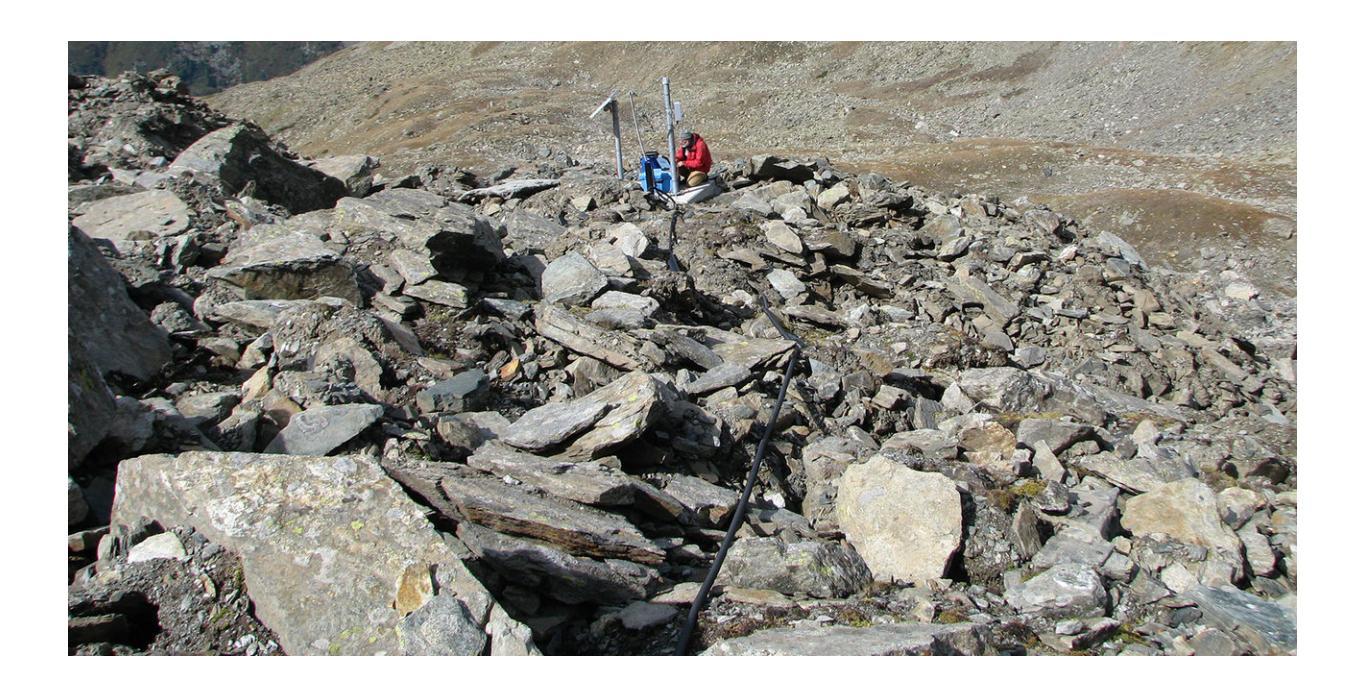
Nothing stands still for long here: measurement station on the rock glacier at the foot of the Furggwanghorn mountain. Credit: Thomas Buchli / ETH Zurich

Among other things, the researchers used radar and laser measuring devices to characterise the surface. With the help of GPS, they also determined the surface creep velocity of the rock glacier. To investigate

the structure of the ground, the temperature and water content, as well as the internal creep rates, the engineers bored several holes up to 30 metres deep into the permafrost. They inserted thermistors to measure the temperature and also novel inclinometers in these boreholes. Some of the measurements were unique: in one borehole, for example, Buchli was able to detect for the first time continuous creep movements by the rock glacier of up to three metres. The researchers gained additional information on the stratification and structure of the rock glacier with geophysical investigations.

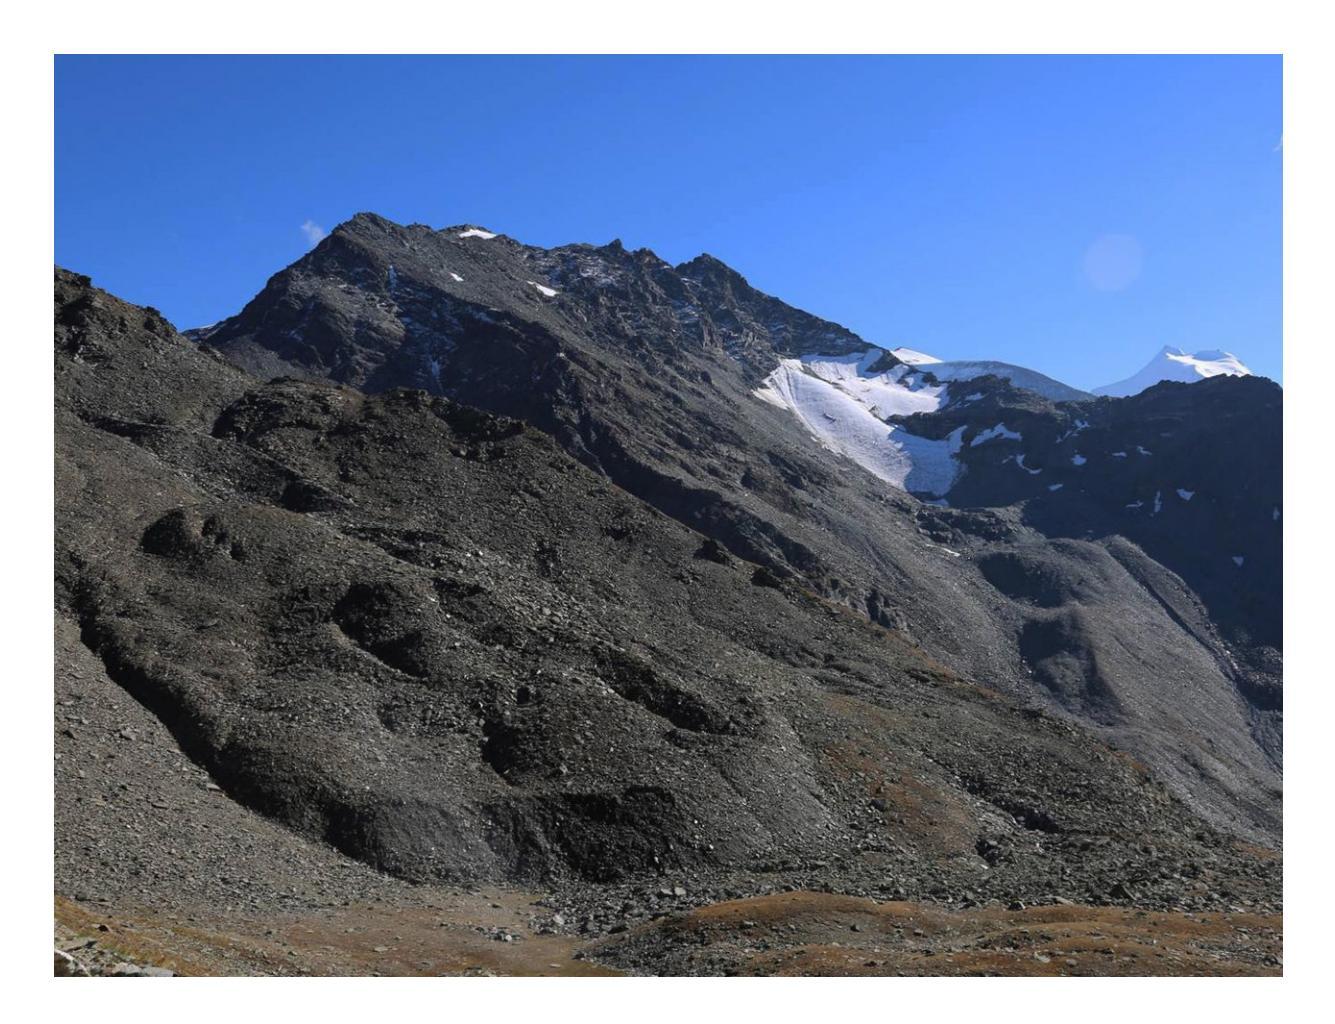
The surface of the rock glacier pictured on the left in the canton of Valais is changing rapidly as it moves downhill at a steadily increasing pace. Credit: ETH Zurich

It was striking how quickly and powerfully the surface of the rock glacier moved and changed during the investigation period. Scientists already knew that the Furggwanghorn rock glacier is warming and degrading faster than the majority of other rock glaciers. "Even so, I was surprised by the speed," says Buchli. "Tilting, twisting, subsiding –everything on the rock glacier was somehow in constant motion."

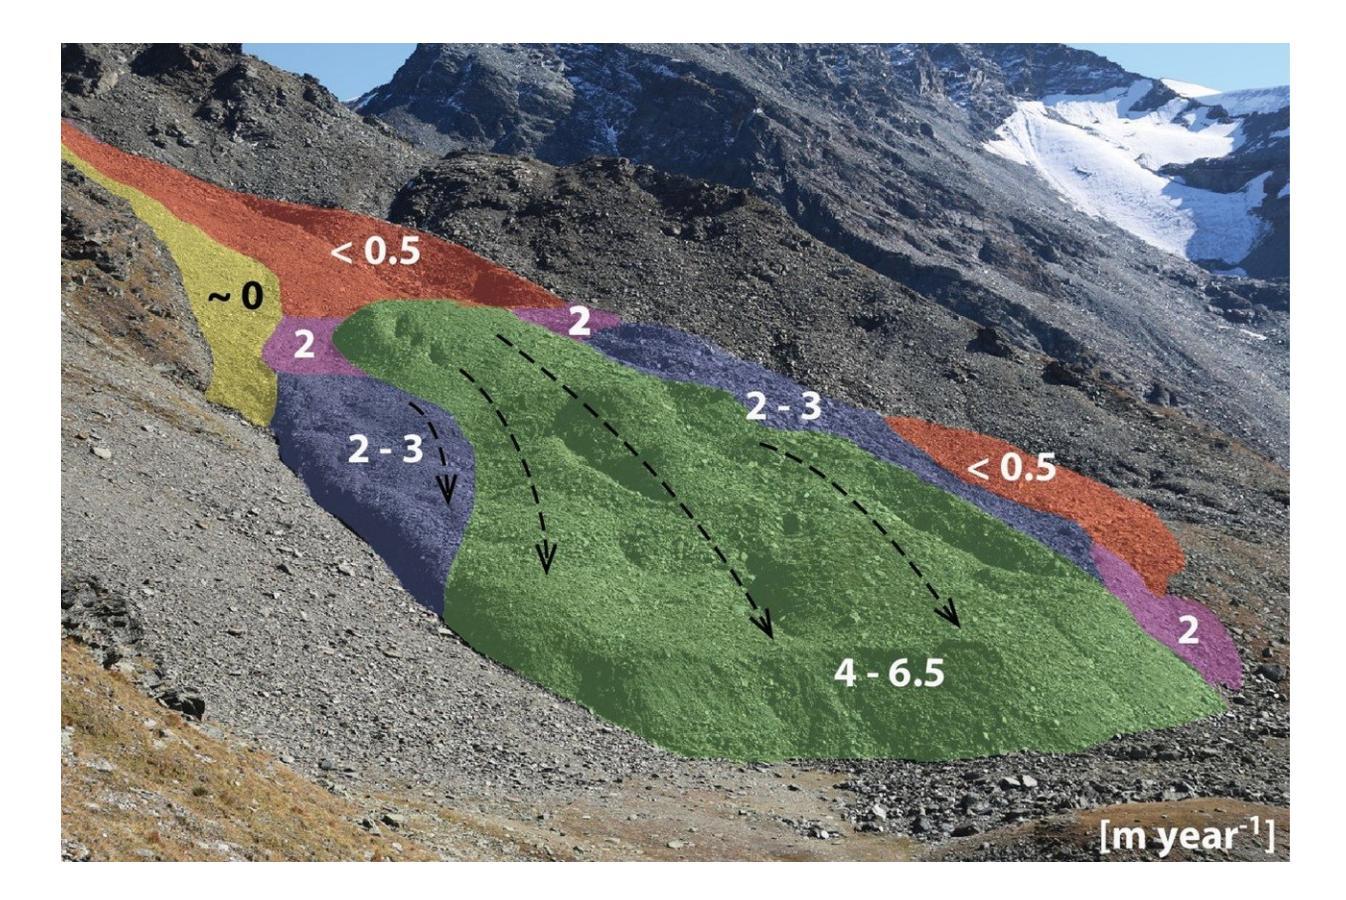
The surface of the rock glacier showing zones with different creep velocities. Credit: Thomas Buchli / ETH Zurich

However, the rock glacier did not move as one mass, but in sections. It moved downhill over several metres per year in one part of the frontal area, while the movement in its accumulation zone was only a few decimetres and it was entirely static in another part of the front section.
