## **Problem with new US weather satellite could affect pictures (Update)**

May 23 2018, by Marcia Dunn

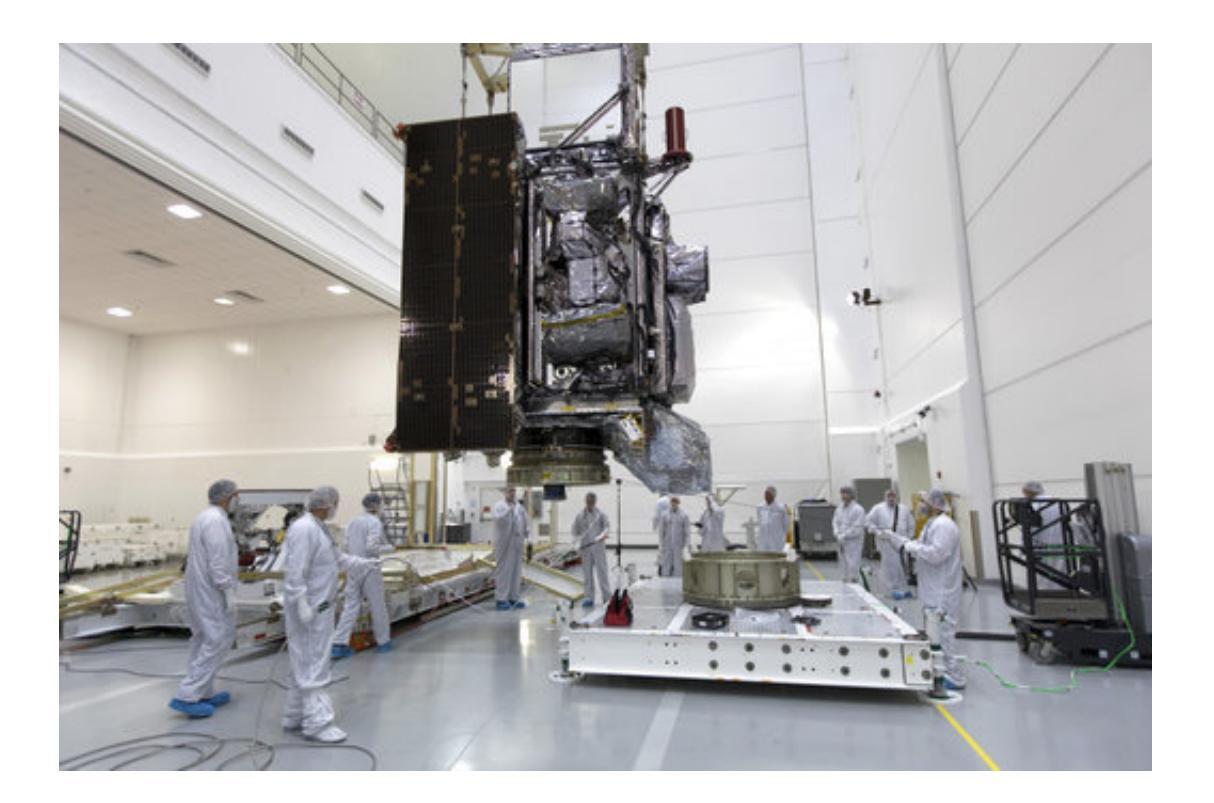
In this Dec. 6, 2017 photo made available by NASA, technicians and engineers move the National Oceanic and Atmospheric Administration's Geostationary Operational Environmental Satellite-S (GOES-S) to a work stand at Astrotech Space Operations in Titusville, Fla., near Kennedy Space Center. On Wednesday, May 28, 2018, NOAA said that the GOES-17's imager is not providing proper cooling for its infrared sensors. (Leif Heimbold/NASA via AP)

Fahrenheit (minus 200 degrees Celsius). The imager's cooling system—which uses propolyne—is not maintaining that frigid temperature during the warmer part of each orbit, and so the channels aren't working well about half the time.
