## Hayabusa2 drops target marker at asteroid Ryugu

June 10 2019

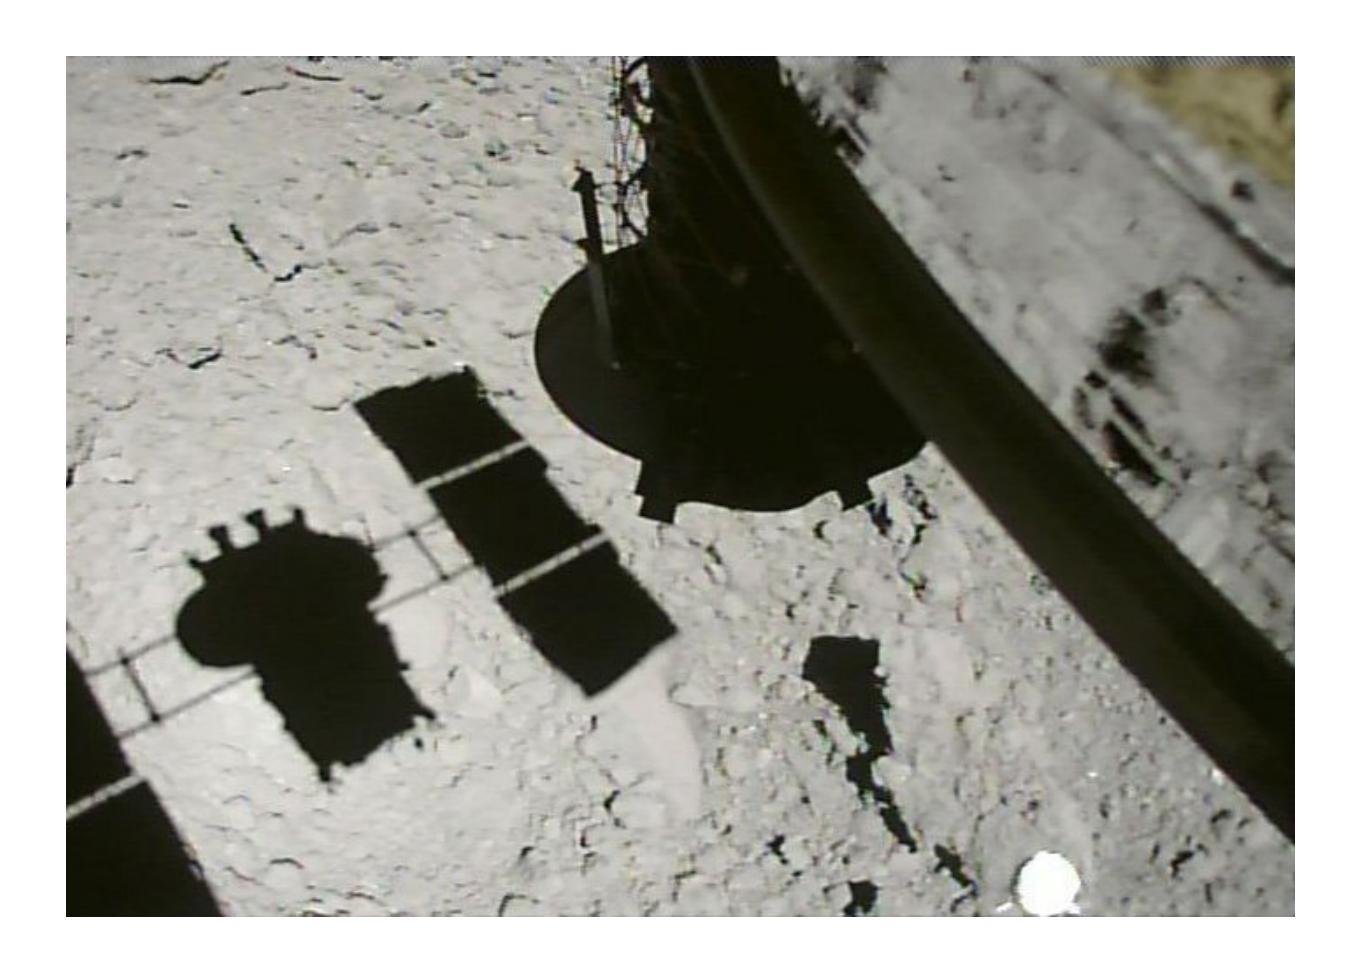
The target marker separation on May 30 during PPTD-TM1A was caught at the last moment by the small monitor camera, CAM-H! The image time was May 30, 11:18 JST (on-board time) at an altitude of about 9m. CAM-H was built with donations from all of you & is a big success! Thank you! pic.twitter.com/pHSwqPaywh

The latest image was taken when Hayabusa2 was just nine meters (29.5 ft) from Ryugu and shows the spacecraft's shadow on the surface, as well as that of the target marker. This successful deployment comes on the heels of a delay in mid-May, when the spacecraft was forced to abort descent operations due to an error with the spacecraft's LIDAR data.
