Nanoparticles with quantum dots for restoring monuments

May 11 2020

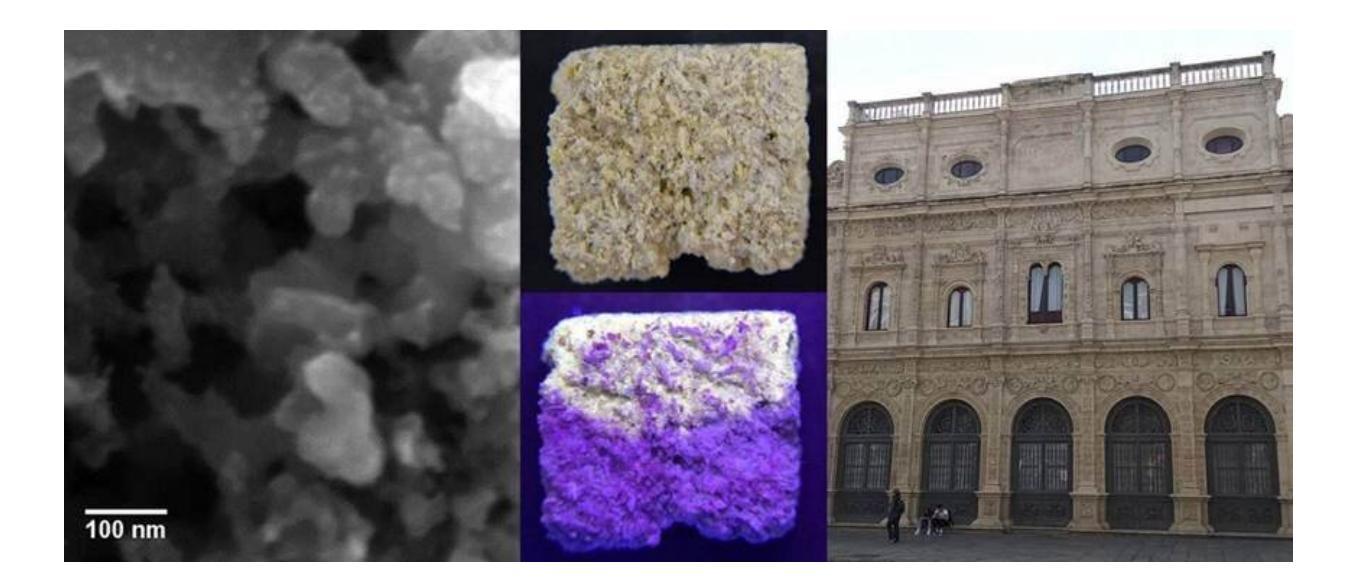
Calcium hydroxide nanoparticles doped with zinc oxide quantum dots (tiny white spheres). By treating the limestone samples with this material, the ultraviolet radiation can detect the penetration of the treatment (yellowish) into the stone. On the right, the Seville City Hall. Credit: José María Martín/Javier Becerra

"Thanks to the fluorescence of these <u>quantum dots</u>, we can evaluate the suitability of the treatment for a monument," he adds. "We only need to illuminate with <u>ultraviolet light</u> a cross-section of the treated material to determine how far the consolidating matter has penetrated."
