Red River flooding is worst in a decade

May 23 2022, by Michael Carlowicz

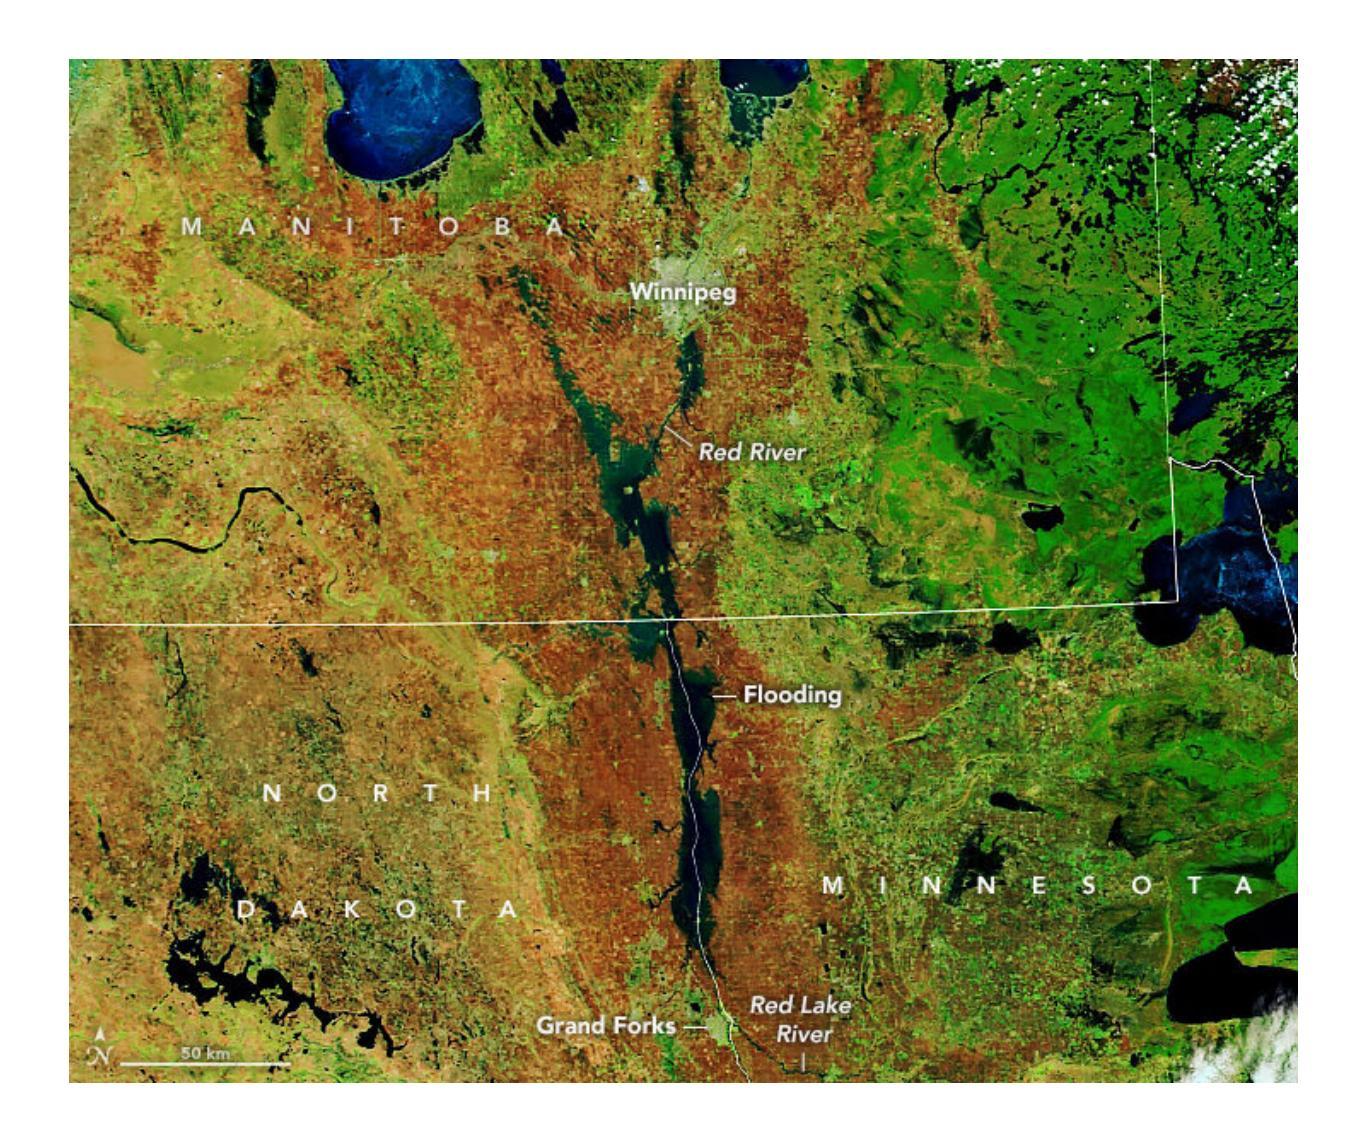
May 10, 2022. Credit: NASA Earth Observatory

The false-color images were acquired with the Moderate Resolution Imaging Spectroradiometer (MODIS) instruments on NASA's Terra and Aqua satellites. The first image shows the flooded valley as observed by Terra on May 10, 2022; Aqua acquired the second image two years earlier on May 11, 2020, under more typical spring conditions. The images combine shortwave infrared and <u>visible light</u> (MODIS bands 7-2-1) to better distinguish <u>river water</u> out of its banks.
