What's next for Artemis I after 2nd scrub?

September 7 2022, by Richard Tribou, Orlando Sentinel

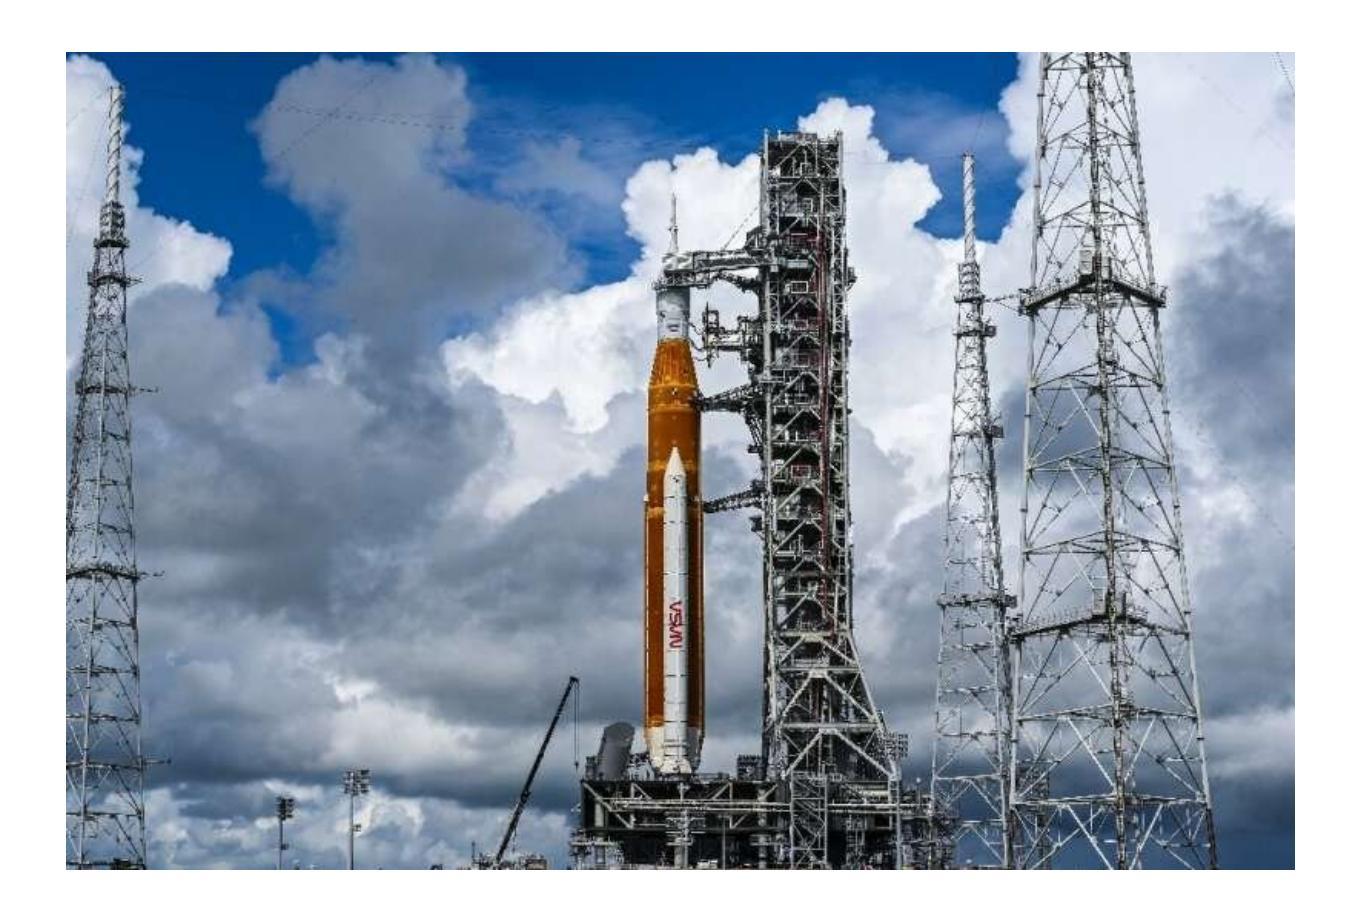
The Artemis I unmanned lunar rocket sits on the launch pad at the Kennedy Space Center in Cape Canaveral, Florida, on August 25, 2022. Credit: NASA
