The first SLS launch caused damage to the launch pad. How bad was it?

November 28 2022, by Scott Alan Johnston

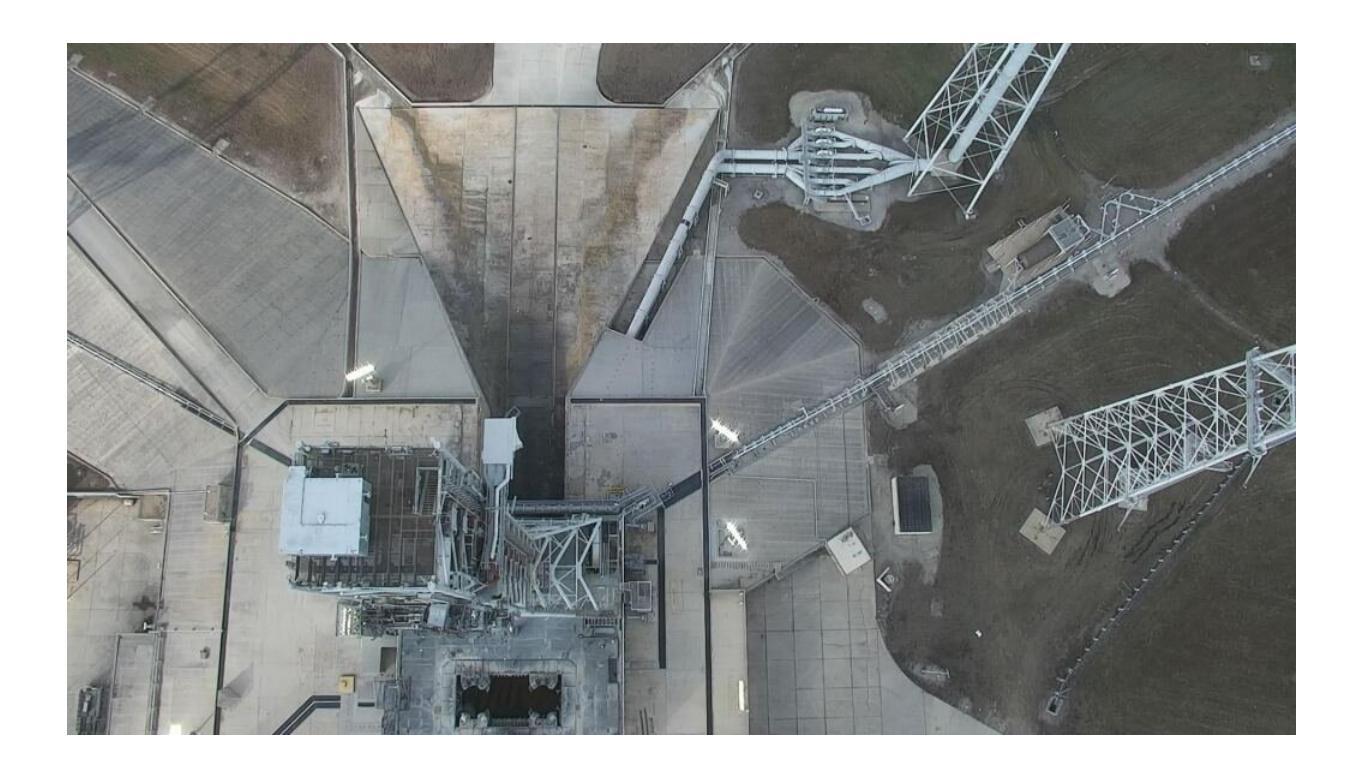
Launch pad 39B at Kennedy Space Centre, following the launch of Artemis I on November 16. Credit: <u>NASA</u>

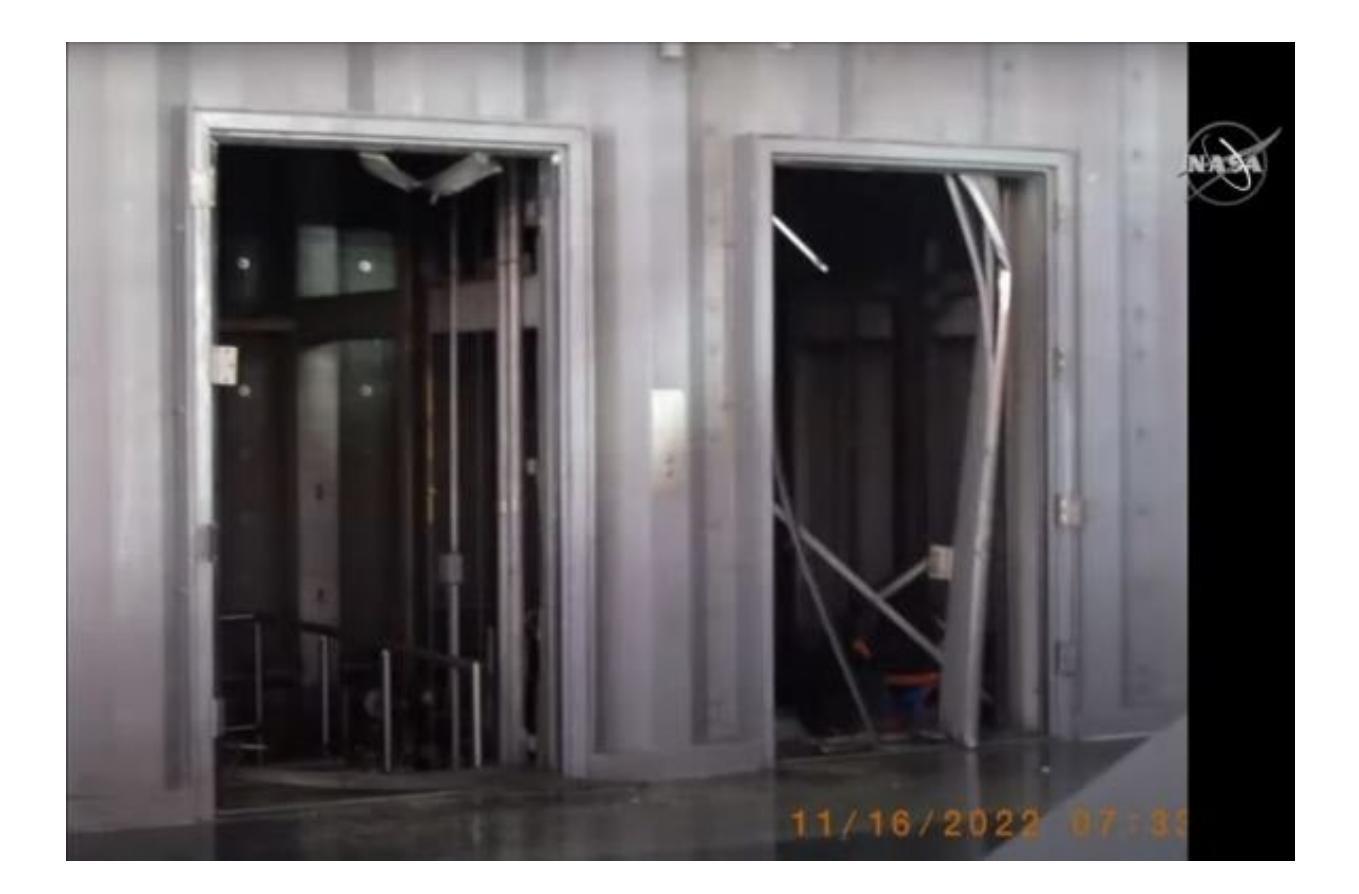
Damage included discoloration and peeling of paint on the pad, two cameras that were rendered inoperable, as well as the destruction of a pair of elevator doors, blown out by the intense pressure at launch. The upper levels of the mobile launcher are currently only accessible by stairs, and the elevators will take several months to repair.

The damaged elevator doors at pad 39B (Kennedy Space Centre). Credit: NASA TV screenshot

While the damage means some expensive repairs are required before a <u>second flight</u>, the pad "will be ready to support Artemis II and we had accounted for that previously in our pre-plan and our budget for the time between Artemis I and II," Sarafin assured reporters.
