## Solving the RIME deployment mystery on ESA's Juice mission

July 6 2023

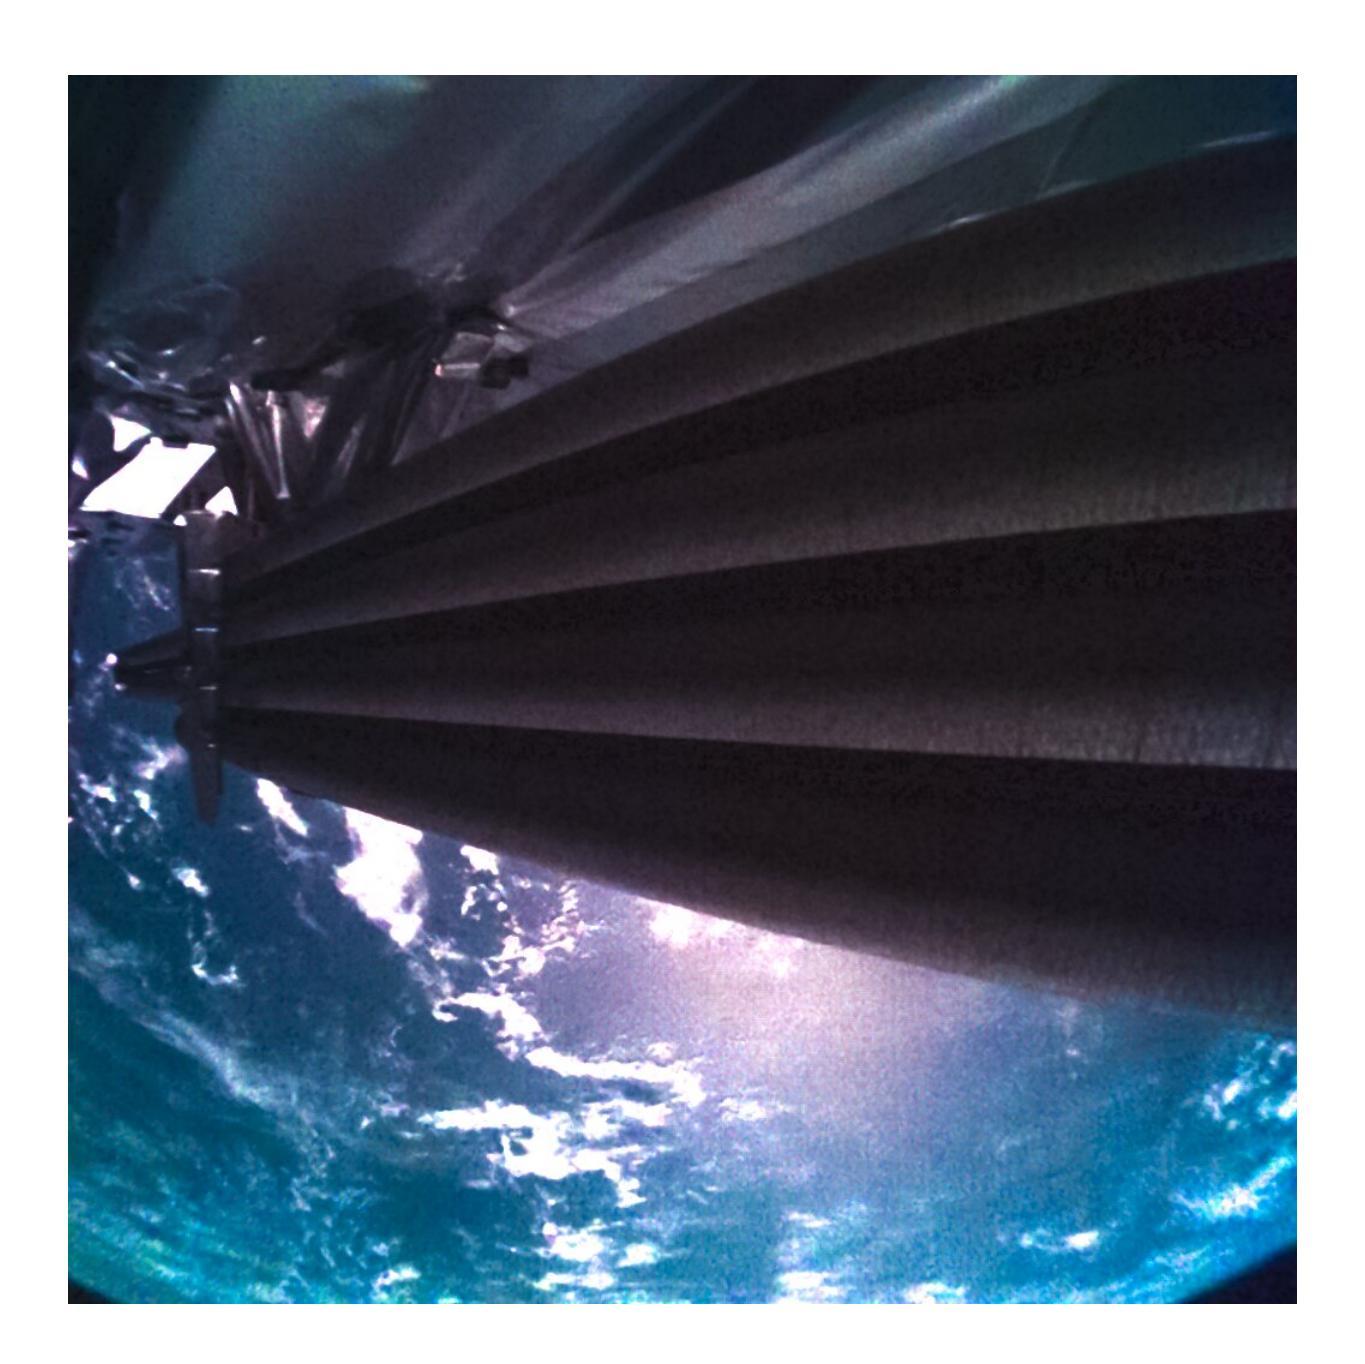
Juice's longest antenna awaits deployment. Credit: ESA/Juice/JMC, <u>CC BY-SA</u> <u>3.0 IGO</u>
