## **Study reveals material erosion and deposition in fusion reactors**

June 19 2024, by Zhang Nannan

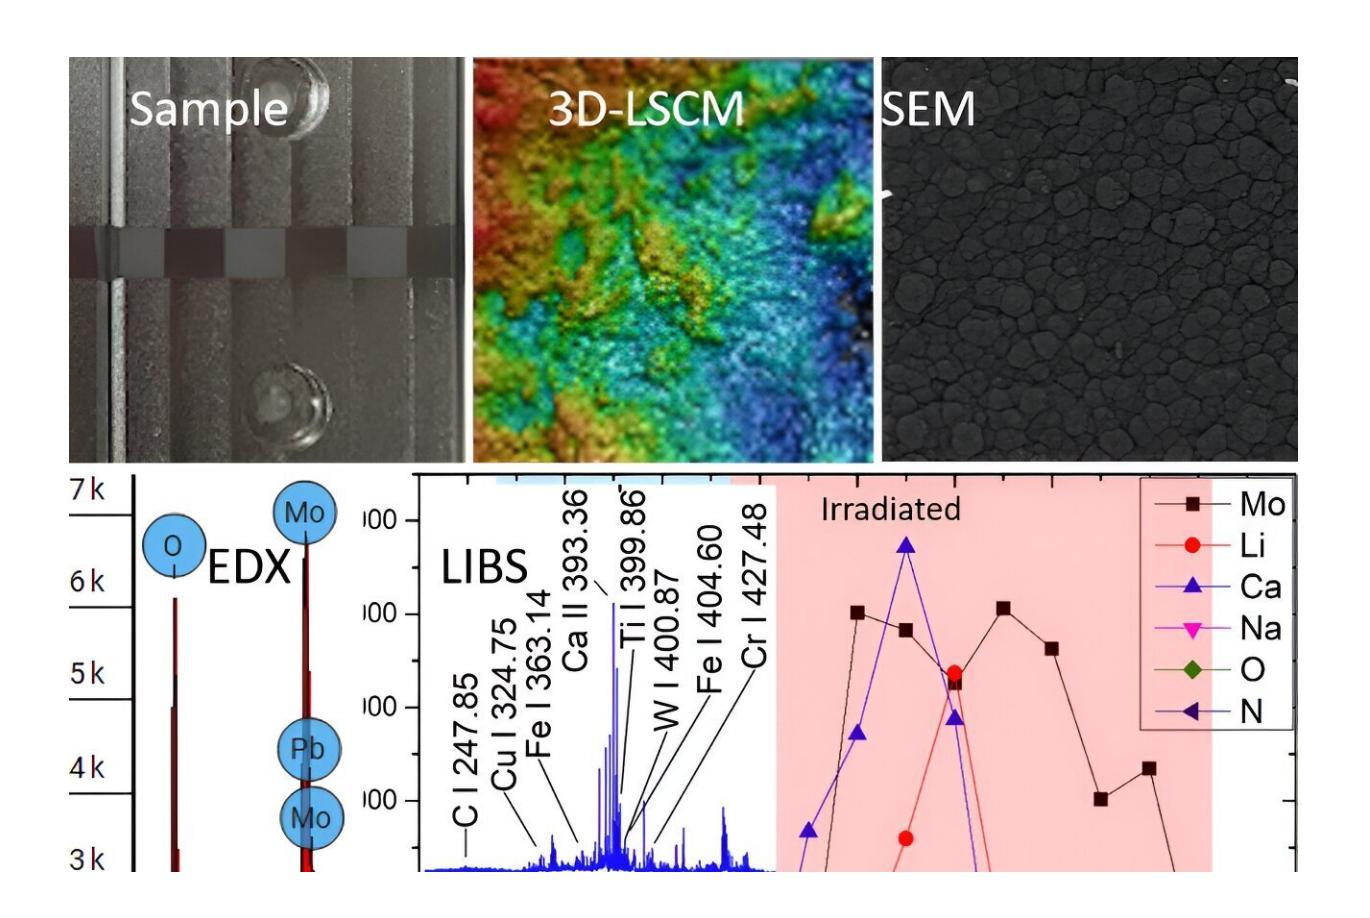
Surface morphology of irradiated test tiles and depth profiling of impurities by laser-induced breakdown spectroscopy. Credit: Muhammad Imran

In this study, the researchers used a technique called laser-induced breakdown spectroscopy to study these impurities. They found that the impurities come from the <u>erosion</u> of various materials, such as <u>tungsten</u>, <u>molybdenum</u>, and carbon used in the tokamak's walls and limiters.

The study showed that a layer of impurities about three micrometers thick formed on the surfaces inside the <u>tokamak</u>, indicating that all components experienced erosion due to high heat loads and energetic ions.
