Grenfell: a year on, here's what we know went wrong

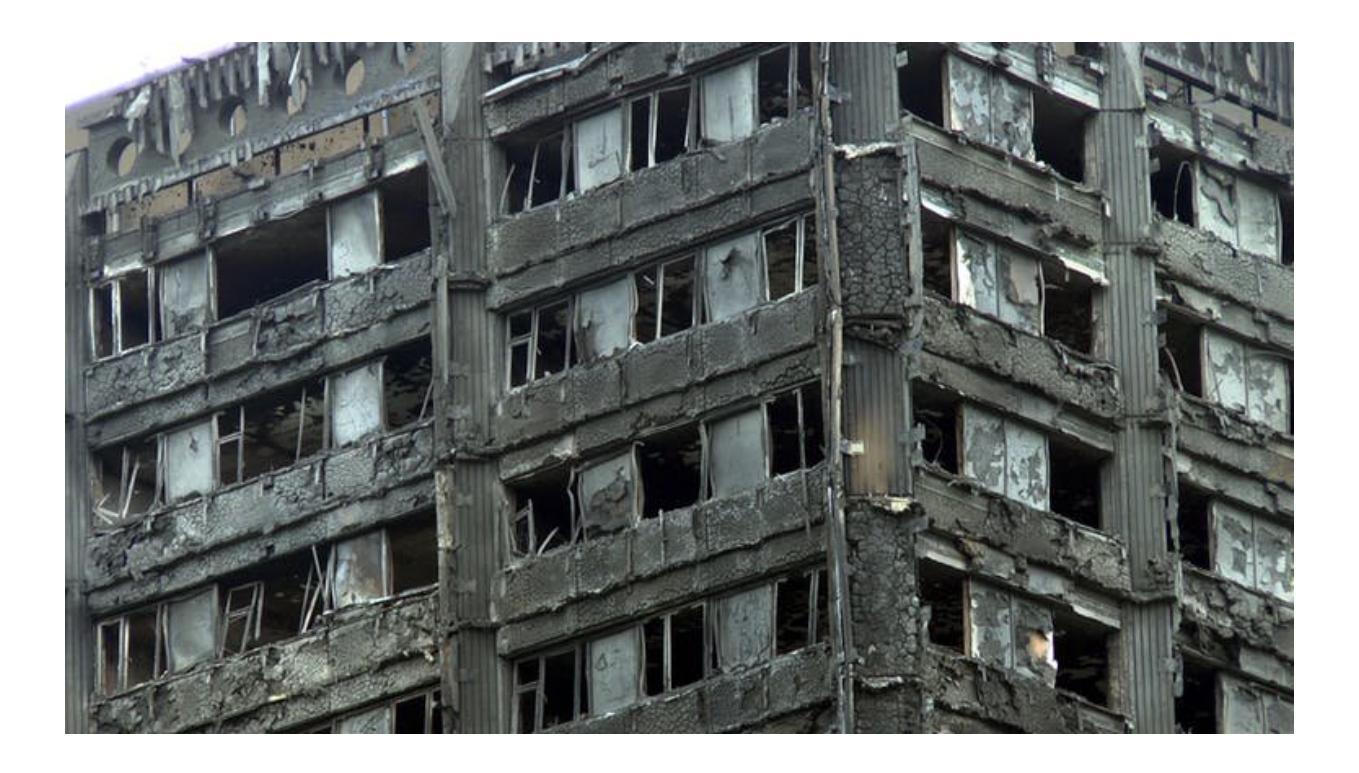
The flammable cladding was instrumental in the fire spreading so quickly. Credit: <u>Flickr/ChiralJohn</u>, <u>CC BY</u>

Immediately, the focus was put on the new exterior skin (cladding), which not only contained flammable materials (polyethylene insulation covered by thin aluminium sheets that buckle in high temperatures and

expose the internal material to flames) but was also installed onto the existing incombustible reinforced-concrete structure, in a way that left a gap between the facade and the building's structure. This enabled what is known as the "chimney effect". Put simply, the gap between the facade and the structural skeleton of the building meant that the fire sought oxygen and quickly travelled vertically, while burning more of the flammable skin.
