# Stress Management: X-Rays Reveal Si Thin-Film Defects

July 6 2006

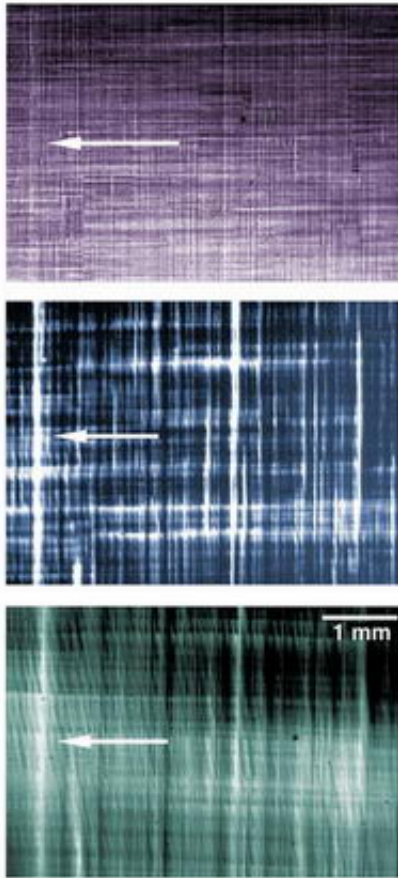
X-ray topographs of three different strata of a strained-silicon wafer show close correspondence in defects from the base silicon layer (top) through the final strained-silicon layer (bottom). Color has been added for contrast, one particular defect area is highlighted. Credit: NIST

interaction of defects in the multiple layers of these complex Si – SiGe – Si wafers. In a recent paper in *Applied Physics Letters*, researchers from NIST and AmberWave Systems Corporation (Salem, N.H.) detail a high-resolution form of X-ray topography that can distinguish individual crystal defects layer by layer. The technique combines an extremely low-angle incident X-ray beam (“glancing incidence”) to increase the signal from one layer over another and the use of highly monochromatic X-rays tuned to separate the contributions from each layer based on their different lattice spacings.

Their results show that crystal defects initially created at the interface between the silicon wafer and the SiGe layer become “templates” that propagate through that layer and create matching defects in the strained-silicon top layer. These defects, in turn, are notably persistent, remaining in the strained-silicon even through later processing that includes stripping the layer off, bonding it to an oxidized silicon wafer, and annealing it to create strained-silicon-on-insulator (SSOI) substrates.
