# 'Mighty Mouse' robot frees stuck radiation source

December 15 2005

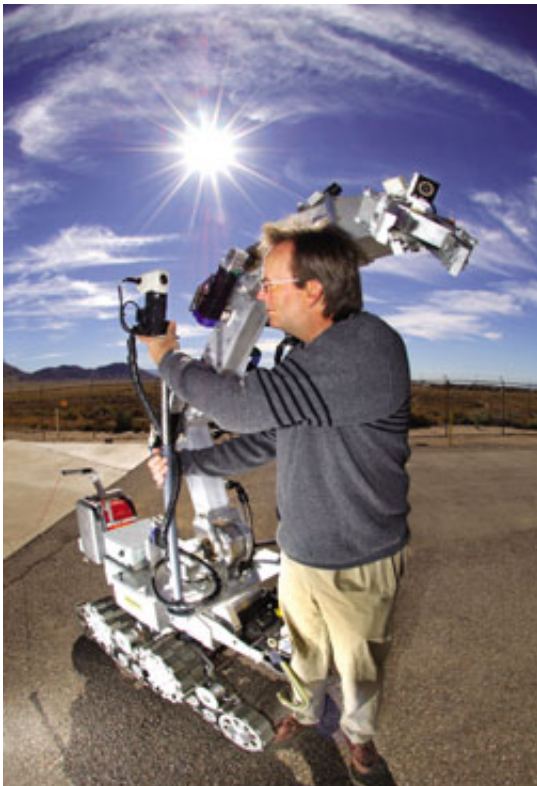
*Image: Bob Anderson demonstrates the capabilities of the robot affectionately known as the M2, for Mighty Mouse. (Photo by Randy Montoya)*

Richard Stump, Sandia RAP leader, explained the problem to robotics manager Phil Bennett, who said his group had a robot that might do the job. The 600-pound, five-foot-long robot, which became unofficially known as M2, rolled on treads, could maneuver around obstacles, and had a long, multi-jointed gripper arm with the dexterity to reach into awkward places and apply force to drills and screwdrivers. It could remember positions, important in starting with tools at the right height and depth. It was intended as a bomb-disabling unit.

Because the robot lacked a trigger finger to depress and release a drill control, the Sandia team stalked the aisles of local hardware stores, buying cordless drills and other equipment they modified into remotely operated drills, hooks, and grippers. On tests performed at Sandia by Bob Anderson and Jim Buttz on a mock-up of the stuck container and switch sent north from White Sands, M2 performed perfectly.
