# Sandia announces completion of mixed waste landfill cover construction

November 3 2009

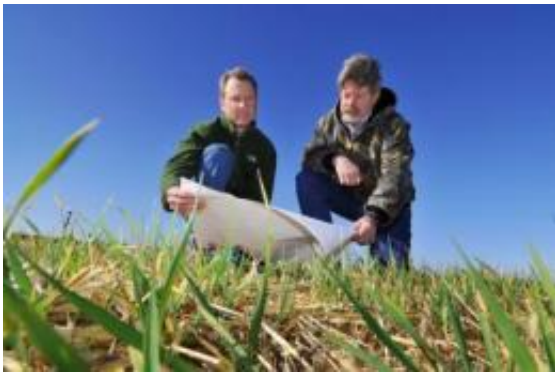
Environmental managers Mike Mitchell and Don Schofield are on the evapotranspirative cover of the Mixed Waste Landfill. Credit: Photo by Randy Montoya

The protective cover consists of four engineered layers, including three layers of compacted soil and a biointrusion rock barrier that will keep burrowing animals out of the former disposal areas. Together, these four layers and the native plants will control water infiltration, thus isolating the wastes from the accessible environment. Because the cover is

constructed without rigid layers, it can accommodate differential subsidence without undue impairment of its performance.

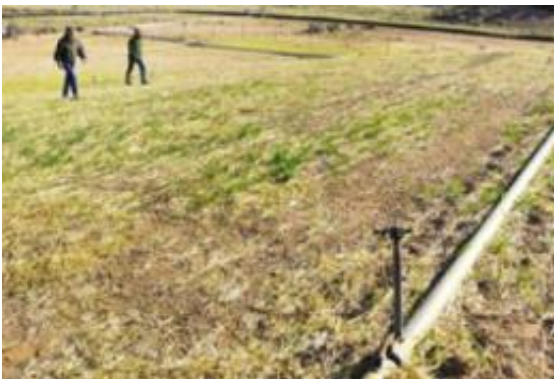
Environmental managers Mike Mitchell and Don Schofield check on the

establishment of the new vegetation on the MWL cover. Credit: Randy Montoya
