Tracking down rust

April 5 2010

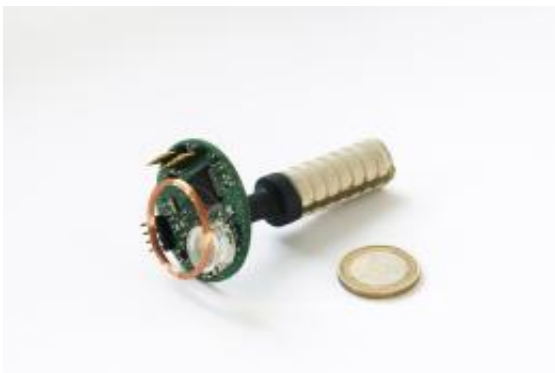
The passive sensor-transponder continuously monitors the protective coating of concrete bridges, allowing corrosion damage to be detected at an early stage. (© Fraunhofer IMS)

The sensor itself is crisscrossed by very fine iron wires, laid down at even distances. "If the dissolved salts reach the iron wires, these begin to corrode and break. The number of defective iron wires is an indicator of the extent of corrosion and the depth to which the concrete's protective layer has been penetrated. This allows us to determine when the next repair work needs to be carried out," explains Frederic Meyer, a researcher at the IMS. The transponder transmits the measured data by wireless to the reading device carried by the construction workers. "Our transponder does not get the energy it needs to measure the corrosion from a battery, but from a magnetic field. This means it does not need to be replaced and can remain within the [concrete](#) structure permanently," says Meyer.
