Report cites 'liquefaction' as key to much of Japanese earthquake damage

April 18 2011

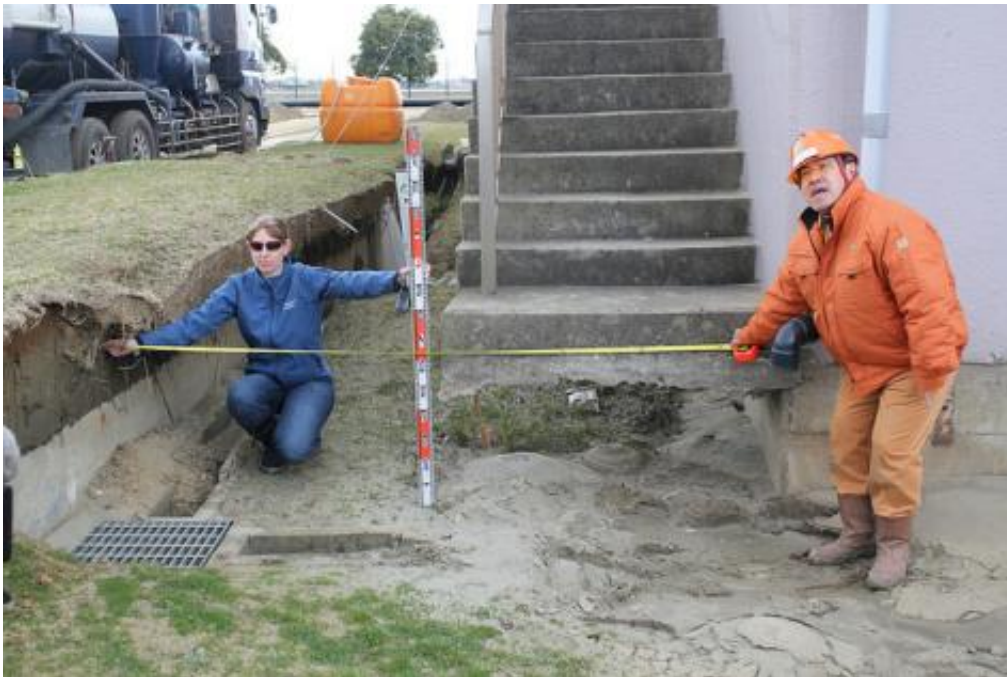
Liquefaction induced by the recent earthquake in Japan caused nearly three feet of settlement at this water purification plant that serves 19,000 people, breaking pipes and flooding underground structures. Measuring the damage are Jennifer Donohue, a member of the Geotechnical Extreme Events Reconnaissance team with Geosyntec Consultants, and an engineer from the Wanigawa Water Purification Plant. (Photo by Scott Ashford, courtesy of Oregon State University)
