Accident damages mirror on telescope slated for dark energy camera

February 27 2012, By Nancy Atkinson

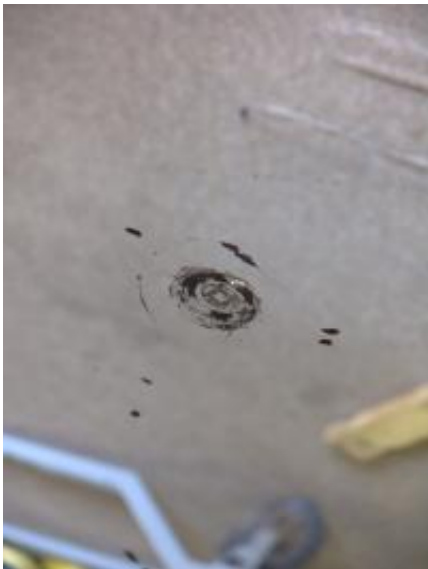
Cracks in the secondary mirror on the Blanco telescope in Chile after an accident on February 20, 2012. Credit: Cerro Tololo Inter-American Observatory

The mirror itself impacted the dome floor, causing the fractures, pictured above.

An accident at the Blanco 4m telescope at Chile's Cerro Tololo Inter-American Observatory has severely damaged a secondary mirror. The telescope is currently shut down for installation of the highly anticipated Dark Energy Survey Camera, and on February 20, 2012, the telescope's f/8 secondary mirror was dropped during testing, resulting in fractures in the glass in the center of the mirror. Officials at the telescope said they are analyzing the extent of the damage to the mirror, and whether it extends beyond the visible cracks on the surface. They are also

Two staff members were injured during the incident, but are expected to fully recover. According to a [post](#) on the CTIO website, the f/8 had been removed for the installation of the DECam, and the f/8 was on the dome floor to test the focus mechanism. “The mirror and its back end assembly were being transferred to a handling cart to enable the tests. Unfortunately, the mirror was improperly installed on the cart and when the mirror was being rotated on the cart, the entire cart/mirror assembly toppled over injuring two of our technical staff,” said the report.

At this time, officials say it is not clear if the mirror is repairable or not and are reviewing what needs to be done to stabilize the cracks in the mirror. The accident is being investigated and initially, officials said they didn’t expect the incident delay the installation and commissioning of [Dark Energy](#) Camera as the f/8 is not required for the installation or operation of the Dark Energy Camera system. However, a later update said the DECam installation schedule was being modified to allow for the absence of the f/8 mirror.
