# Mars rover Curiosity prepares for test drive (Update)

August 21 2012, by ROBERT JABLON

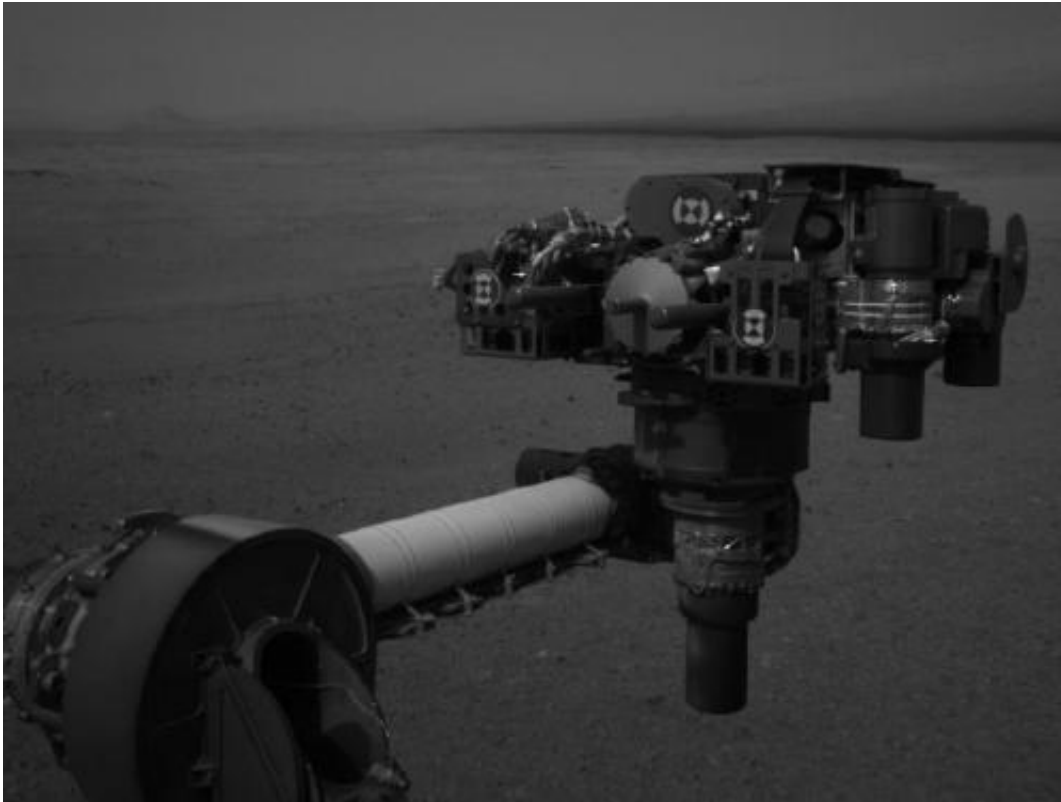
This full-resolution image from NASA's Curiosity shows the turret of tools at the end of the rover's extended robotic arm on Aug. 20, 2012. The Navigation Camera captured this view. Image credit: NASA/JPL-Caltech

Scientists also continued to test and calibrate Curiosity's 7-foot (2.1-meter)-long arm and its extensive tool kit — which includes a drill, a scoop, a spectrometer and a camera — in preparation for collecting its first soil samples and attempting to learn whether the Martian environment was favorable for microbial life.

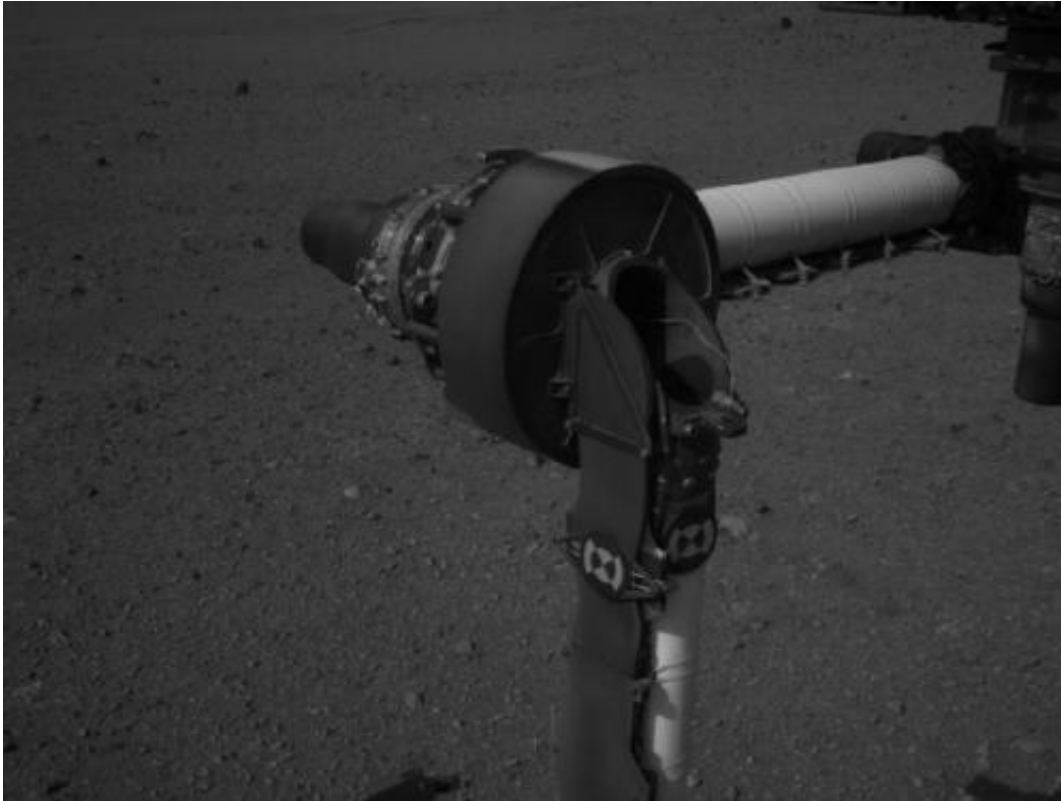
This full-resolution image from NASA's Curiosity shows the elbow joint of the rover's extended robotic arm on Aug. 20, 2012. The Navigation Camera captured this view. Image credit: NASA/JPL-Caltech
