# Long-forgotten seawall protected New Jersey homes from Hurricane Sandy's powerful storm surges

July 16 2013

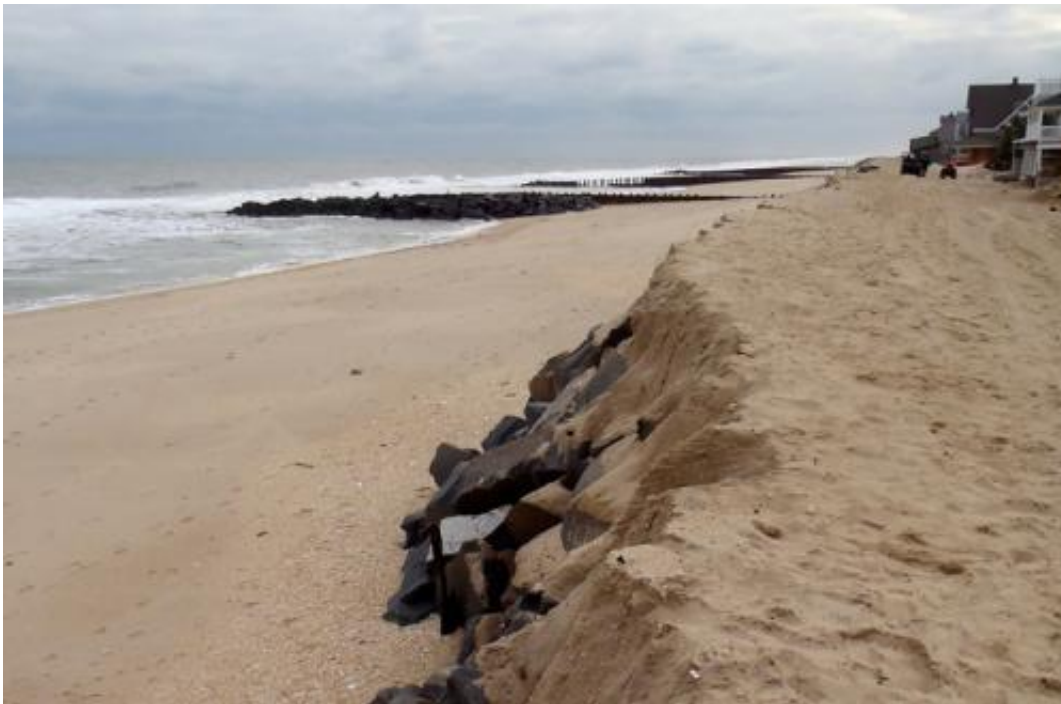
A forgotten, 1,260-meter seawall buried beneath the beach helped Bay Head weather Sandy's record storm surges and large waves over multiple high tides, according to a team of engineers and geoscientists led by Jennifer L. Irish, an authority on storm surge, tsunami inundation, and erosion at Virginia Tech. Credit: Jennifer Irish/Virginia Tech

"Once we got there, we immediately saw the seawall," Irish said. "The beach and dunes did their job to a certain point, then, the seawall took over, providing significant dampening of the waves. It was the difference between houses that were flooded in Bay Head and houses that were reduced to piles of rubble in Mantoloking."

In Mantoloking, the entire dune almost vanished. Water washed over the barrier spit and opened three breaches of 165 meters, 59 meters, and 35 meters, where the land was swept away. In Bay Head, only the portion of the dune located seaward of the seawall was eroded and the section of dune behind the seawall received only minor local scouring.

Despite the immense magnitude and duration of the storm, a relatively small coastal obstacle reduced potential wave loads by a factor of two and was the difference between widespread destruction and minor structural impacts, the researchers said.
