## NASA's Orion sees flawless fairing separation in second test

November 8 2013

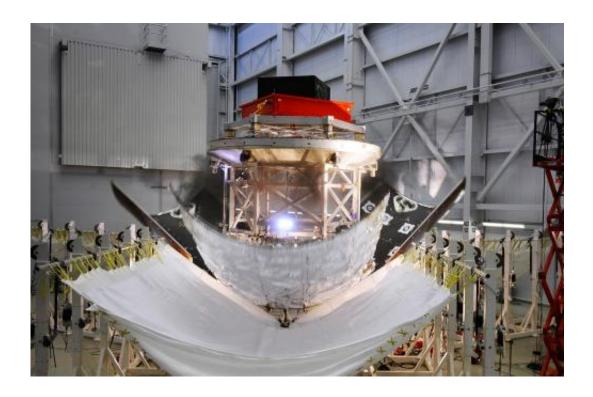
The three panel or fairings encapsulating a stand-in for Orion's service module successfully detach during a test Nov. 6, 2013 at Lockheed Martin's facility in Sunnyvale, Calif. Credit: Lockheed Martin

Unlike conventional rocket fairings, these panels are designed to support half of the weight of Orion's crew module and launch abort system during launch and ascent, which improves performance, saves weight and maximizes the size and capability of the spacecraft. Each panel is 14 feet high and 13 feet wide.

The fairings' work is done soon after launch. They must be jettisoned when Orion has reached an altitude of about 560,000 feet. To make that possible, six breakable joints and six explosive separation bolts are used to connect the fairing panels to the rocket and each other. In a carefully timed sequence, the joints are fired apart, followed shortly by the bolts. Once all of the pyrotechnics have detonated, six spring assemblies will push the three panels away, leaving the service and <u>crew module</u> exposed to space as they travel onward.

This test, conducted by Orion's primary contractor, Lockheed Martin, at the company's Sunnyvale, Calif., facility, was the second test of the fairing separation system. The first occurred in June, when one of the three fairing panels did not completely detach. Engineers determined the issue was caused when the top edge of the fairing came into contact with the adapter ring and kept it from rotating away and releasing from the spacecraft. Because of the engineers' confidence in successfully eliminating the interference, they maintained plans to increase this week's test fidelity by emulating the thermal loads experienced by the fairings during ascent. They used strip heaters to heat one of the fairings to 200 degrees Fahrenheit and simulate the temperatures the panels will experience.
