New view of dendrites in Li batteries gets to the root of the problem

December 9 2013, by Lisa Zyga

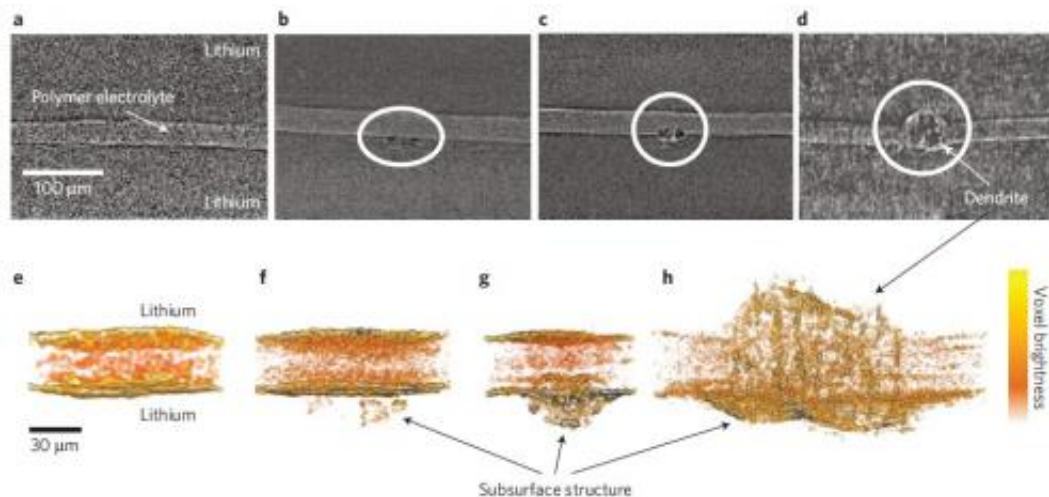
(a-d) X-ray tomography slices showing the evolution of dendrite growth as the charge increases from 0 to a shorted cell. (e-h) 3D reconstructions of the cells shown in the top panel show the formation of dendritic structures as they begin to form in the bottom electrode until they span the thickness of the electrolyte in the shorted cell (d, h). Credit: Harry, et al. ©2013 Macmillan Publishers Limited. All rights reserved.

Using this technique, the researchers could watch as the seeds of dendrite formation appear in the electrode material, and then as the dendrites continue to grow into the electrolyte as the battery is repeatedly cycled. The researchers observed that in the early and intermediate stages of battery cycling, the majority of the dendrite's volume lies within the electrode, not the electrolyte. Only at the more advanced stages does the bulk of the dendrite volume lie within the electrolyte. Yet when imaged with a commonly used scanning electron microscope, none of the dendrites in the electrode are visible.

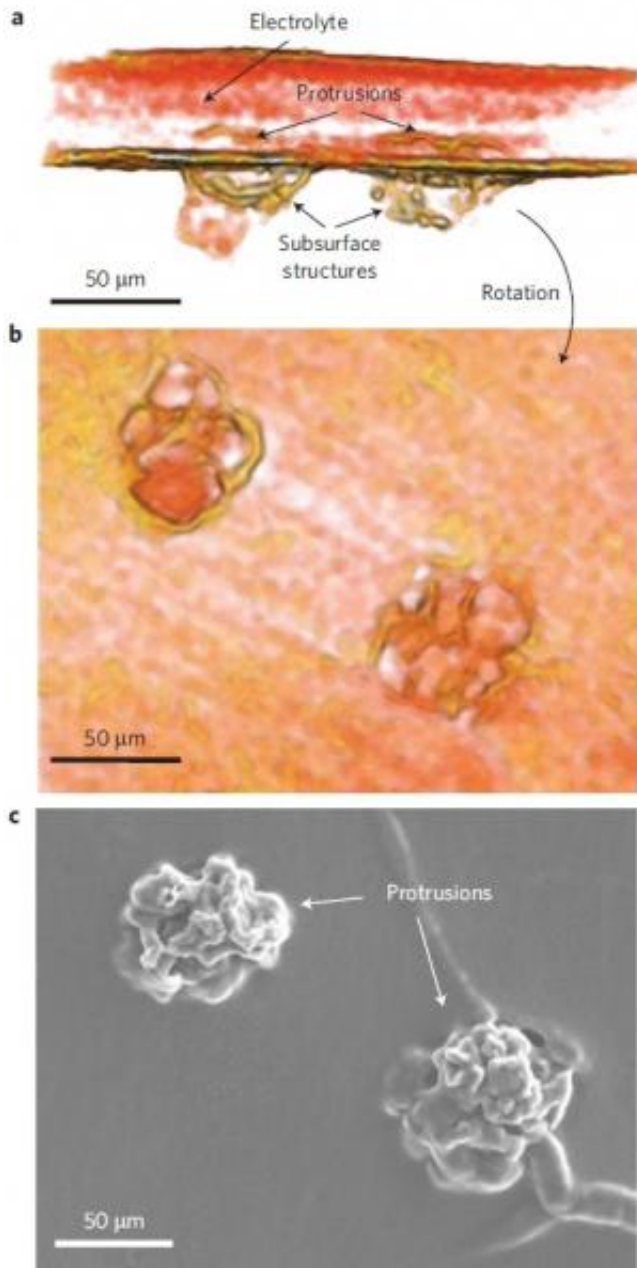
(a) A 3D reconstruction of two dendrites show the subsurface structures below the protrusions into the electrolyte. (b) A rotated view. (c) An SEM micrograph of the same cell contains no direct evidence for the presence of subsurface structures under the protrusions. Credit: Harry, et al. ©2013 Macmillan Publishers Limited. All rights reserved.

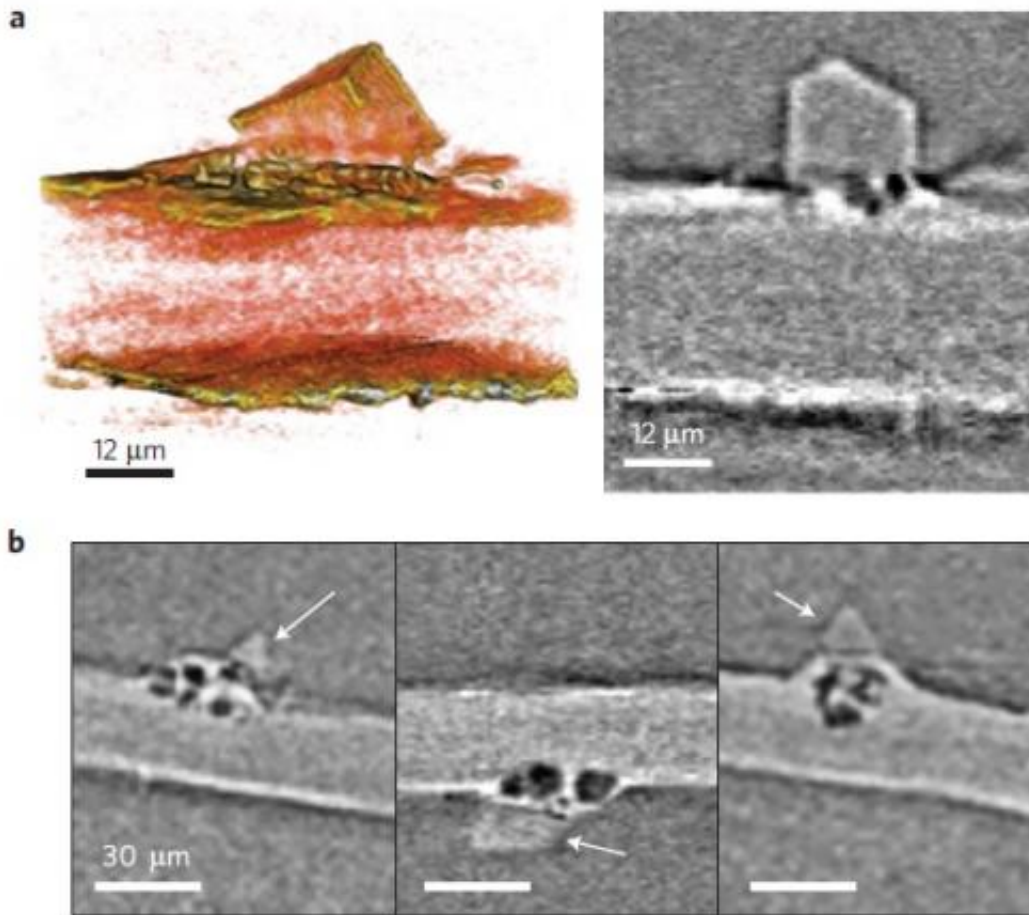
(a) A 3D reconstruction of a crystallite at the electrolyte/electrode interface. (b) X-ray microtomography images of dendrites with crystallites at their base. Arrows point to the crystallites. Credit: Harry, et al. ©2013 Macmillan Publishers Limited. All rights reserved.

Using the X-ray tomography technique, the researchers could see crystalline contaminants appearing as bright specks in the Li electrode. They note that every dendritic structure that they observed has a bright speck at its base, which suggests that eliminating these contaminants may be key to solving the Li dendrite problem.
