Building 'belt' offers cheap, quick repair of earthquake damage

January 13 2014

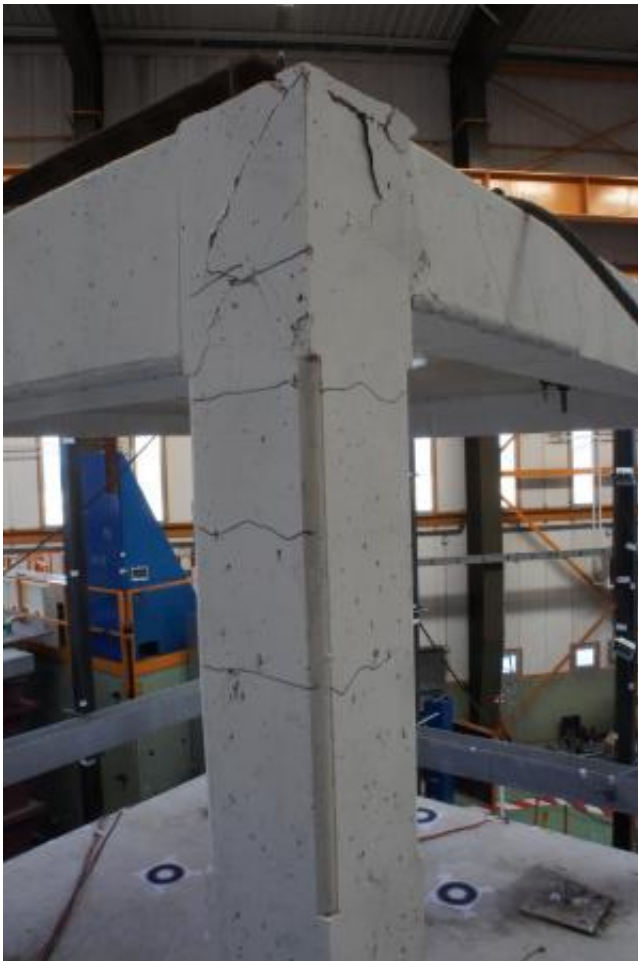
This is a damaged second floor building joint prior to testing with post tensioned metal straps. Credit: University of Sheffield

The building was constructed on a specially designed 'shaking table' which can simulate ground movement caused by earthquakes. During the first test, the building was very near collapse following a small earthquake similar in scale to a magnitude 4 on the Richter scale having

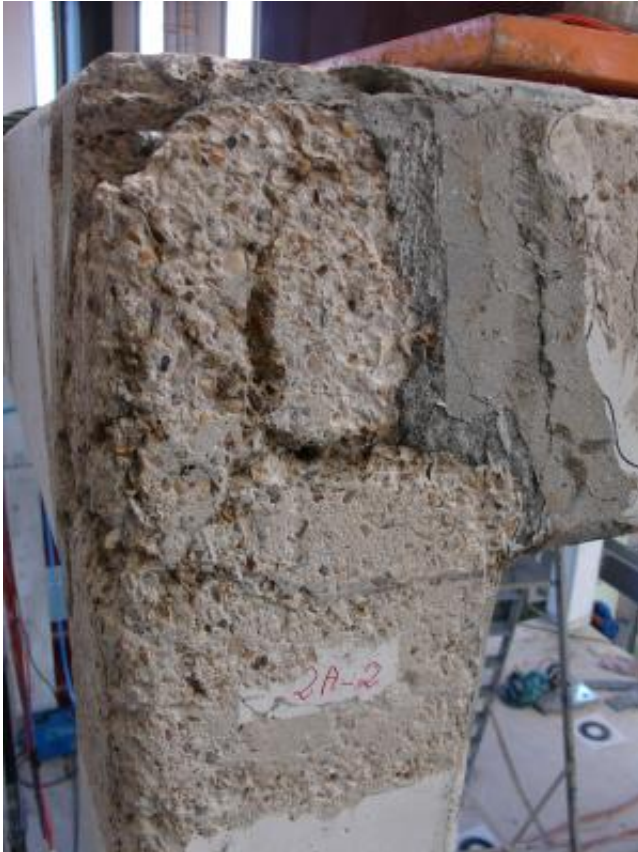
This is the same building joint, following application of post tensioned metal straps and tested on shaking table to equivalent of magnitude 7 earthquake.
Credit: University of Sheffield

The technology involves wrapping metal straps around each floor of the building, which are then tensioned either by hand or using compressed air tools. It is designed for use on reinforced concrete frame buildings – a common construction technique around the world, including countries like Haiti. Unlike other repair methods, it does not require expensive materials or a high level of technical knowledge, making it ideal for use in the [developing world](#).

The building was then repaired using the post-tensioned metal straps and retested. The researchers were unable to make the building fail during a major earthquake similar in scale to the magnitude 7 Haiti earthquake at the epicentre and stopped the test at that point.
