# NASA aces delicate operation with aircraft tail

March 28 2014, by Jim Banke

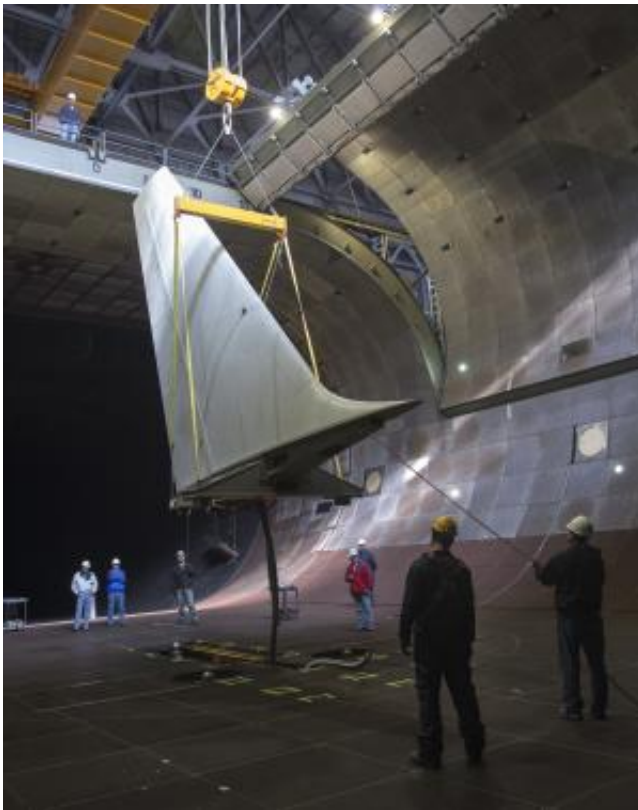
A 40-ton crane carefully lowers the aircraft tail from the rafters down through the open doors of the tunnel's roof. Credit: NASA / Eric James

Beginning in an enclosed staging area outside the wind tunnel, the 757 tail was lifted into its vertical position and raised high up into the rafters by a 40-ton bridge crane. A pair of clamshell-like doors that make up the roof of the 40x80 wind tunnel was opened and the tail was moved sideways into place above the open cavity.

Here some handrails in the highest levels of the complex had to be removed, requiring spotters to wear safety tethers, so there would be room for the tail to pass. At one point the top of the tail had to go in between two of the bridge crane beams in order to give the bottom of the tail enough room to clear the top of the tunnel.

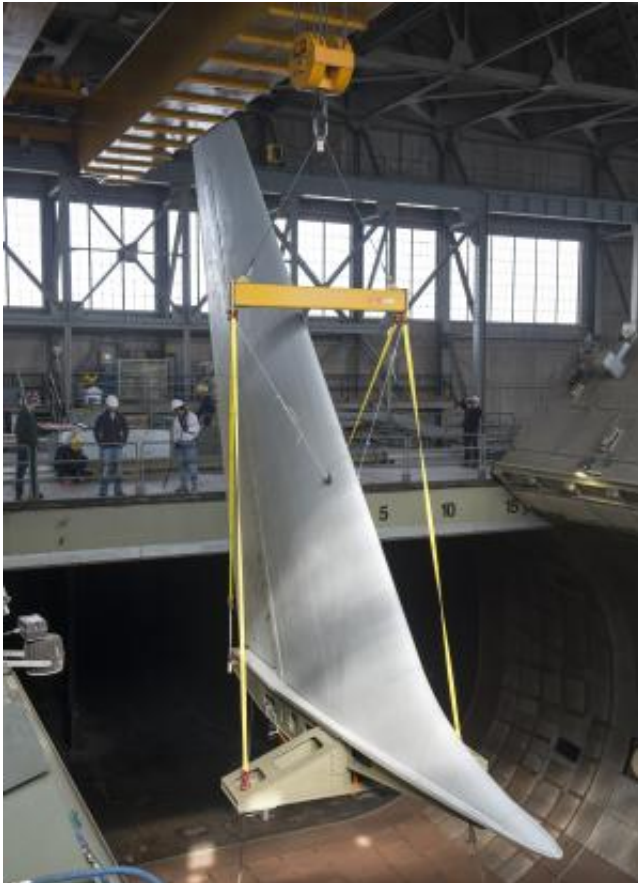
Almost there! Workers guide the full-size aircraft tail closer to its position on the tunnel floor. Credit: NASA / Eric James

Then the tail was lowered into position and attached to a special mount on the floor of the wind tunnel, allowing everyone to breathe a sigh of relief and press on with the tests that were the whole reason the installation was required in the first place.
