How salt causes buildings to crumble

September 11 2014

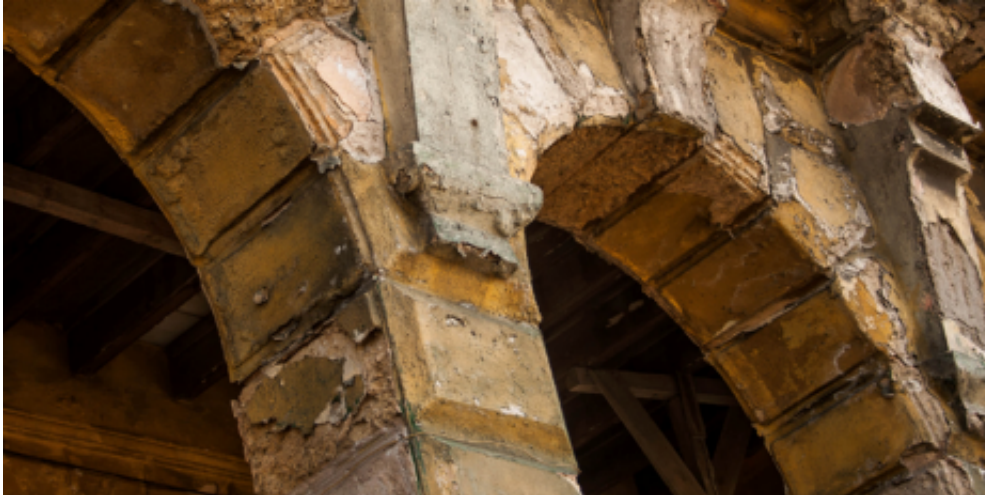
Salt is a big problem for buildings in Havana's old town, which lies by the sea.
Credit: Julio Llopiz / ETH Zurich

The researchers at ETH are now planning to use their findings in a project in Havana's old town, where salt is a major issue. The special render used in restoration work crumbles away from building façades after just a few years, and the aim of the research project is to discover the exact cause. The scientists involved in this research at ETH Zurich and Princeton University are also hoping to find ways to reduce salt damage, such as by changing the pores of building materials on a molecular scale.
