NASA's Wallops flight facility completes initial assessment after Orbital launch mishap

October 30 2014, by Stephanie Schierholz

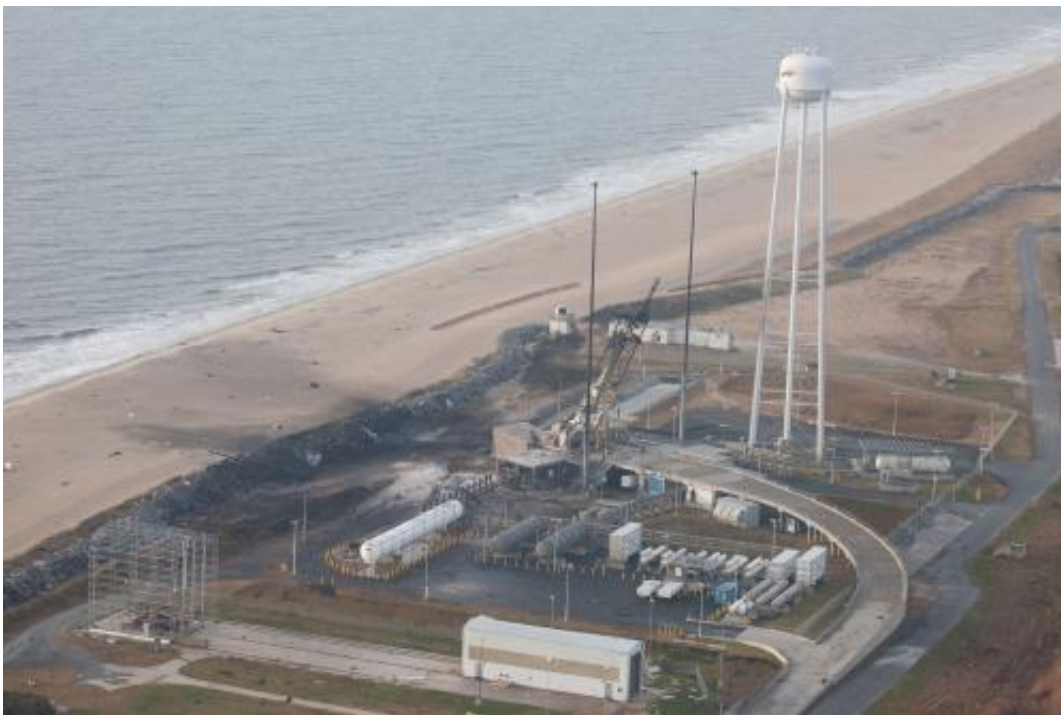
An aerial view of the Wallops Island launch facilities taken by the Wallops Incident Response Team Oct. 29 following the failed launch attempt of Orbital Science Corp.'s Antares rocket Oct. 28. Credit: NASA/Terry Zaperach

The initial assessment is a cursory look; it will take many more weeks to further understand and analyze the full extent of the effects of the event. A number of support buildings in the immediate area have broken windows and imploded doors. A sounding rocket launcher adjacent to the pad, and buildings nearest the pad, suffered the most severe damage.

At Pad 0A the initial assessment showed damage to the transporter erector launcher and lightning suppression rods, as well as debris around the pad.
