Premature wear on WA roads caused by wet base coat

March 24 2015, by Cristy Burne

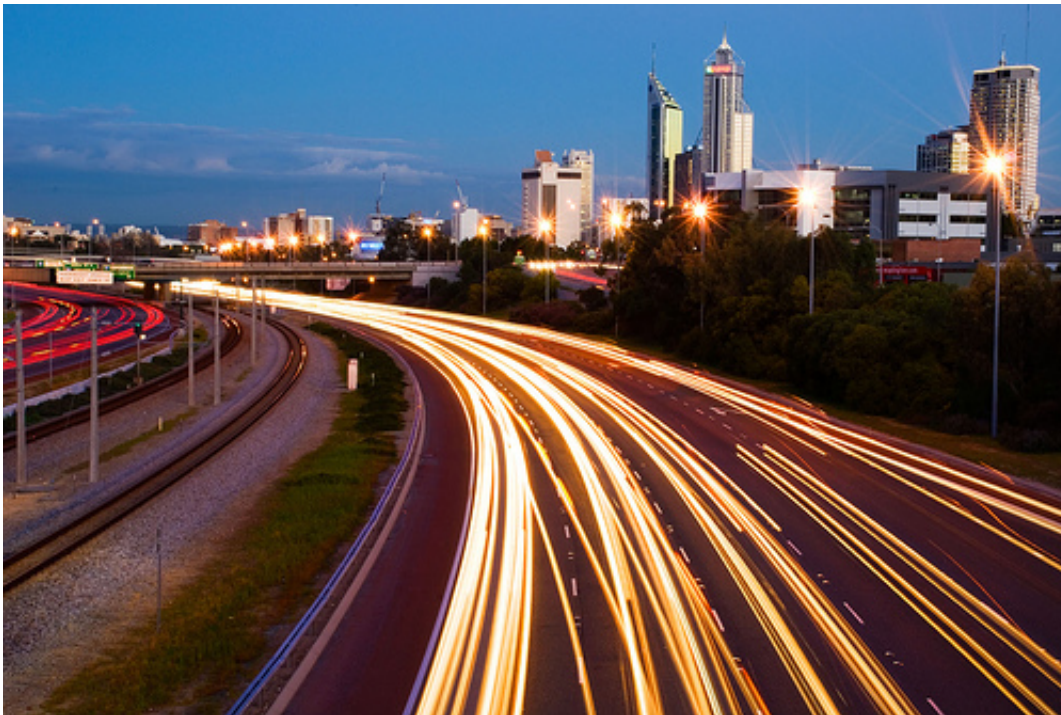
HCTCRB, which was first developed to increase the strength of crushed rock bases and overcome the shrinkage problem associated with ordinary CTB, offers higher strength, improved flexibility and lower moisture sensitivity, making it especially useful for heavily trafficked roads. Credit: Petar
