# First robot into Fukushima reactor stalls, but gets some data

April 13 2015, byMari Yamaguchi

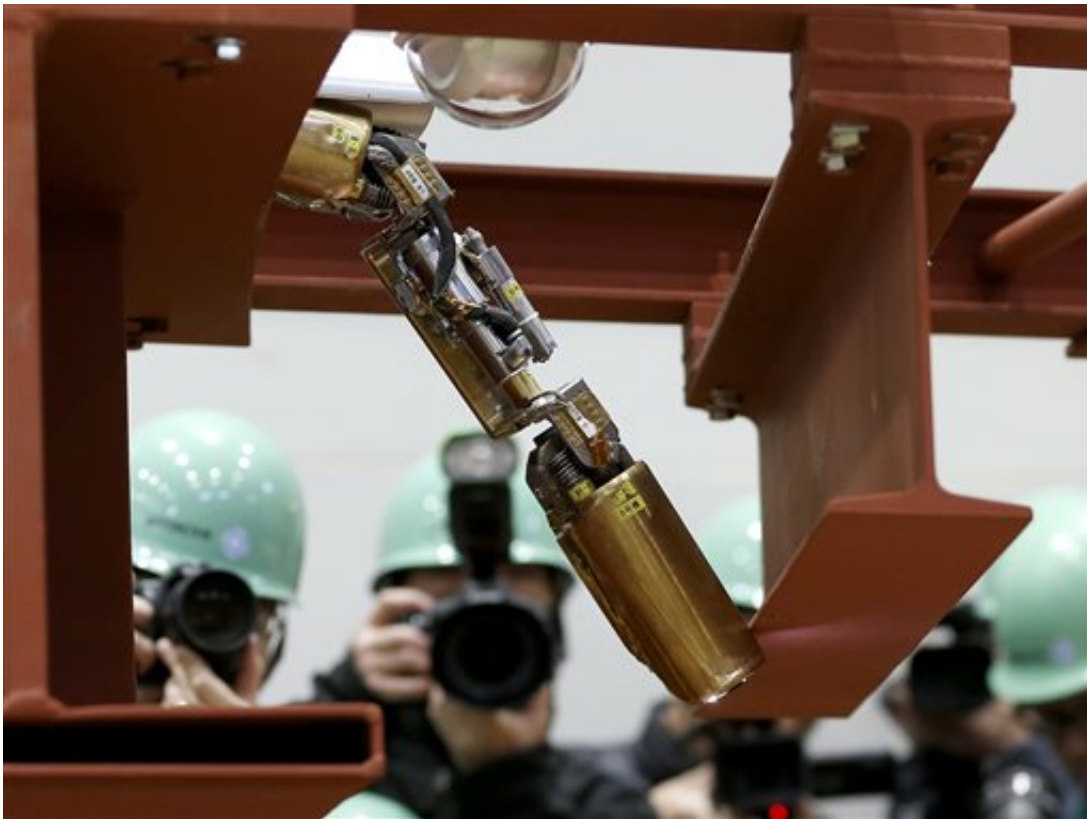
In this Thursday, Feb. 5, 2015 file photo, a remote-controlled robot that looks like an enlarged fiberscope crawls down into the mock-up of a primary containment chamber of Fukushima Dai-ichi nuclear plant, during a demonstration for the media at a government facility in Hitachi, Ibaraki Prefecture, northeast of Tokyo. Tokyo Electric Power Co., the operator of the wrecked Fukushima nuclear plant, said Monday, April 13, the first robot, the same type shown in the photo, sent inside one of melted reactors stalled before finishing its work but it collected data that indicates a path to send robots deeper into the reactor is intact. TEPCO said the robot stalled after completing two-

thirds of Friday's planned mission inside the Unit 1 containment vessel. (AP Photo/Shizuo Kambayashi)

The 60-centimeter (2-foot) -long, snake-shaped robot entered the containment chamber through a pipe and transformed into a U-shape crawler after it landed on the platform.
