Video reveals dramatic SpaceX falcon rocket barge landing and launch

April 20 2015, by Ken Kremer

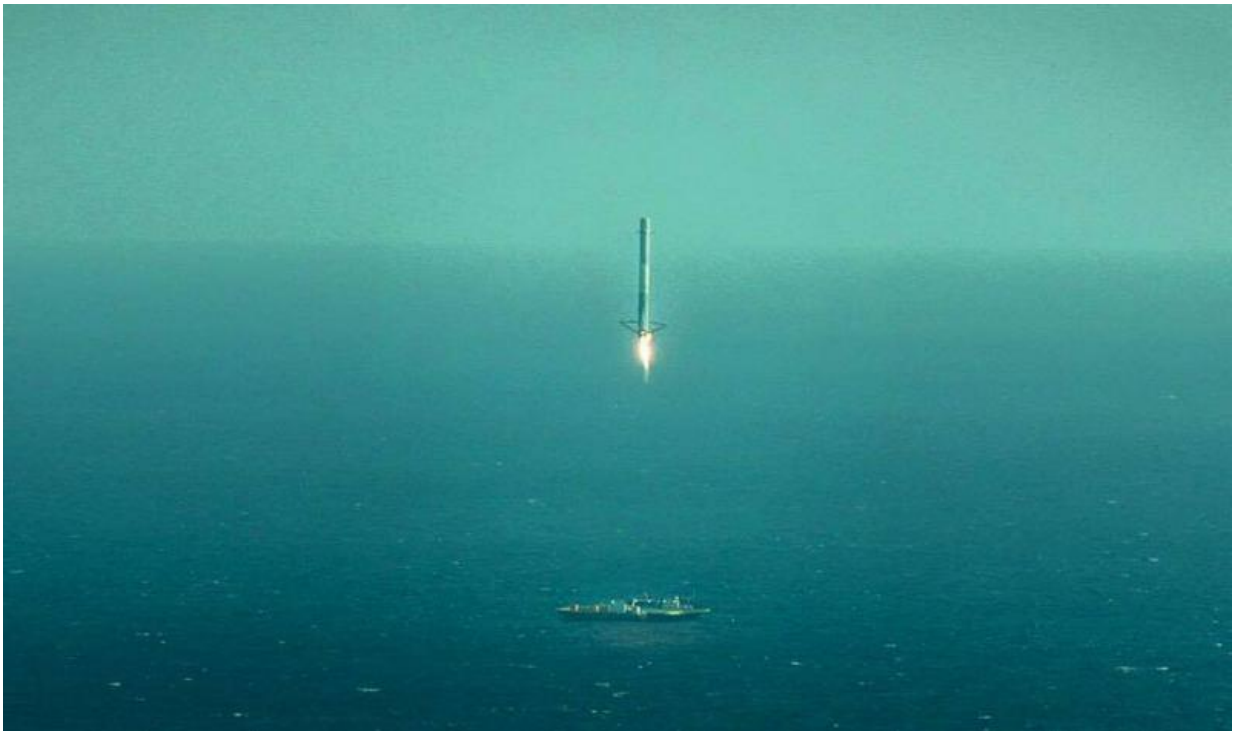
View of Falcon 9 first stage landing burn and touchdown on 'Just Read the Instructions' landing barge. Credit SpaceX

The dramatic hi res landing video was released by SpaceX CEO Elon Musk. It clearly reveals the deployment of the four landing legs at the base of the booster as planned in the final moments of the landing attempt, aimed at recovering the first stage booster.

"Looks like Falcon landed fine, but excess lateral velocity caused it to tip over post landing," tweeted SpaceX CEO Elon Musk.

The Falcon successfully reached the tiny ocean floating barge in the Atlantic Ocean, but tilted over somewhat over in the final moments of the approach, and tipped over after landing and exploded in a fireball.

"Either not enough thrust to stabilize or a leg was damaged. Data review needed."

"Looks like the issue was stiction in the biprop throttle valve, resulting in control system phase lag," Musk elaborated. "Should be easy to fix."

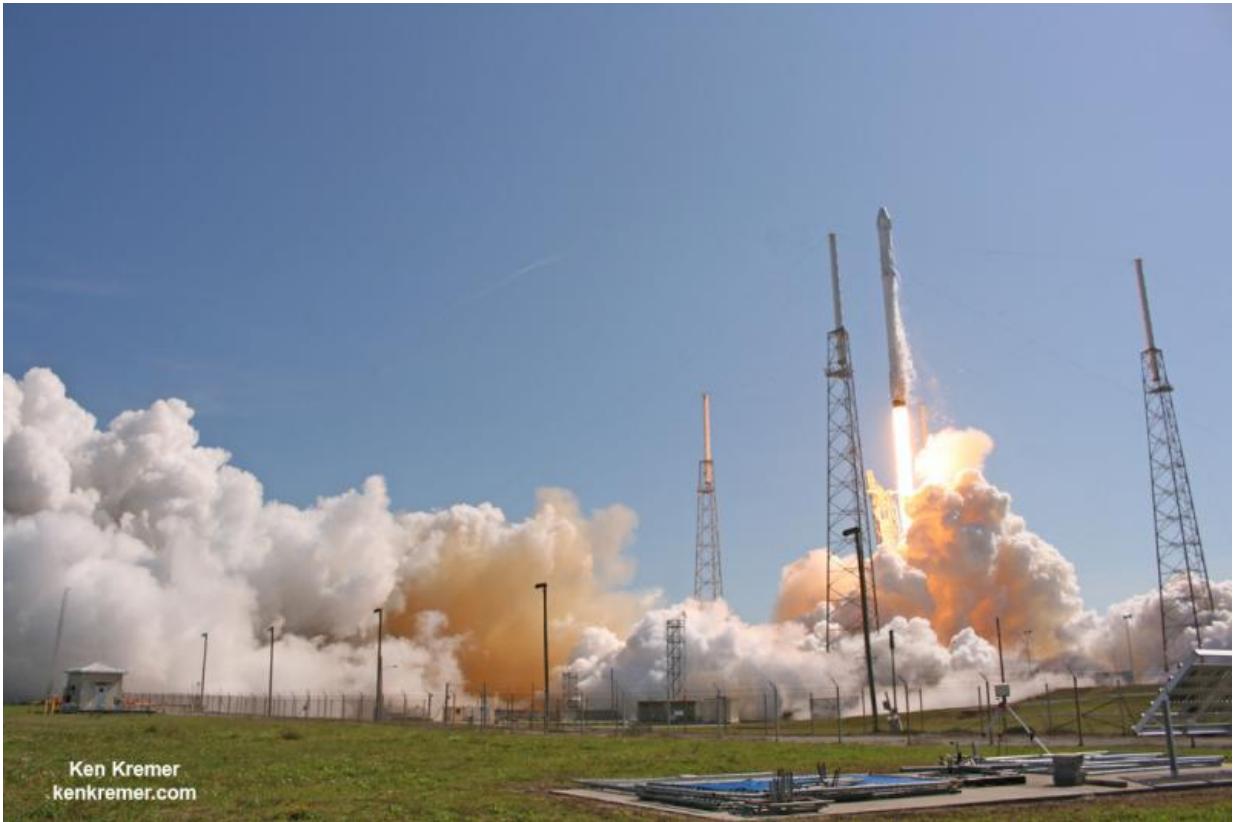
SpaceX Falcon 9 and Dragon blastoff from Space Launch Complex 40 at Cape Canaveral Air Force Station in Florida on April 14, 2015 at 4:10 p.m. EDT on the CRS-6 mission to the International Space Station. Credit: Ken Kremer/kenkremer.com

The SpaceX Falcon 9 carrying the Dragon cargo vessel blasted off from Space Launch Complex 40 at Cape Canaveral Air Force Station in Florida on April 14, 2015 at 4:10 p.m. EDT (2010:41 GMT) on the CRS-6 mission bound for the space station.

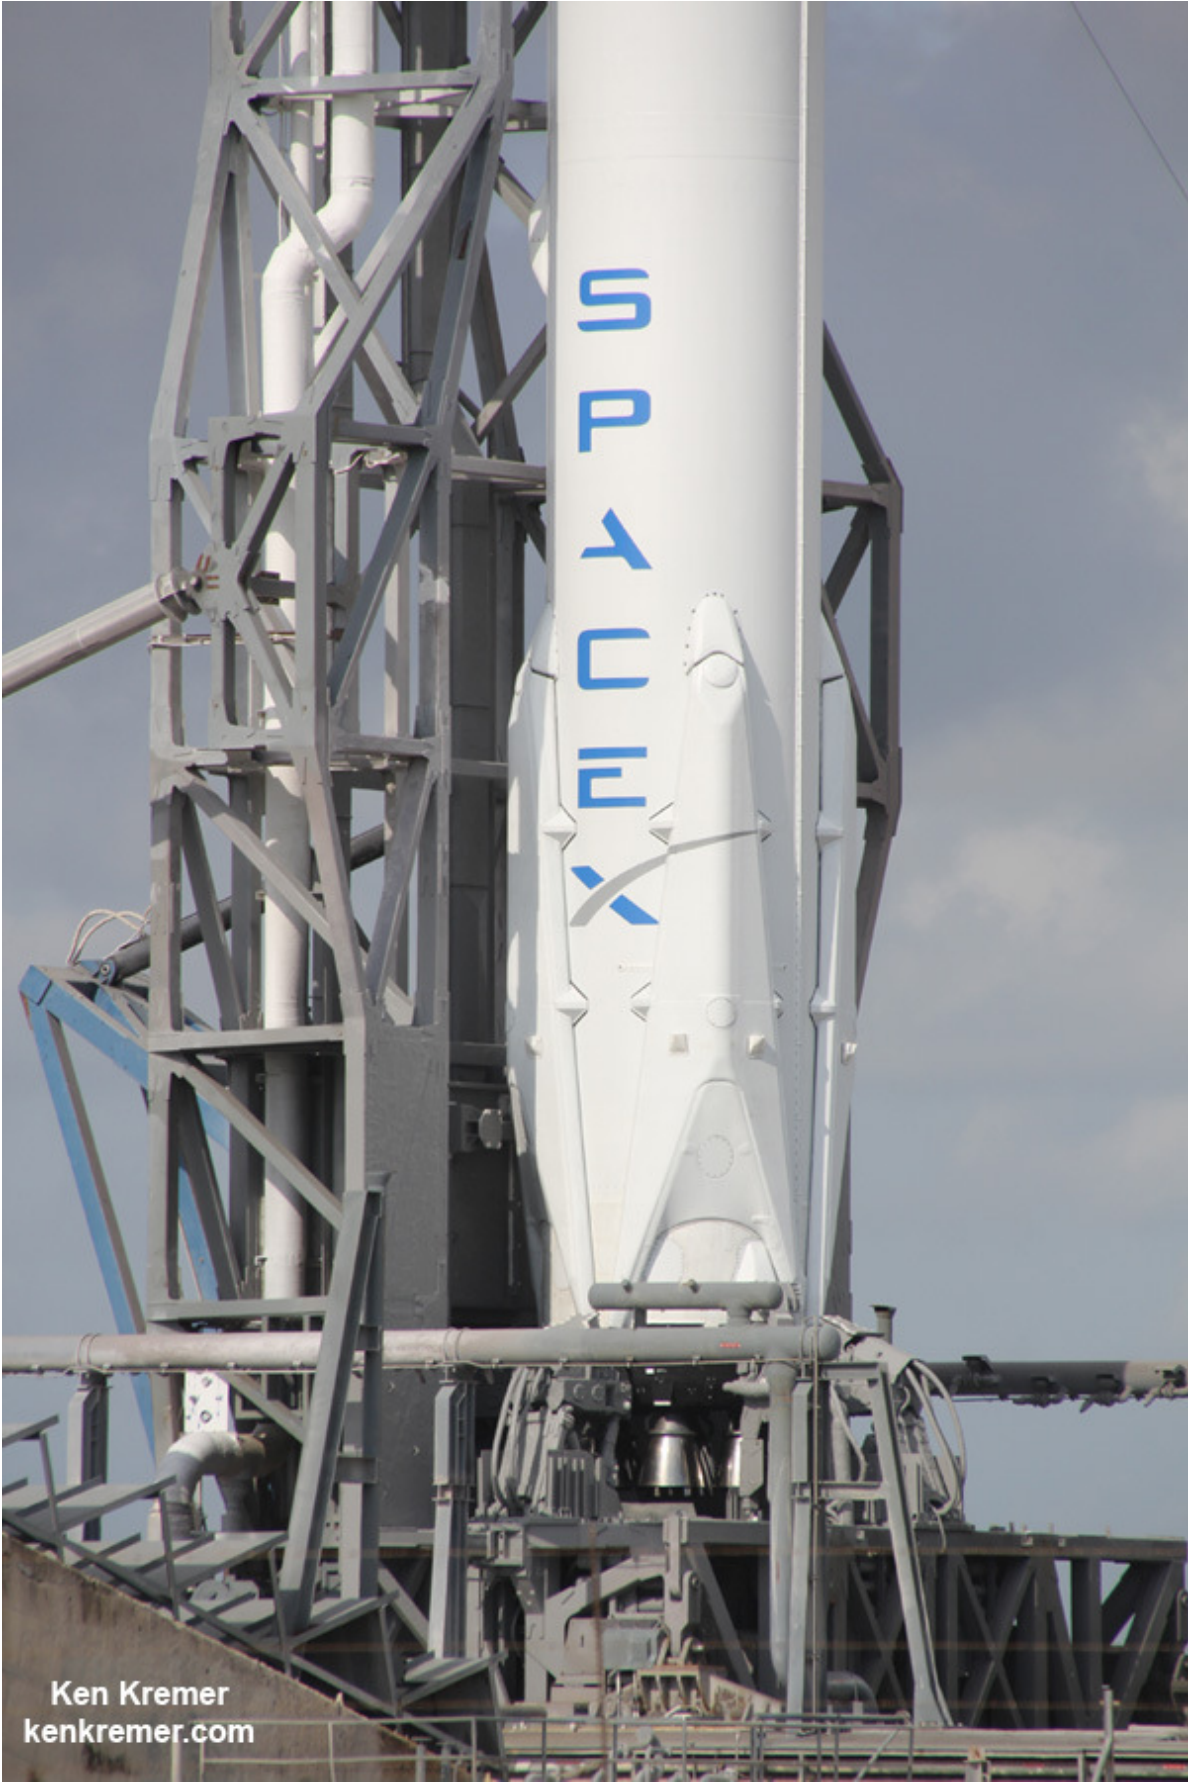
Up close view of the SpaceX Falcon 9 rocket landing legs prior to launch on April 14, 2015 on the CRS-6 mission to the International Space Station. Credit: Ken Kremer/kenkremer.com
