## Image: Hypervelocity impact test damage

June 11 2015

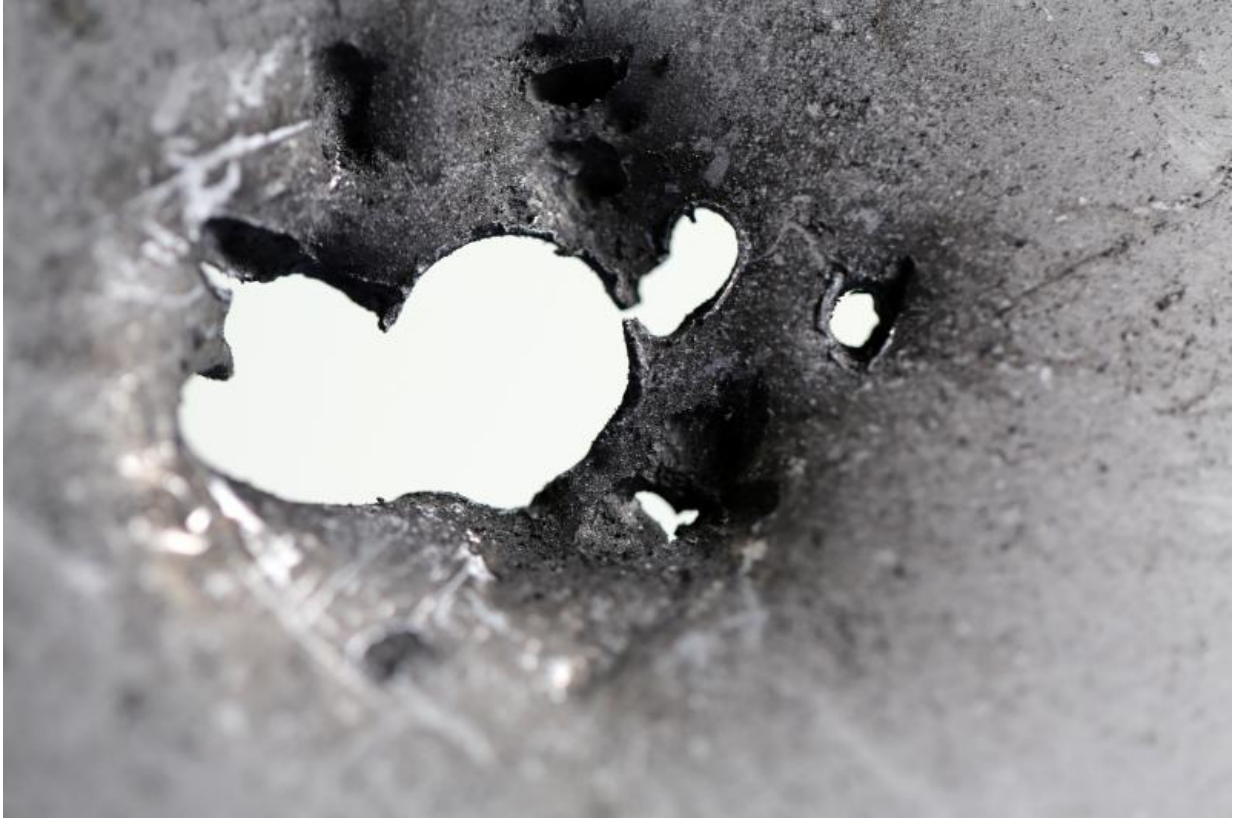
An aluminium plate, ripped inwards by a single sand grain-sized fleck of aluminium oxide shot at it during hypervelocity testing.

Measuring approximately 15x15 cm across, the 1.2 mm-thick plate is displayed outside the Materials and Electrical Components Laboratory of ESA's ESTEC technical centre in Noordwijk, the Netherlands. The main hole, seen here, measures 28x12 mm across, with a few smaller adjacent holes.

Typical impact speeds encountered by satellites are 10 km/s for space debris and 20 km/s for meteoroids – some 10–20 times faster than a bullet from a gun.
