X-ray imaging reveals secrets in battery materials

June 18 2015

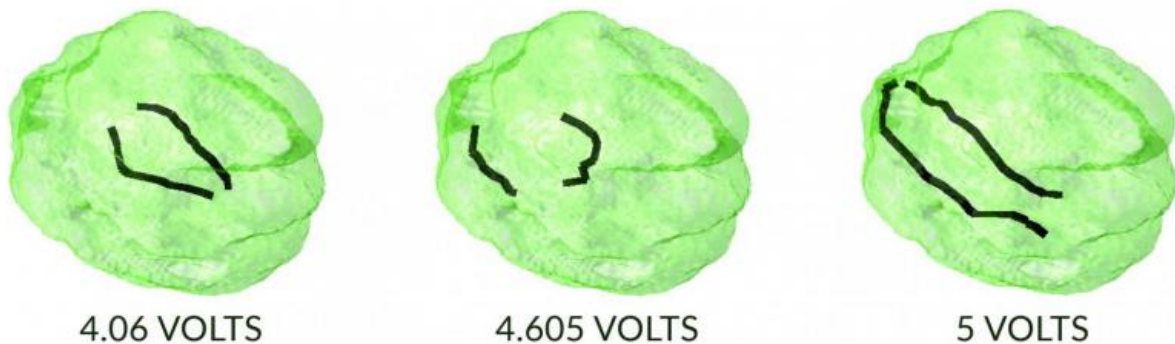
The 3D X-ray imaging technique used in the study shows how the defects move around inside the LNMO spinel as the battery is charged to higher voltages. Credit: Andrew Ulvestad/Department of Physics, Jacobs School of Engineering/UC San Diego

Using Argonne National Laboratory's Advanced Photon Source, the team imaged the cathode material while it was inside a charging lithium-ion battery. Analyses of the images revealed that the defects are stationary when the battery is at rest. But when the battery is charged to

high voltage, the defects move around within the cathode material. The researchers report that this is a significant finding because it shows that the material has a unique way of responding to the strain that is induced at high voltage.

The breakthroughs in this research came from analyzing data from an imaging technique called Bragg coherent diffractive imaging.

The method uses laser-like X-ray beams and novel computer algorithms to reconstruct high-resolution 3D images of nano-scale structures, such as the LNMO spinel described in this study.

Defects are difficult to image directly because they are extremely small — less than a nanometer in size. However, each defect causes a strain field, which is an area of deformation surrounding the defect in the atomic structure. The strain fields are much larger — tens of

nanometers in size — making them large enough to be imaged. By analyzing the strain fields in the LNMO spinel, the team mapped out the defects and studied how they play a role in the material's performance at high voltage.
