Curiosity discovers Mars rock like none before, sets drill campaign

August 3 2015, by Ken Kremer

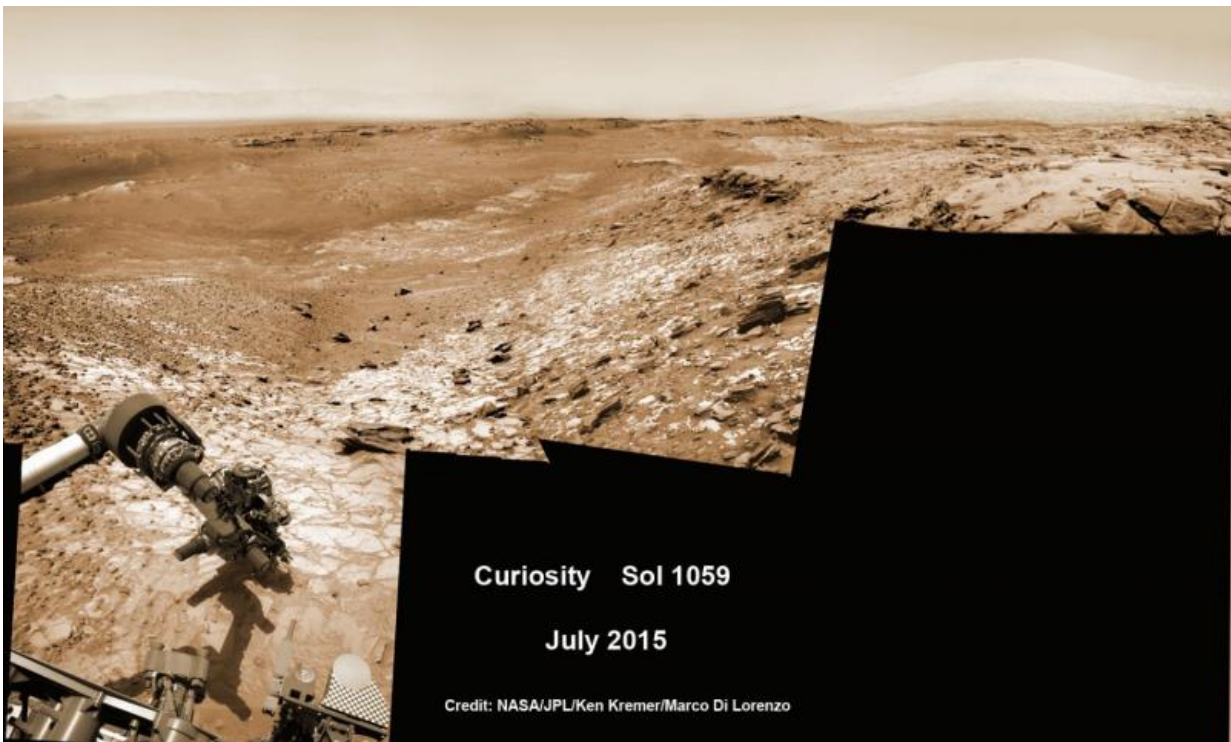
Curiosity extends robotic arm and conducts test drill at “Buckskin” rock target at bright toned “Lion” outcrop on the lower region of Mount Sharp on Mars, seen at right. Gale Crater eroded rim seen in the distant background at left, in this composite multisol mosaic of navcam raw images taken to Sol 1059, July 30, 2015. Navcam camera raw images stitched and colorized. Credit: NASA/JPL-Caltech/Ken Kremer/kenkremer.com/Marco Di Lorenzo

An initial test bore operation was conducted first to confirm whether that it was indeed safe to drill into "Buckskin" and cause no harm to the rover before committing to the entire operation.

The bore hole is about 1.6 cm (0.63 inch) in diameter.

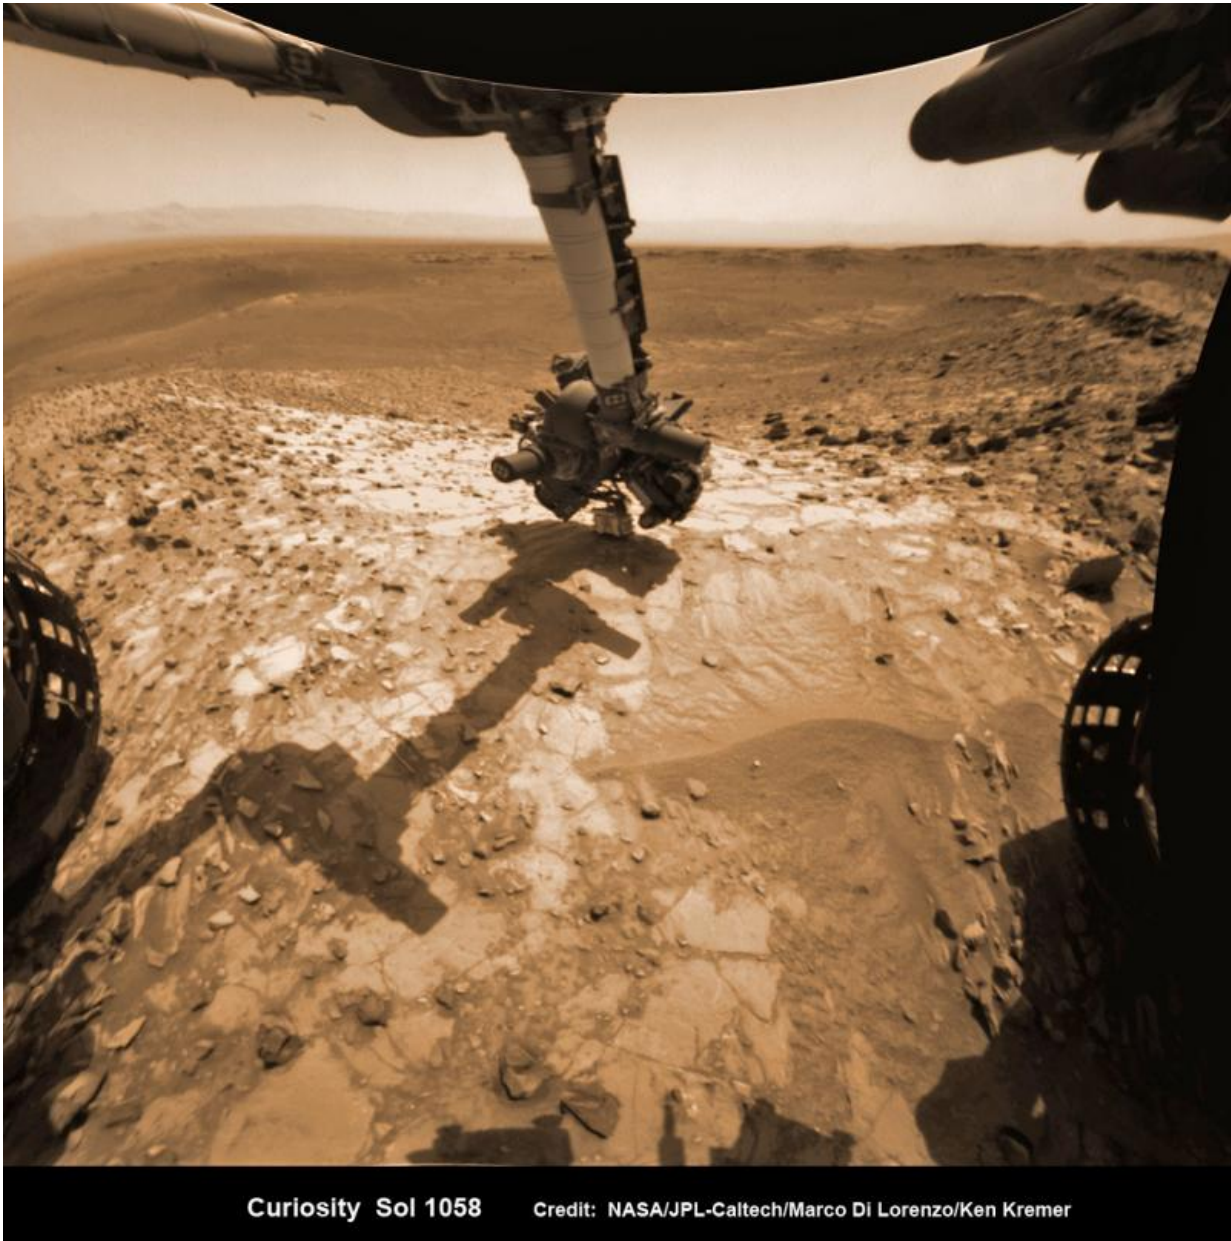
NASA Curiosity rover inspects ‘Buckskin’ rock outcrop on Mars with APXS mineral spectrometer in this hazcam camera raw image taken on July 29, 2015 (Sol 1058), colorized and linearized. Credit: NASA/JPL-Caltech/Marco Di Lorenzo/Ken Kremer/kenkremer.com

"The plan also includes Navcam imaging of the workspace, and Mastcam imaging of the target and drill bit. In addition to drilling, we're getting CheMin ready to receive sample in an upcoming plan. Fingers crossed!" Surface observations with the arm-mounted Alpha Particle X-ray Spectrometer (APXS) instrument are also planned.

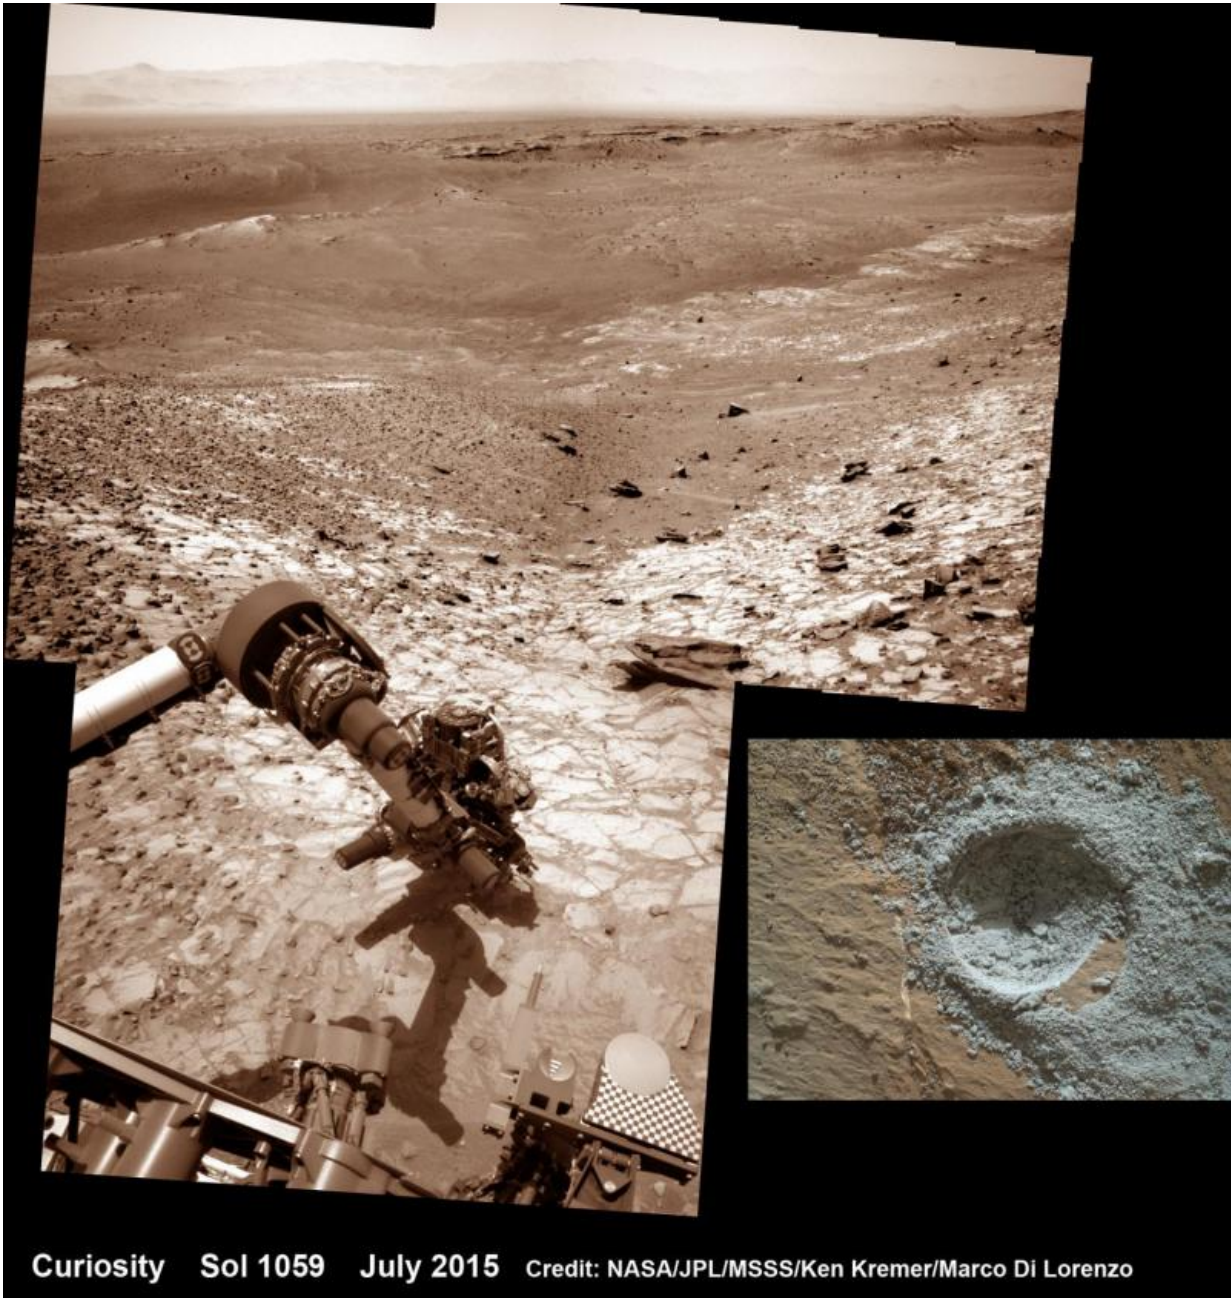
Curiosity extends robotic arm and conducts test drill at “Buckskin” rock target at bright toned “Lion” outcrop on the lower region of Mount Sharp on Mars. Gale crater rim seen in the distant background, in this composite mosaic of navcam raw images taken to Sol 1059, July 30, 2015. Inset: MAHLI camera up close image of test drill at “Buckskin” rock target. Navcam camera raw images stitched and colorized. Credit: NASA/JPL-Caltech/Ken Kremer/kenkremer.com/Marco Di Lorenzo Credit: NASA/JPL-Caltech/MSSS

"We successfully completed a mini drilling test yesterday (shown in the MAHLI image). That means that today we're going for the FULL drill hole" Edgar confirmed.

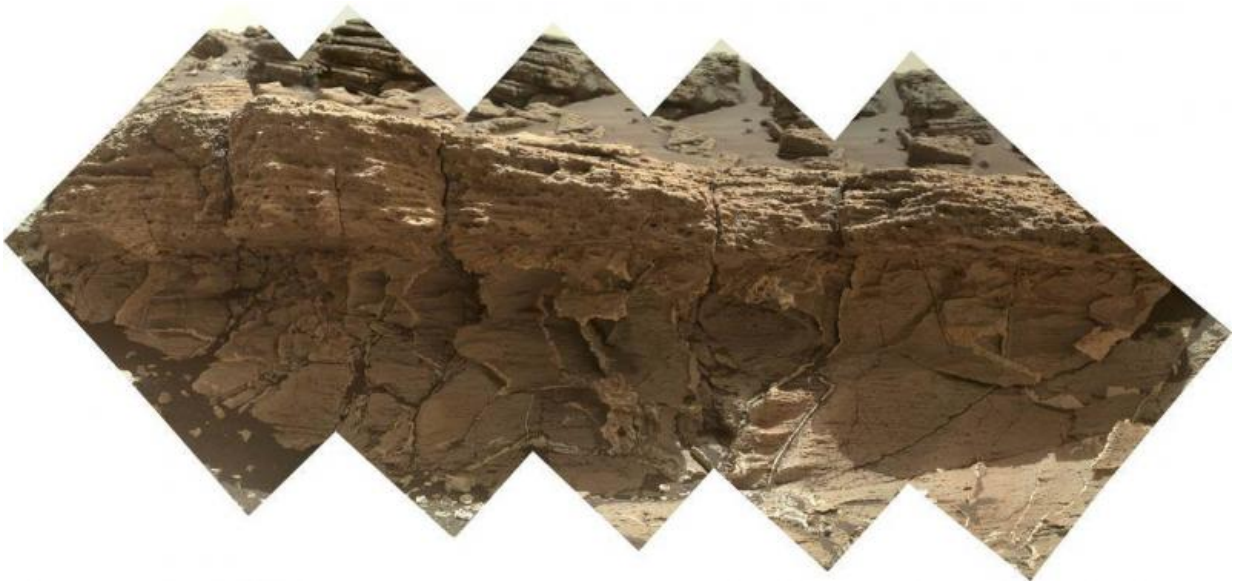
A rock outcrop dubbed “Missoula,” near Marias Pass on Mars, is seen in this image mosaic taken by the Mars Hand Lens Imager on NASA’s Curiosity rover. Pale mudstone (bottom of outcrop) meets coarser sandstone (top) in this geological contact zone, which has piqued the interest of Mars scientists. Credit: NASA/JPL-Caltech/MSSS

"We found an outcrop named Missoula where the two rock types came together, but it was quite small and close to the ground. We used the robotic arm to capture a dog's-eye view with the MAHLI camera, getting our nose right in there," said Ashwin Vasavada, the mission's project scientist at NASA's Jet Propulsion Laboratory in Pasadena, California.

White mineral veins, possibly comprised of calcium sulfate, filled the fractures by depositing the mineral from running groundwater.

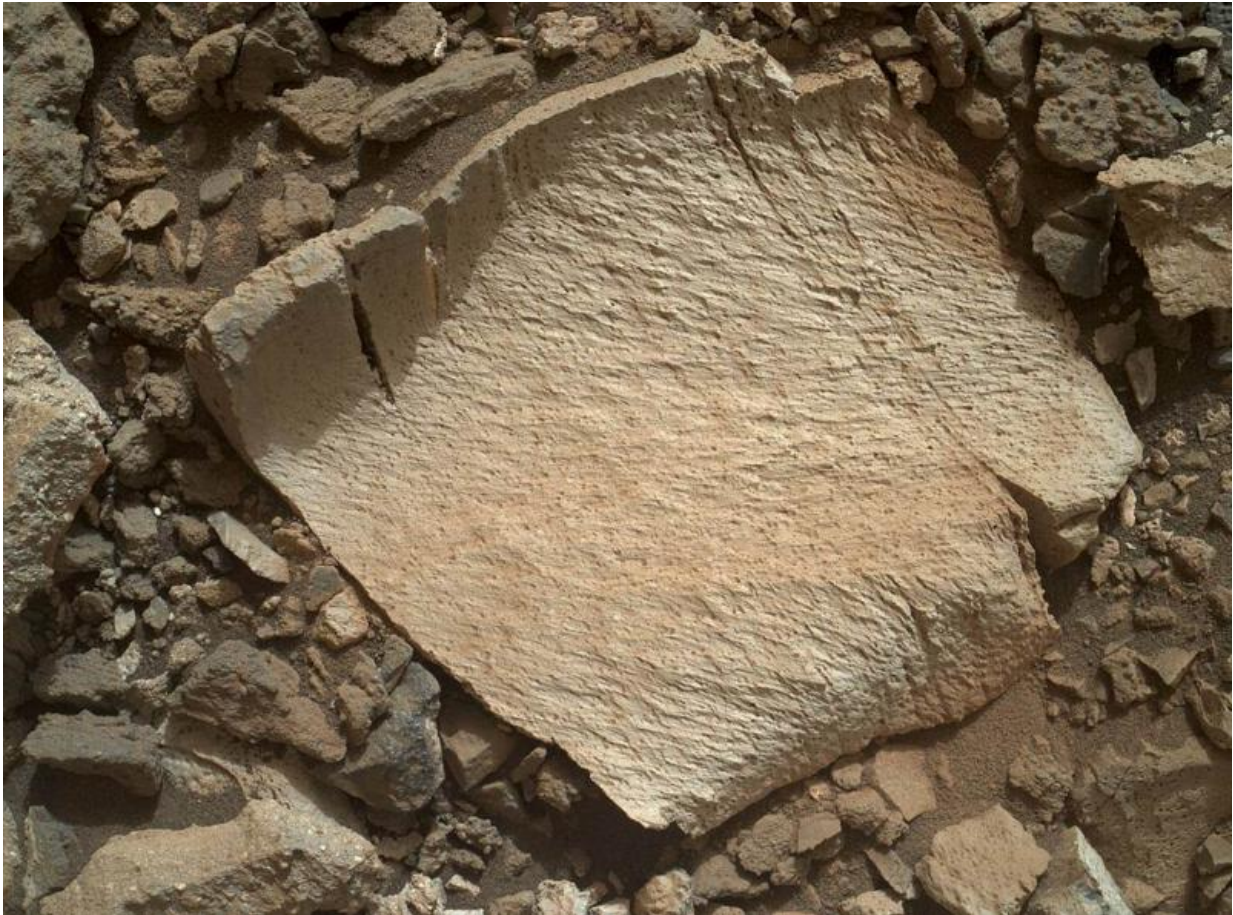
A rock fragment dubbed “Lamoose” is shown in this picture taken by the Mars Hand Lens Imager (MAHLI) on NASA’s Curiosity rover. Like other nearby rocks in a portion of the “Marias Pass” area of Mt. Sharp, Mars, it has unusually high concentrations of silica. The high silica was first detected in the area by the Chemistry & Camera (ChemCam) laser spectrometer. This rock was targeted for follow-up study by the MAHLI and the arm-mounted Alpha Particle X-ray Spectrometer (APXS). Credits: NASA/JPL-Caltech/MSSS
