Upgraded MOIRCS instrument achieves better images

January 20 2016

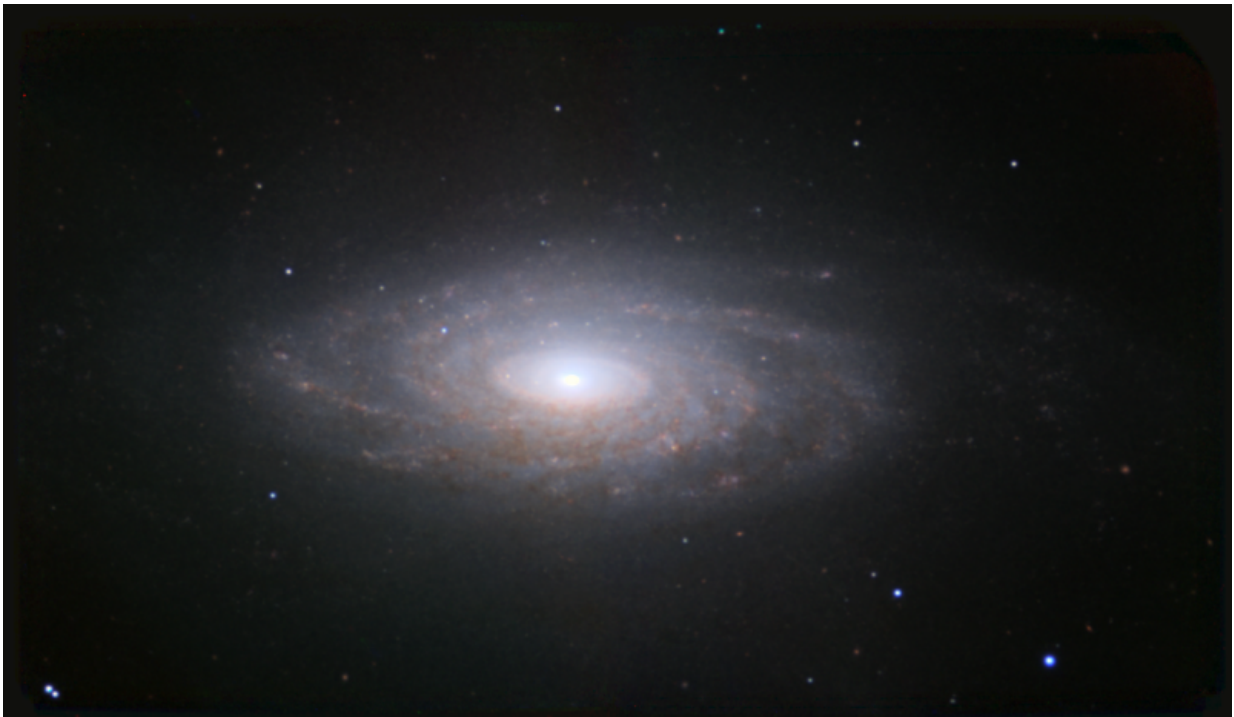
Figure 1: Color composite image of the spiral galaxy NGC 3521 taken by upgraded MOIRCS and processed by Ichi Tanaka. The field of view is 4 arcminutes x 7 arcminutes. The integration time was 5.3 minutes, 4 minutes and 7.1 minutes for J, H, and Ks band, respectively on the night of December 26, 2015. Unfortunately the seeing was very bad at that night at 1.3 arcseconds. Much better seeing in the usual, good condition should prove much sharper imaging capability of MOIRCS on the Subaru Telescope. Credit: NAOJ

During the night after Christmas (morning of December 27) in 2015, the upgraded MOIRCS instrument received light from the universe for the first time (Figure 1). The test observations were performed successfully despite this being the first time the new software interfaced with the telescope control system which has been upgraded since the original MOIRCS saw first light in 2004.

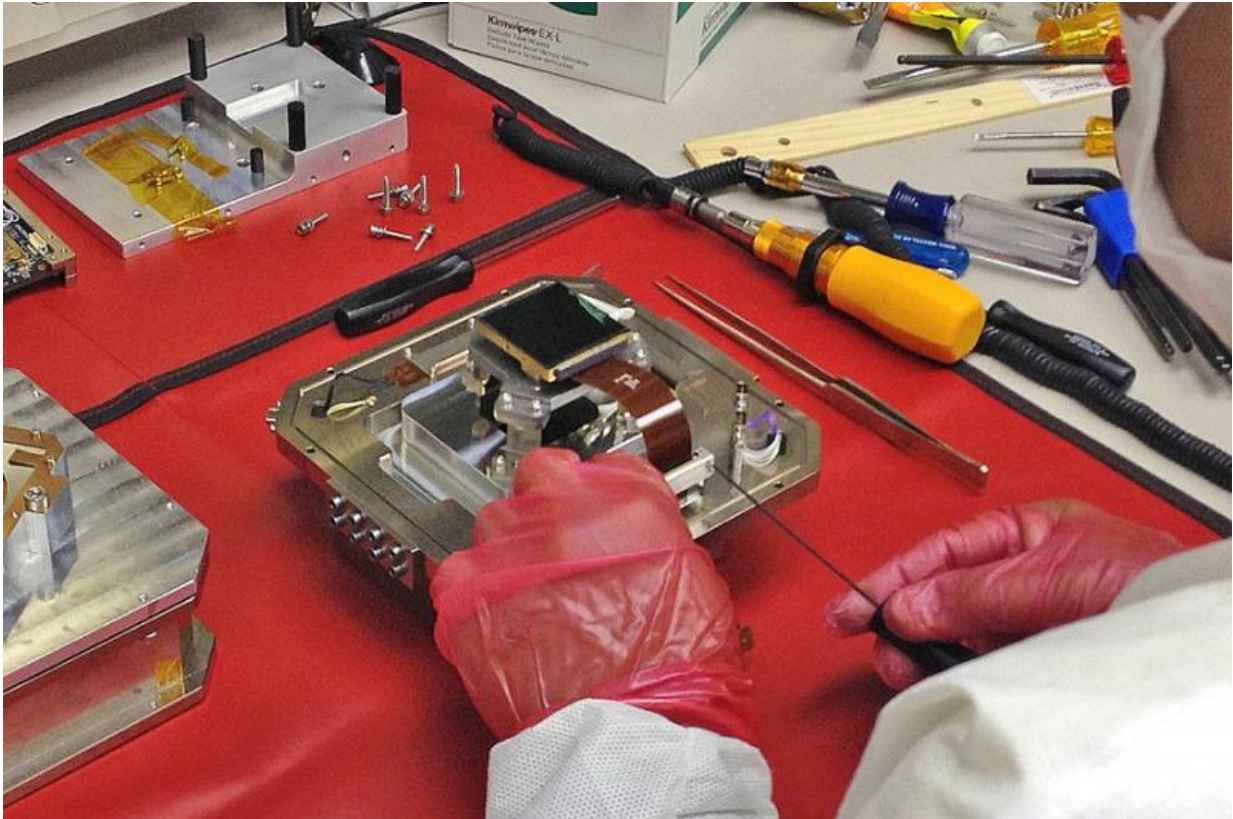
Figure 2: Electronics technician Lucio Ramos carefully installed Hawaii 2 RG detector in the laboratory at the base facility of the Subaru Telescope. Credit: NAOJ

MOIRCS now has two new detector arrays (Teledyne Hawaii 2 RG, see Figure 2) and new array control electronics (ASIC and SAM from Teledyne). The new detectors and electronics provide a significant

reduction in electronic noise in the data. The new detectors have 14 and 15 electrons respectively of read noise in a CDS frame, an improvement of about a factor of 2.

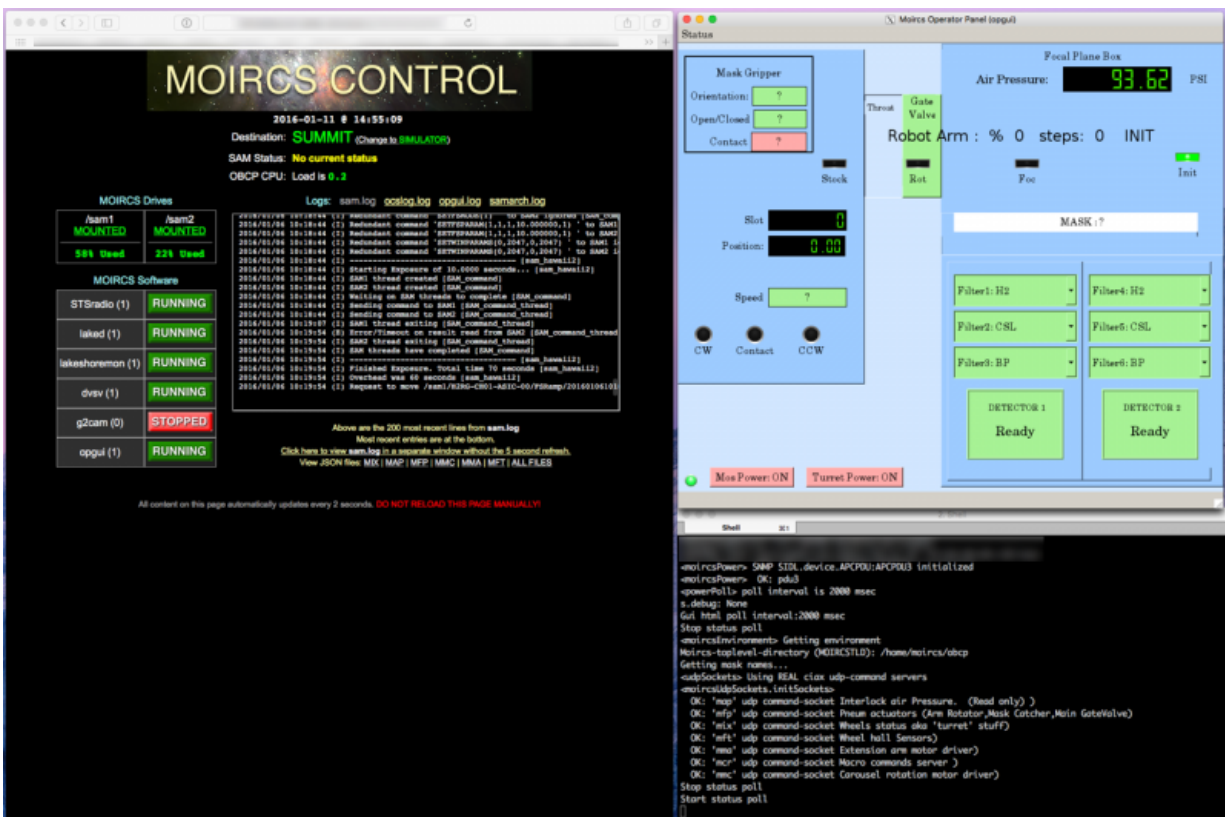
Figure 3: Overview of the new control system. Left window is for the system control, top-right is for the status, and the bottom-right is the command terminal.

It is easier to get the necessary information and respond promptly. The user interface continues to evolve as the users return their inputs. Credit: NAOJ

The instrument control system (ICS) software is the first amongst the Subaru Telescope's second generation instruments that was made entirely by the staff at the Subaru Telescope rather than outsourcing the software work. The original instrument builders, a group at Tohoku University, provided the first generation control system, but that was incompatible with the new detector control electronics. By using the in-house expertise, the project team was able to design a new control system which is simpler during night time use and which automates and scripts many daytime maintenance tasks (Figure 3).

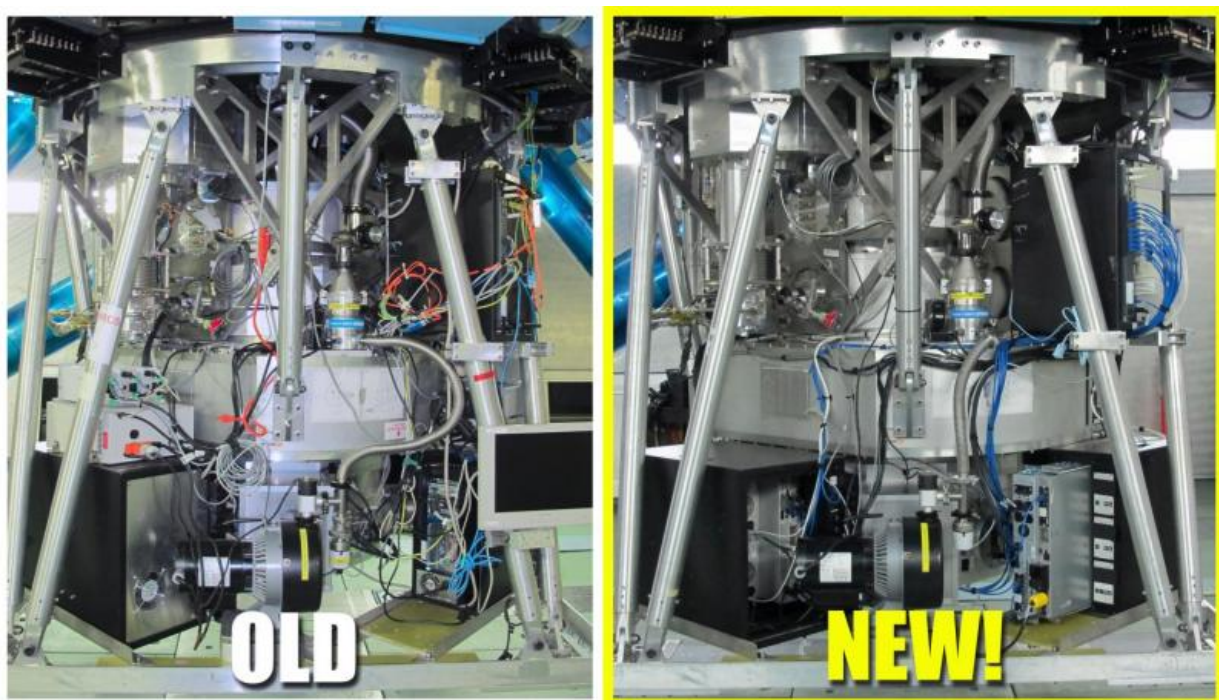
Figure 4: MOIRCS, before (left panel) and after (right panel) the upgrade, with new auxiliary hardwares. The cables are now neatly bundled. Credit: NAOJ

MOIRCS was originally designed and built using technologies of early 2000s. The hardware of the communication system, temperature controllers, computers, etc. has changed a lot during the intervening years. The team took this opportunity to replace many of these supporting hardware components with newer, more reliable, devices and to redesign some sub-systems to improve usability and reliability (Figure 4).
