# ESA image: Impact chip

May 12 2016

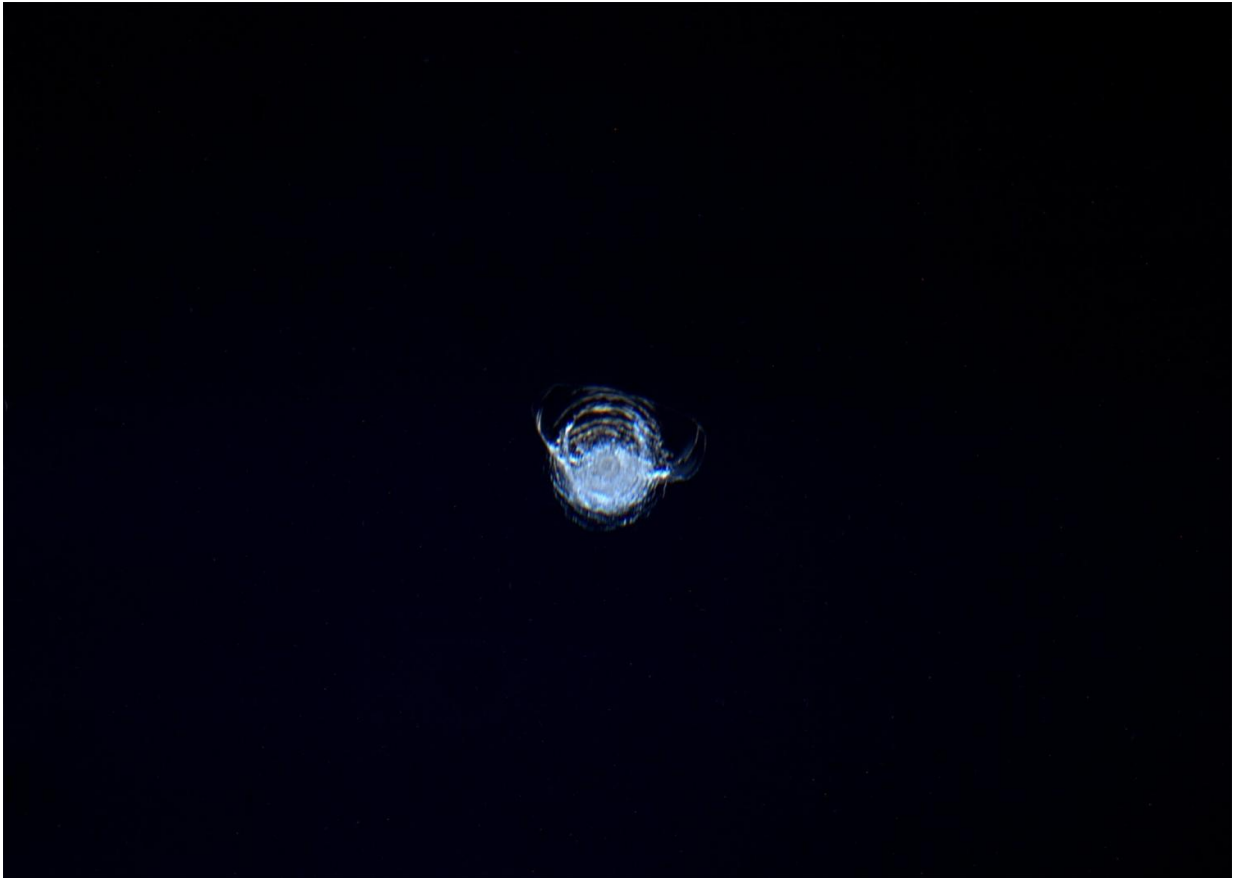
Its fused-silica and borosilicate-glass windows, however, sometime suffer from impacts by tiny artificial objects: space debris.

ESA astronaut Tim Peake took this photo from inside Cupola last month, showing a 7 mm-diameter circular chip gouged out by the impact from a tiny piece of space debris, possibly a paint flake or small metal fragment no bigger than a few thousandths of a millimetre across. The background just shows the inky blackness of space.

"I am often asked if the International Space Station is hit by [space debris](#) . Yes – this is the chip in one of our Cupola windows, glad it is quadruple glazed!" says Tim.

To cater for such possibilities, the Station is provided with extensive shielding around all vital crew and technical areas, so that minor strikes, like this one, pose no threat.

While a chip like the one shown here may be minor, larger debris would pose a serious threat. An object up to 1 cm in size could disable an instrument or a critical flight system on a satellite. Anything above 1 cm could penetrate the shields of the Station's crew modules, and anything larger than 10 cm could shatter a satellite or spacecraft into pieces.
