# SpaceX adopts lessons learned from multiple booster landings

August 1 2016, by Ken Kremer

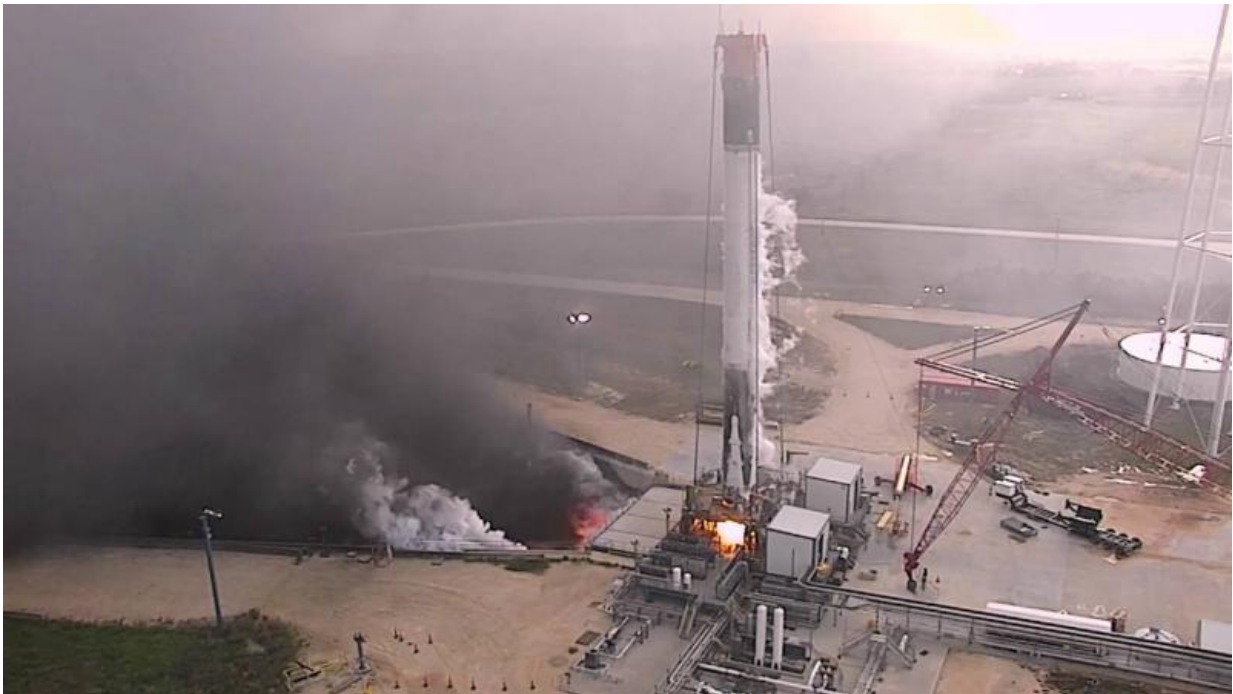
SpaceX completed the first full duration test firing of a landed first stage booster on July 28, 2016 on a test stand at their rocket development facility in McGregor, Texas. Credit: SpaceX

On Thursday, July 28, SpaceX engineers successful conducted a full duration static engine test firing of the 156-foot-tall (47-meter) recovered Falcon 9 first stage booster while held down on a test stand at the company's rocket development test facility in McGregor, Texas.

The July 28 test firing is part of that long life endurance testing and involved igniting all nine used first stage Merlin 1D engines housed at the base of a used landed rocket.

The Falcon 9 first stage generates over 1.71 million pounds of thrust when all nine Merlin engines fire up on the test stand for a duration of up to three minutes – the same as for an actual launch.

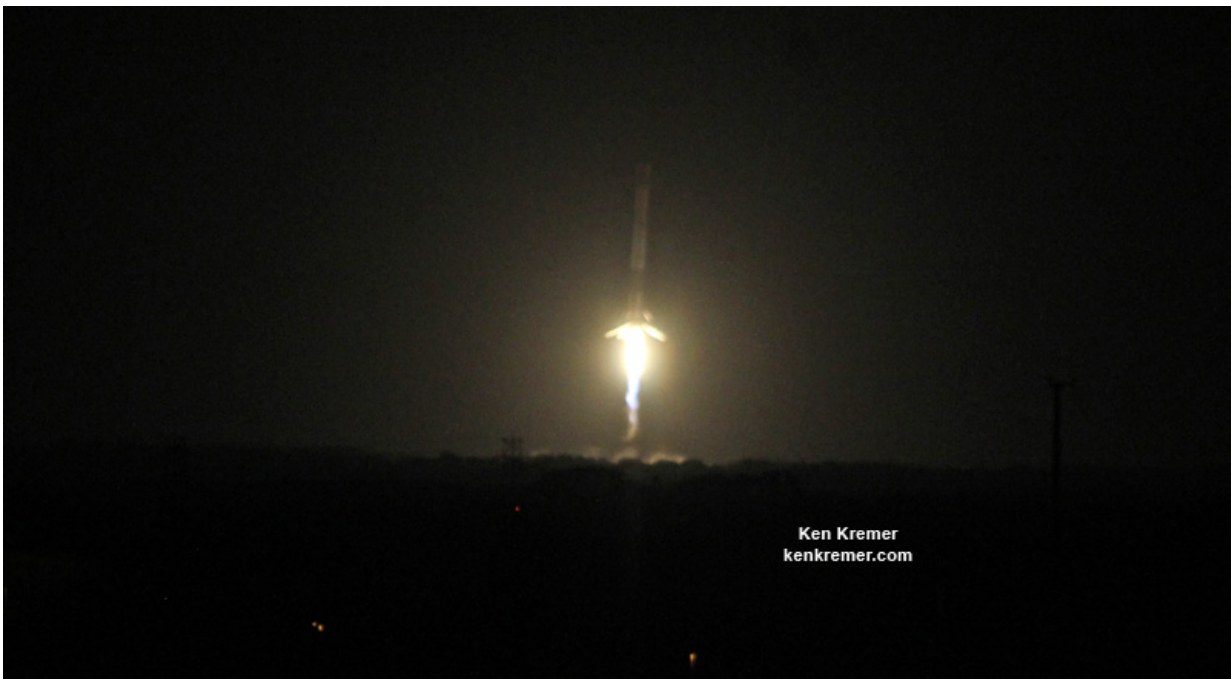
Moments before dramatic touchdown of SpaceX Falcon 9 1st stage at Landing

Zone-1 (LX-1) accompanied by sonic booms after launching Dragon CRS-9 supply ship to orbit from Cape Canaveral Air Force Station, Florida at 12:45 a.m., bound for the International Space Station (ISS). Credit: Ken Kremer/kenkremer.com

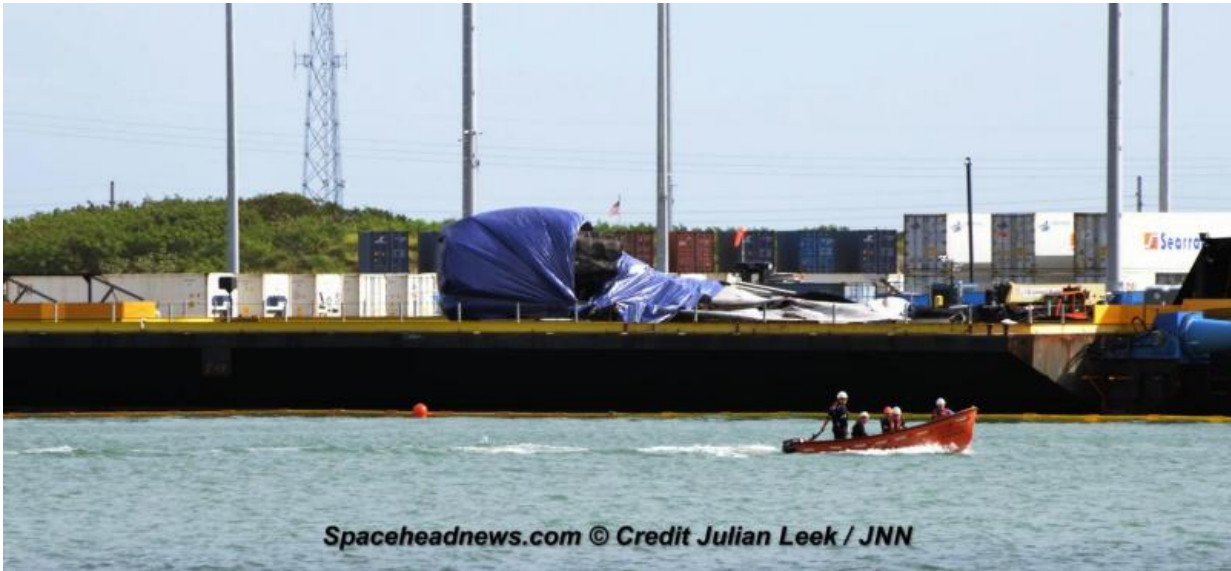
Flattened SpaceX Falcon 9 first stage arrived into Port Canaveral, FL atop a dronship late Saturday, June 18 after hard landing and tipping over following successful June 15, 2016 commercial payload launch. Credit: Julian Leek

However while trying to extend the touchdown streak to 4 in a row during the latest drone ship landing attempt following the June 15 Eutelsat telecom launch to GTO, the booster basically crashed because it descended too quickly due to insufficient thrust from the Merlin descent engines.

The rocket apparently ran out of liquid oxygen fuel in the final moments before touchdown, hit hard, tipped over and pancaked onto the deck.

"Looks like early liquid oxygen depletion caused engine shutdown just above the deck," Musk explained via twitter at the time.

"Looks like thrust was low on 1 of 3 landing engines. High g landings v sensitive to all engines operating at max."
