Sentinel-1 satellites confirm San Francisco's Millennium Tower is sinking

November 29 2016, by Evan Gough

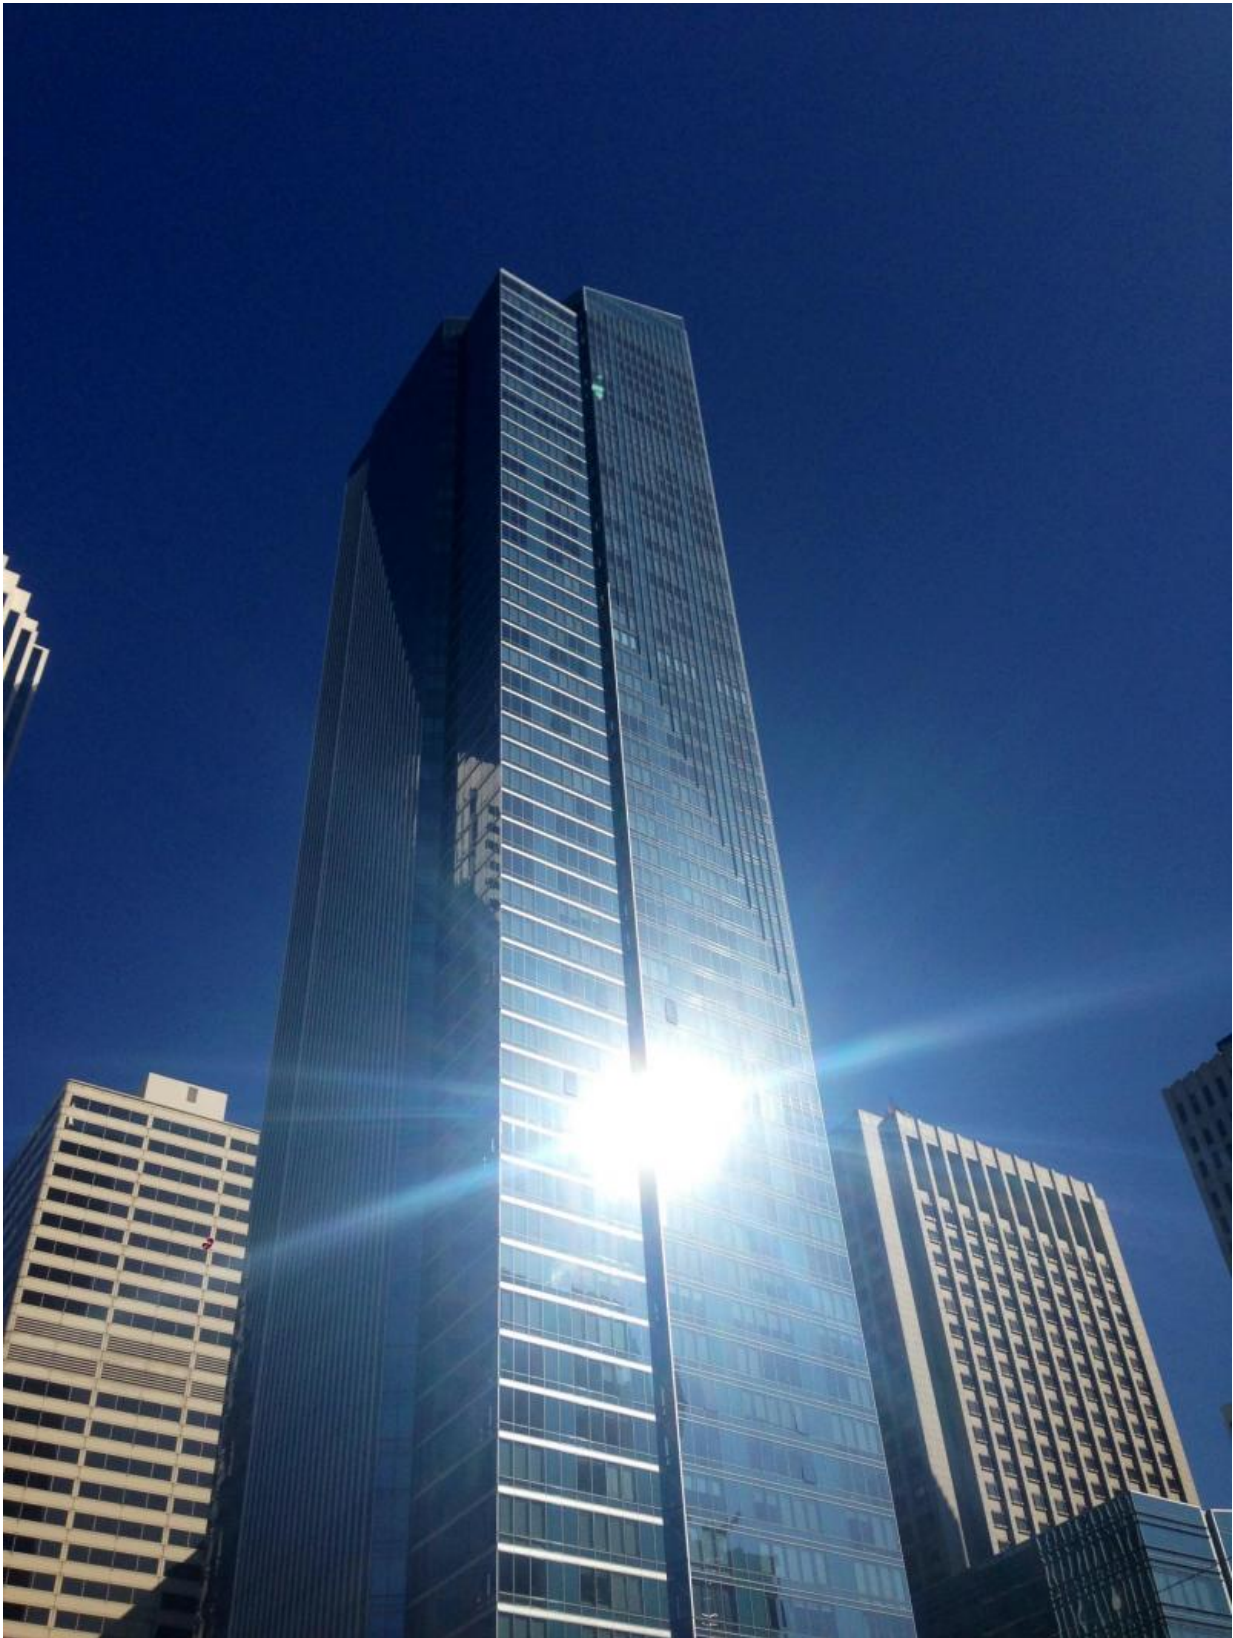
The Millennium Tower luxury skyscraper in San Francisco is sinking and tilting.
Credit: MichaelTG - Own work, CC BY-SA 4.0,
<https://commons.wikimedia.org/w/index.php?curid=51657571>

The Millennium Tower is a luxury skyscraper in San Francisco. It has been sinking and tilting since its construction 8 years ago. In fact, the 58 story building has sunk 8 inches, and tilted at least 2 inches. San Francisco is experiencing a building boom, and planners and politicians want to know why the Millennium Tower is having these problems.

The European Space Agency's (ESA) Copernicus Sentinel-1 satellites have trained their radar on San Francisco. They've found that the Millennium Tower is sinking, or subsiding, at the alarming rate of almost 50 mm per year. Although the exact cause is not yet known for sure, it's suspected that the building's supporting piles are not resting on solid bedrock.
