What we know so far about problems at the tallest US dam

February 16 2017, by Paul Elias

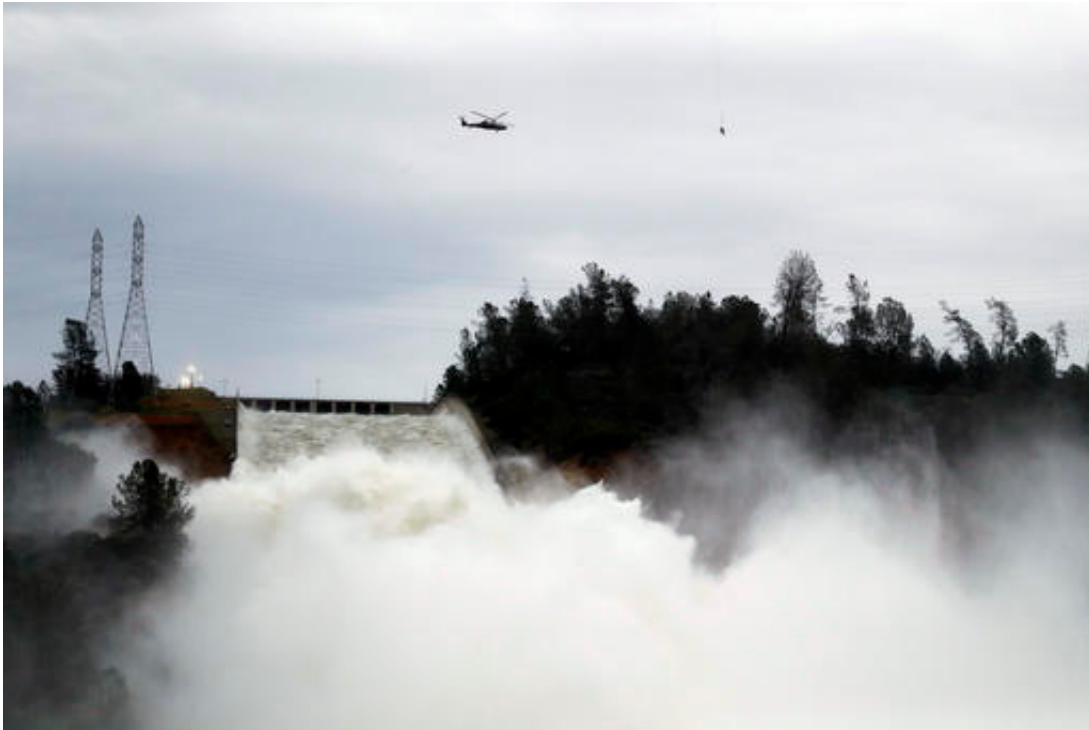
Water gushes down the Oroville Dam's main spillway Wednesday, Feb. 15, 2017, in Oroville, Calif. The Oroville Reservoir is continuing to drain Wednesday as state water officials scrambled to reduce the lake's level ahead of impending storms. (AP Photo/Marcio Jose Sanchez)

Engineers noticed an odd flow pattern on the main concrete spillway Feb. 7 and shut off the water to investigate. They discovered a large crater in the bottom.

Despite heavy rain and melting snow, engineers slowed releases later in the week after the hole grew. Compounding matters, concrete from the eroding hole clogged the power plant's exit channel and forced it to shut down.

Engineers determined the hole couldn't immediately be fixed and decided to keep using the damaged spillway with reduced flows. The next day, it rained harder than expected, and a day later, water was flowing in almost twice as fast as it was draining.

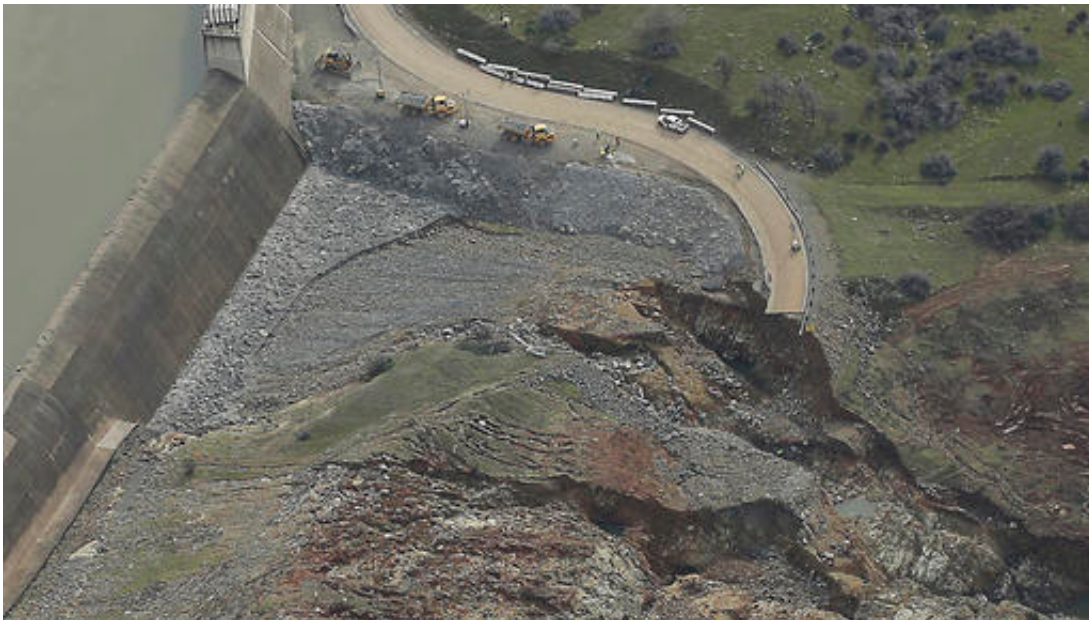
This photo taken Monday, Feb. 13, 2017, shows erosion caused when overflow water cascaded down the emergency spillway, right, of the Oroville Dam in Oroville, Calif. Water flowed over the emergency spillway Sunday morning when Lake Oroville reached capacity, and engineers determined the hillside was

eroding faster than expected, undermining the concrete wall. Officials fearing it was about to collapse ordered thousands of residents downstream to evacuate. (AP Photo/Rich Pedroncelli)

The emergency spillway is an earthen structure—a big hill—with a 30-foot concrete wall on top. It is several feet lower than the main dam, and water will flow over it uncontrollably when the lake is over capacity. Water had never flowed over the emergency spillway until Saturday.

A few hours later, engineers determined the hillside was eroding faster than expected, undermining the concrete wall. Officials feared it was about to collapse and cause a catastrophic flood.

Environmental groups demanded 12 years ago that the hillside be paved with concrete to prevent erosion. But federal regulators decided against ordering the work after state water agencies argued it would cost too much for a structure that, at that point, had never been used.

The emergency spillway also has been repaired enough to handle any overflow, Croyle said. Officials identified three areas where erosion caused the most concern of potential flooding, including one spot that was completely fixed, he said. The others were partially repaired.
