## Breaks observed in Mars rover wheel treads

March 22 2017

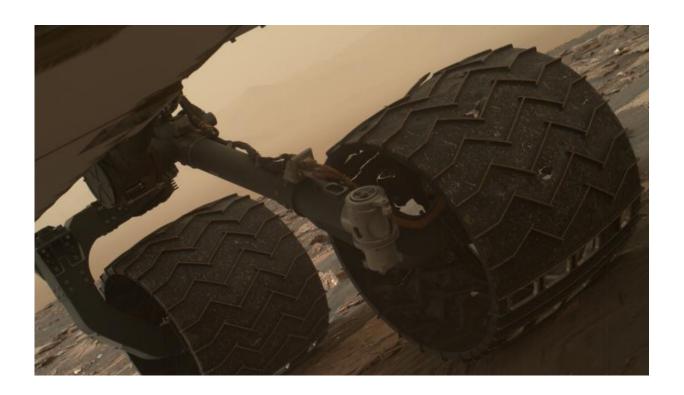
Two of the raised treads, called grousers, on the left middle wheel of NASA's Curiosity Mars rover broke during the first quarter of 2017, including the one seen partially detached at the top of the wheel in this image from the Mars Hand Lens Imager (MAHLI) camera on the rover's arm. Credit: NASA/JPL-Caltech/MSSS

A routine check of the aluminum wheels on NASA's Curiosity Mars rover has found two small breaks on the rover's left middle wheel—the latest sign of wear and tear as the rover continues its journey, now

The mission's first and second breaks in raised treads, called grousers, appeared in a March 19 image check of the wheels, documenting that these breaks occurred after the last check, on Jan. 27.

The monitoring of wheel damage on Curiosity, plus a program of wheel-longevity testing on Earth, was initiated after dents and holes in the wheels were seen to be accumulating faster than anticipated in 2013. Testing showed that at the point when three grousers on a wheel have broken, that wheel has reached about 60 percent of its useful life. Curiosity already has driven well over that fraction of the total distance needed for reaching the key regions of scientific interest on Mars' Mount Sharp.

Each of Curiosity's six wheels is about 20 inches (50 centimeters) in diameter and 16 inches (40 centimeters) wide, milled out of solid aluminum. The wheels contact ground with a skin that's about half as thick as a U.S. dime, except at thicker treads. The grousers are 19 zigzag-shaped treads that extend about a quarter inch (three-fourths of a centimeter) outward from the skin of each <a href="wheel">wheel</a>. The grousers bear much of the rover's weight and provide most of the traction and ability to traverse over uneven terrain.
