Palcacocha icefalls demonstrate hazard vulnerabilities in Peru

June 13 2017, by Ben Orlove

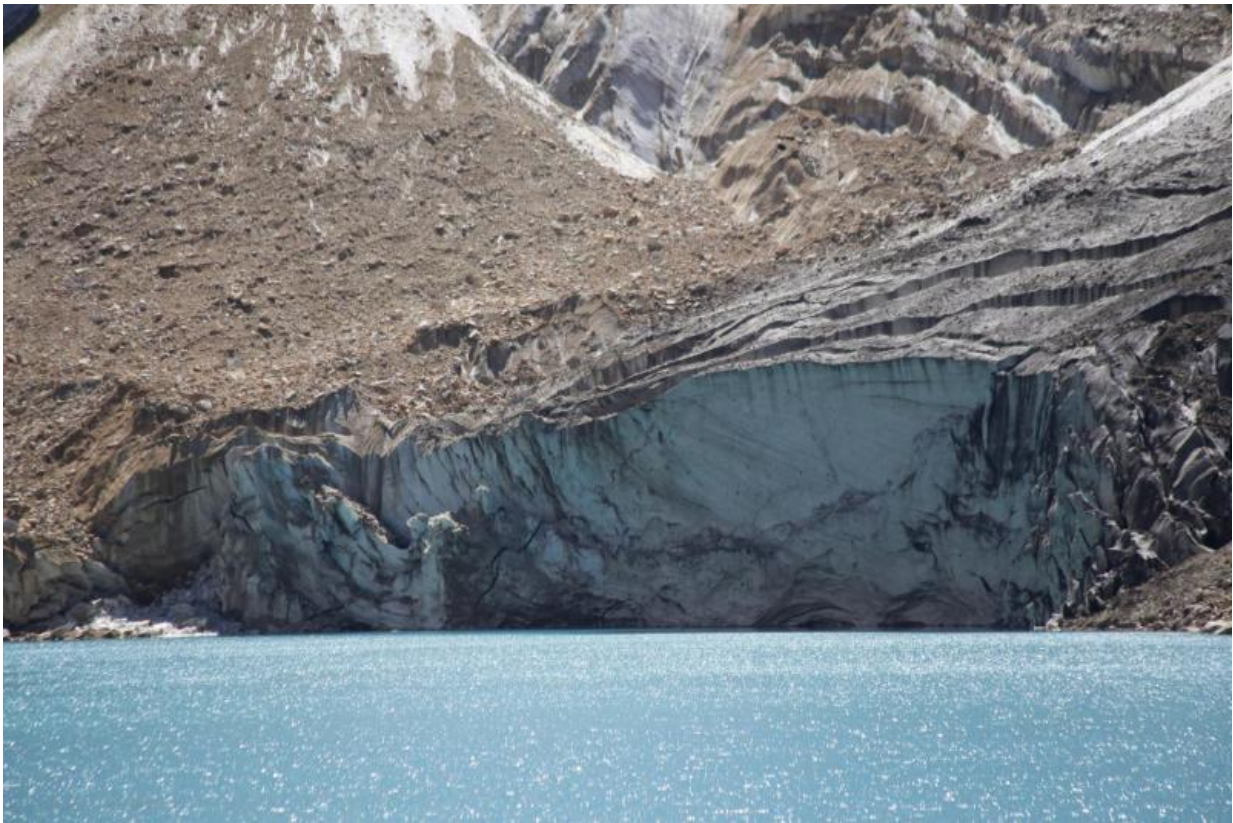
Glacier front subject to calving, Lake Palcacocha. Credit: Jeff Kargel

In the last week, calving events at Lake Palcacocha in the Peruvian Andes released masses of ice from a glacier on Mount Pucaranra. The ice fell into the lake, sending waves across the lake that destroyed

Jeff Kargel, a planetary scientist at the University of Arizona, told GlacierHub that both calving events and avalanches at Palcacocha "dump energy into the lake, and if they are large and sudden enough, a big wave can form. As with other more classical tsunamis, the shoaling in Palcacocha toward the south end of the lake— where the syphons are— can cause a relatively small displacement wave to build up to a much larger size when it nears the shore. Avalanches and calving events are frequent occurrences at this lake, and both should be especially active in the late May-July period, which tends to be the dry season, hence mainly sunny, thus allowing high solar radiation. The air temperature doesn't

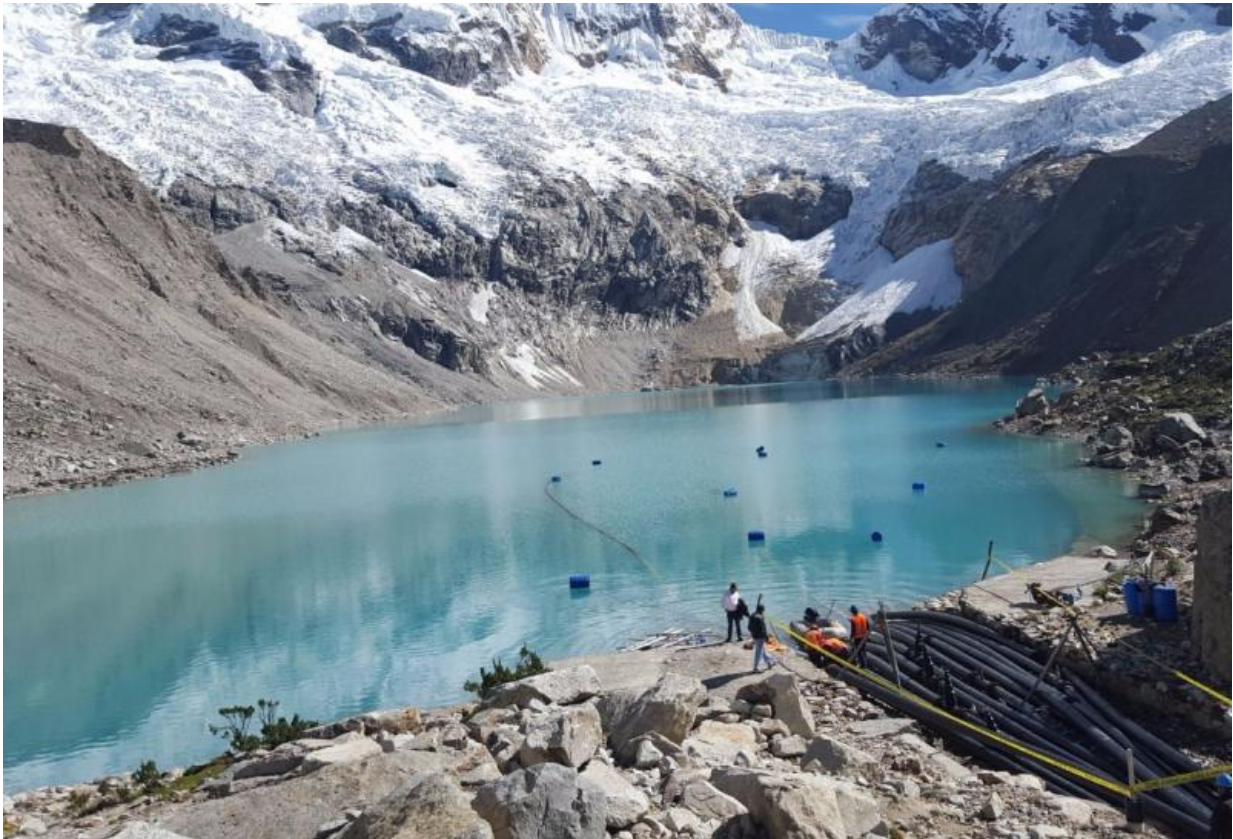
Pucaranra Glacier, Lake Palcacocha, and syphons at the moraine. Credit: INDECI

Zapata indicated that the calving event occurred around 8 p.m. on May 31. The resulting waves, three meters in height, were strong enough to move and damage ten large pipes, rendering them inoperable. These pipes, known locally as "syphons," are designed to draw water from the lake at times when its level is high; in this way, they were thought to reduce flood risk significantly. They had been a point of local pride, seen as a successful application of modern technology to protect against the dangers to which the region has long been subject.

Representatives of INAIGEM and two other organizations, the National Water Authority and the local municipality of Independencia, visited the lake a few days later. They found that the workers on Pucathe site had restored two of the drainage pipes. These officials anticipated that the other eight will soon be functional. Zapata and the other authorities

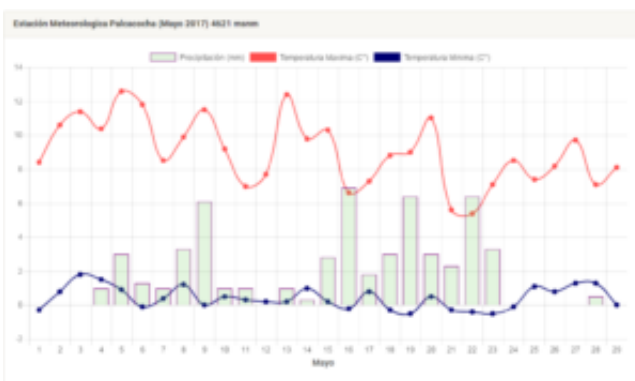
The weather data indicate some warm days in May at Palcacocha. The data also demonstrate that May had less rain than usual, particularly toward the end of the month. Such dry weather is typically associated with less cloud cover, supporting Kargel's suggestion and a report in a regional newspaper, *Ancash Noticias*, which stated that "intense solar radiation" in recent weeks had been the cause of the calving events. The data also support the observations of the local residents about the temperature fluctuations between day and night, since cloudless nights in this region are colder than ones with overcast skies.

Weather data at Palcacocha, May 2017. Credit: INAIGEM
