Palcacocha icefalls demonstrate hazard vulnerabilities in Peru

June 13 2017, by Ben Orlove

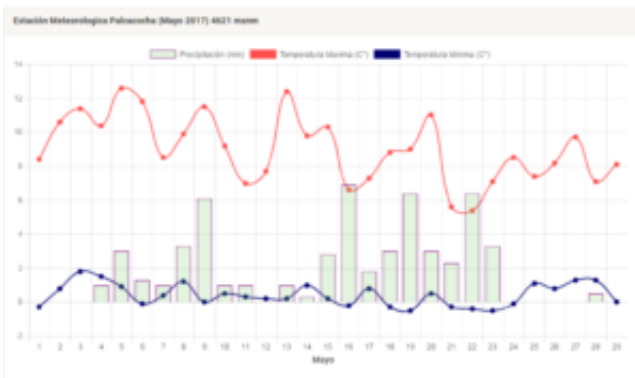
Weather data at Palcacocha, May 2017. Credit: INAIGEM

The weather data indicate some warm days in May at Palcacocha. The data also demonstrate that May had less rain than usual, particularly toward the end of the month. Such dry weather is typically associated with less cloud cover, supporting Kargel's suggestion and a report in a regional newspaper, Ancash Noticias, which stated that "intense solar radiation" in recent weeks had been the cause of the calving events. The data also support the observations of the local residents about the temperature fluctuations between day and night, since cloudless nights in this region are colder than ones with overcast skies.
