Engineers use replica to pinpoint California dam repairs

June 26 2017, by Brady Mccombs

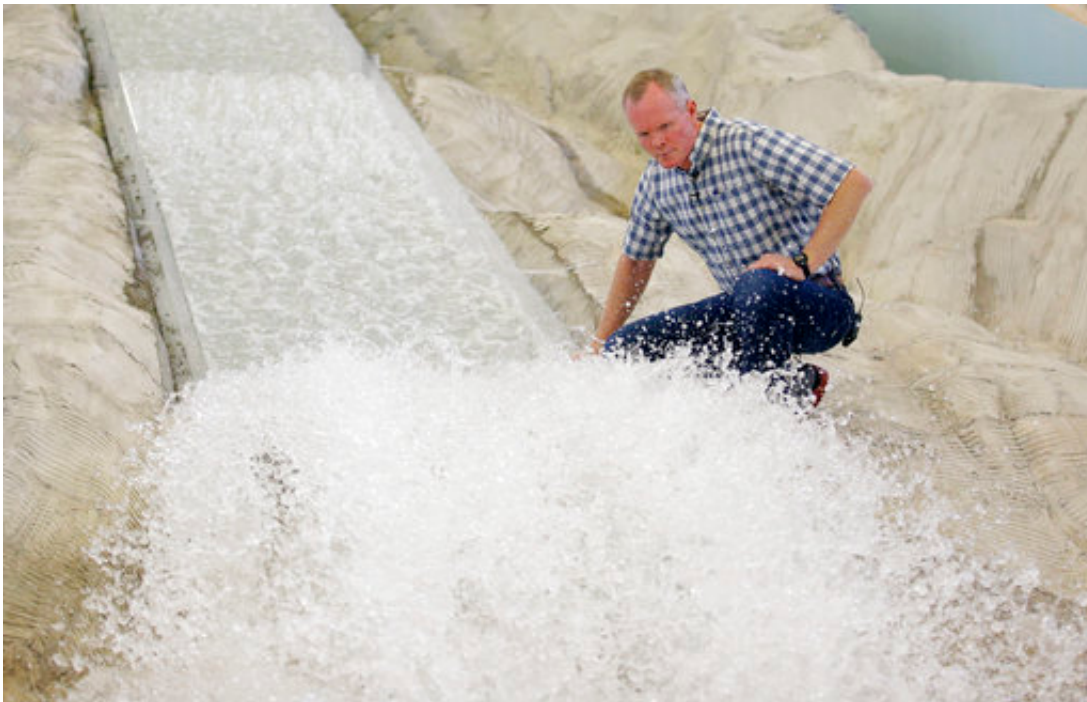
In this Friday, June 16, 2017, photo, hydraulic engineering professor Michael Johnson looks at the water flow on a replica of the Oroville Dam spillway at Utah State University's Water Research Laboratory, in Logan, Utah. California water officials are relying on key hydrology tests being performed on the replica of the spillway to pinpoint what repairs will work best at the tallest dam in the U.S for a spillway that was torn apart in February. (AP Photo/Rick Bowmer)

The sound of rushing water is deafening as Utah State University hydraulics engineering professor Michael Johnson kneels in front of a replica of an Oroville Dam spillway the size of a small house to examine one of two channels that run the width of the spillway to allow air into the water to prevent bubble formations that can damage the concrete spillway of the real dam.

The new channels, called aerators, are one of the key features in the proposed \$300 million spillway reconstruction set to be completed by November—when winter rains and snow will once again increase the flow of water into the lake above the dam.

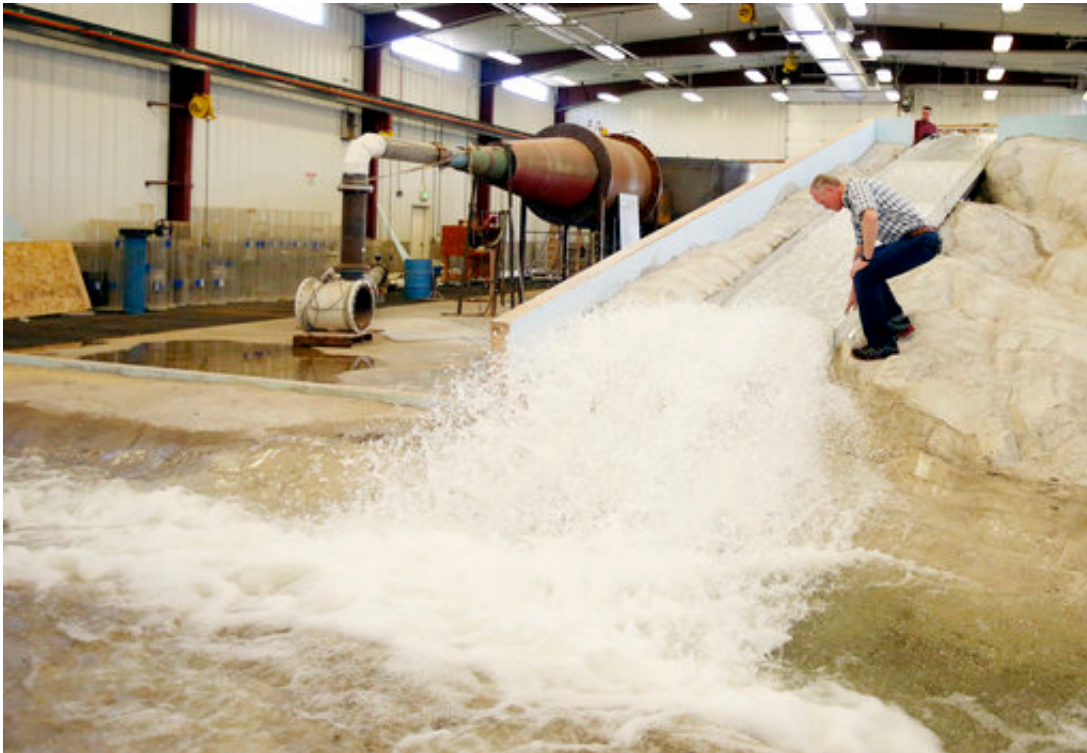
In this Friday, June 16, 2017, photo, hydraulic engineering professor Michael Johnson looks at the water flow on a replica of the Oroville Dam spillway at Utah State University's Water Research Laboratory, in Logan, Utah. California water officials are relying on key hydrology tests being performed on the replica of the spillway to pinpoint what repairs will work best at the tallest dam in the U.S for a spillway that was torn apart in February. (AP Photo/Rick Bowmer)

Besides confirming that the channels to aerate water going down the spillway would ease pressure on the spillway, the Utah testing has determined that an adjustment to a curve about halfway down the spillway would only slightly improve its effectiveness. The idea was to make the curve more gradual near a steep part of the spillway where it caved in and left a gaping hole the size of a football field in the concrete chute.

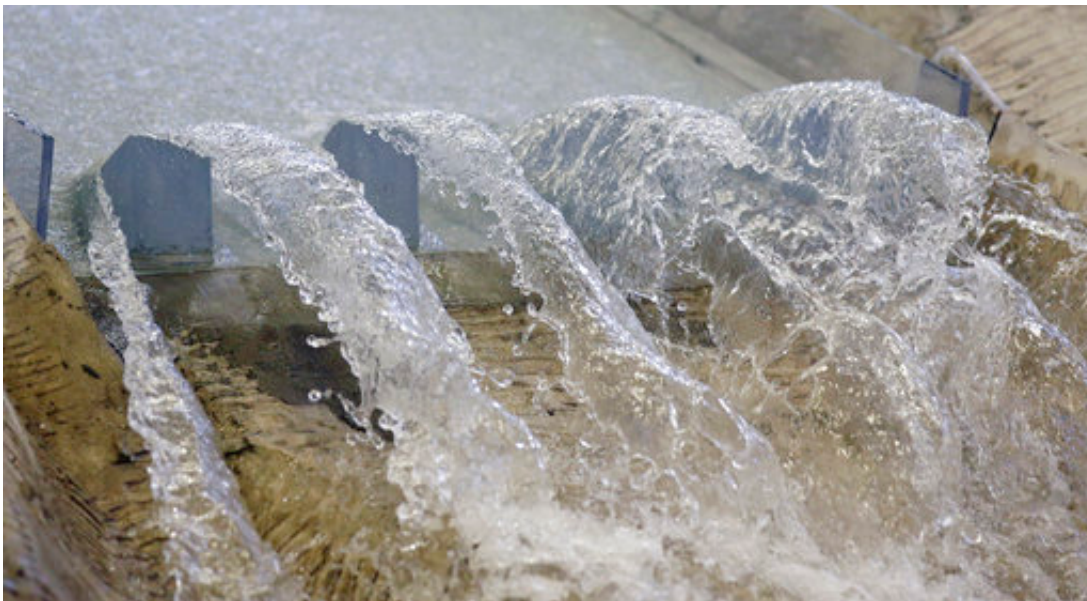
In this Friday, June 16, 2017, photo, water flows from a replica of the Oroville Dam spillway at Utah State University's Water Research Laboratory, in Logan, Utah. California water officials are relying on key hydrology tests being performed on the replica of the spillway to pinpoint what repairs will work best at the tallest dam in the U.S for a spillway that was torn apart in February. (AP Photo/Rick Bowmer)

Each simulation of the 100-foot (30-meter) long replica that took 40 days to build begins when a crew member slowly opens a large steering wheel like valve that sends water screaming down a chute modeled after the spillway and crashing into blocks that disperse it and send it in waves to a replica of the river. Johnson almost has to shout for his team to hear him above the noise of the water mimicking a flood.

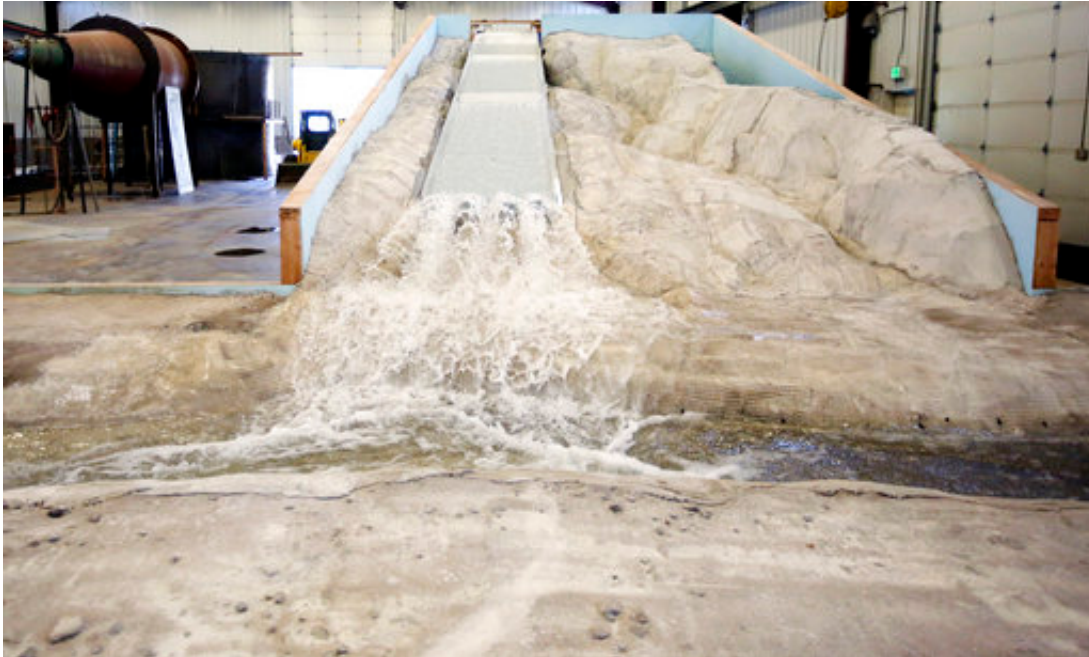
In this Friday, June 16, 2017, photo, water flows from a replica of the Oroville Dam spillway at Utah State University's Water Research Laboratory, in Logan, Utah. California water officials are relying on key hydrology tests being performed on the replica of the spillway to pinpoint what repairs will work best at the tallest dam in the U.S for a spillway that was torn apart in February. (AP Photo/Rick Bowmer)
