Swimming robot probes Fukushima reactor to find melted fuel

July 19 2017, by Mari Yamaguchi

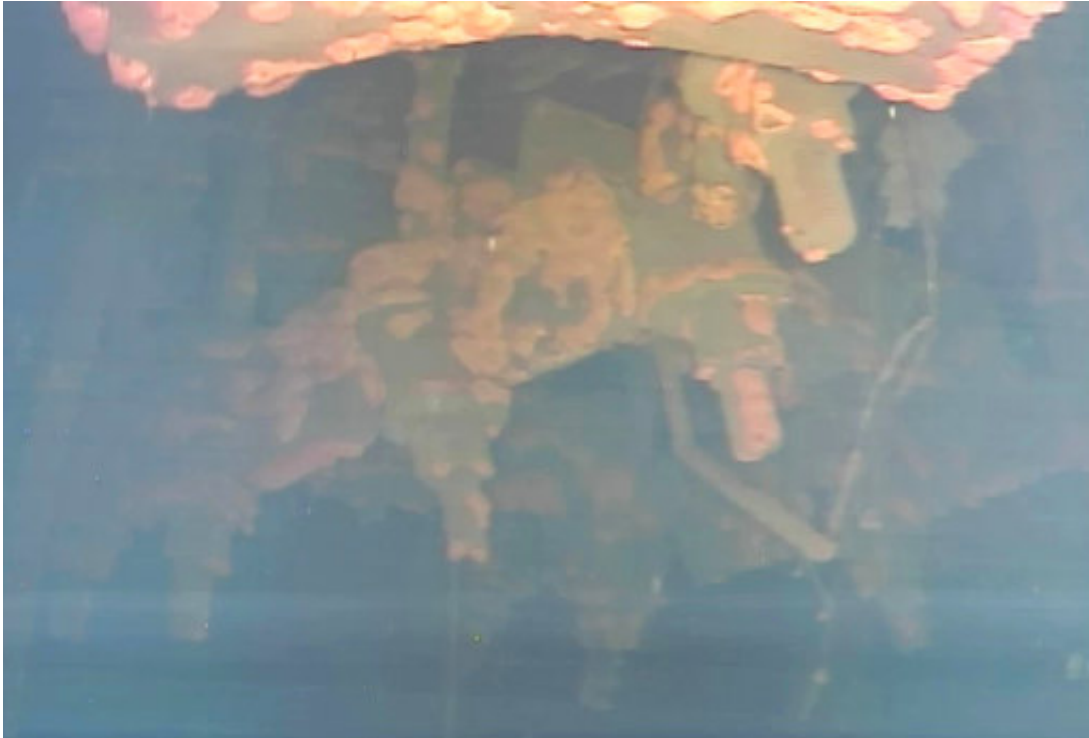
This image captured by an underwater robot provided by International Research Institute for Nuclear Decommissioning shows a part of equipment housing a control rod drive system of Unit 3 at Fukushima Dai-ichi nuclear plant in Okuma town, northeastern Japan Wednesday, July 19, 2017. The underwater robot has captured images and other data inside Japan's crippled nuclear plant on its first day of work. The robot is on a mission to study damage and find fuel that experts say has melted and mostly fallen to the bottom of a chamber and has been submerged by highly radioactive water. (International Research Institute for Nuclear Decommissioning via AP)

The robot discovered that a grate platform that is supposed to be below the reactor core was missing and apparently was knocked down by melted fuel and other materials that fell from above, and that parts of a safety system called a control rod drive were also missing.

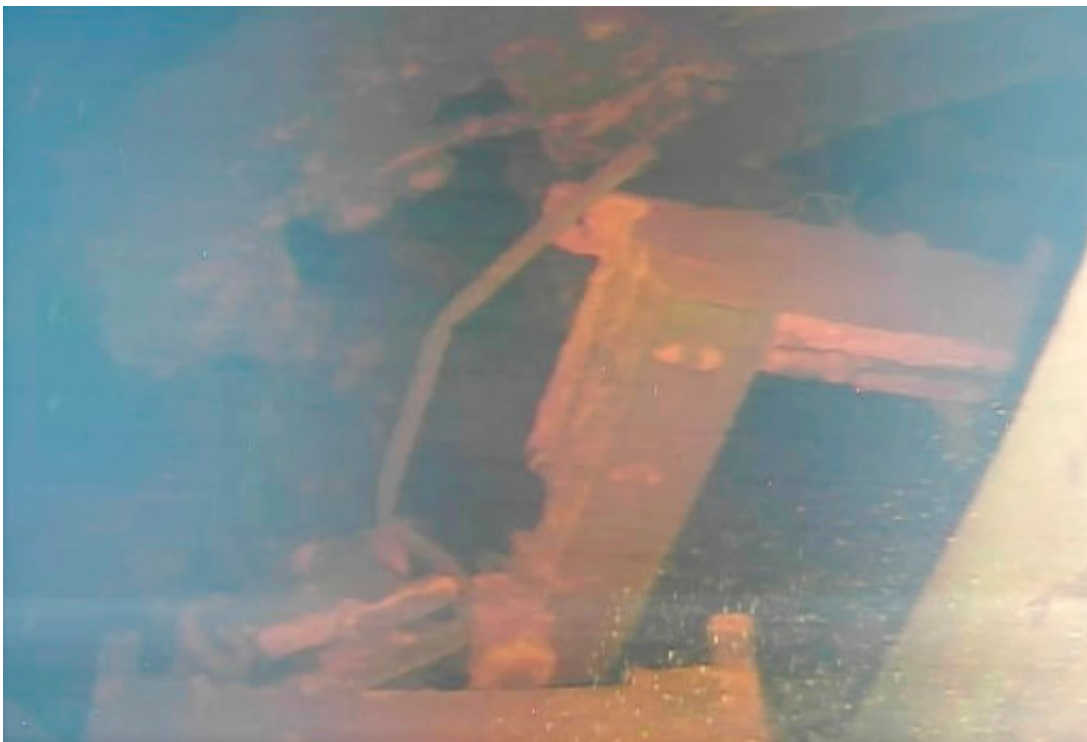
This image captured by an underwater robot provided by International Research Institute for Nuclear Decommissioning shows a damaged platform inside of Unit 3 primary containment chamber at Fukushima Dai-ichi nuclear plant in Okuma town, northeastern Japan Wednesday, July 19, 2017. The underwater robot has captured images and other data inside Japan's crippled nuclear plant on its first day of work. The robot is on a mission to study damage and find fuel that experts say has melted and mostly fallen to the bottom of a chamber and has been submerged by highly radioactive water. (International Research Institute for Nuclear Decommissioning via AP)
