NASA-produced damage maps may aid Mexico quake response

September 22 2017

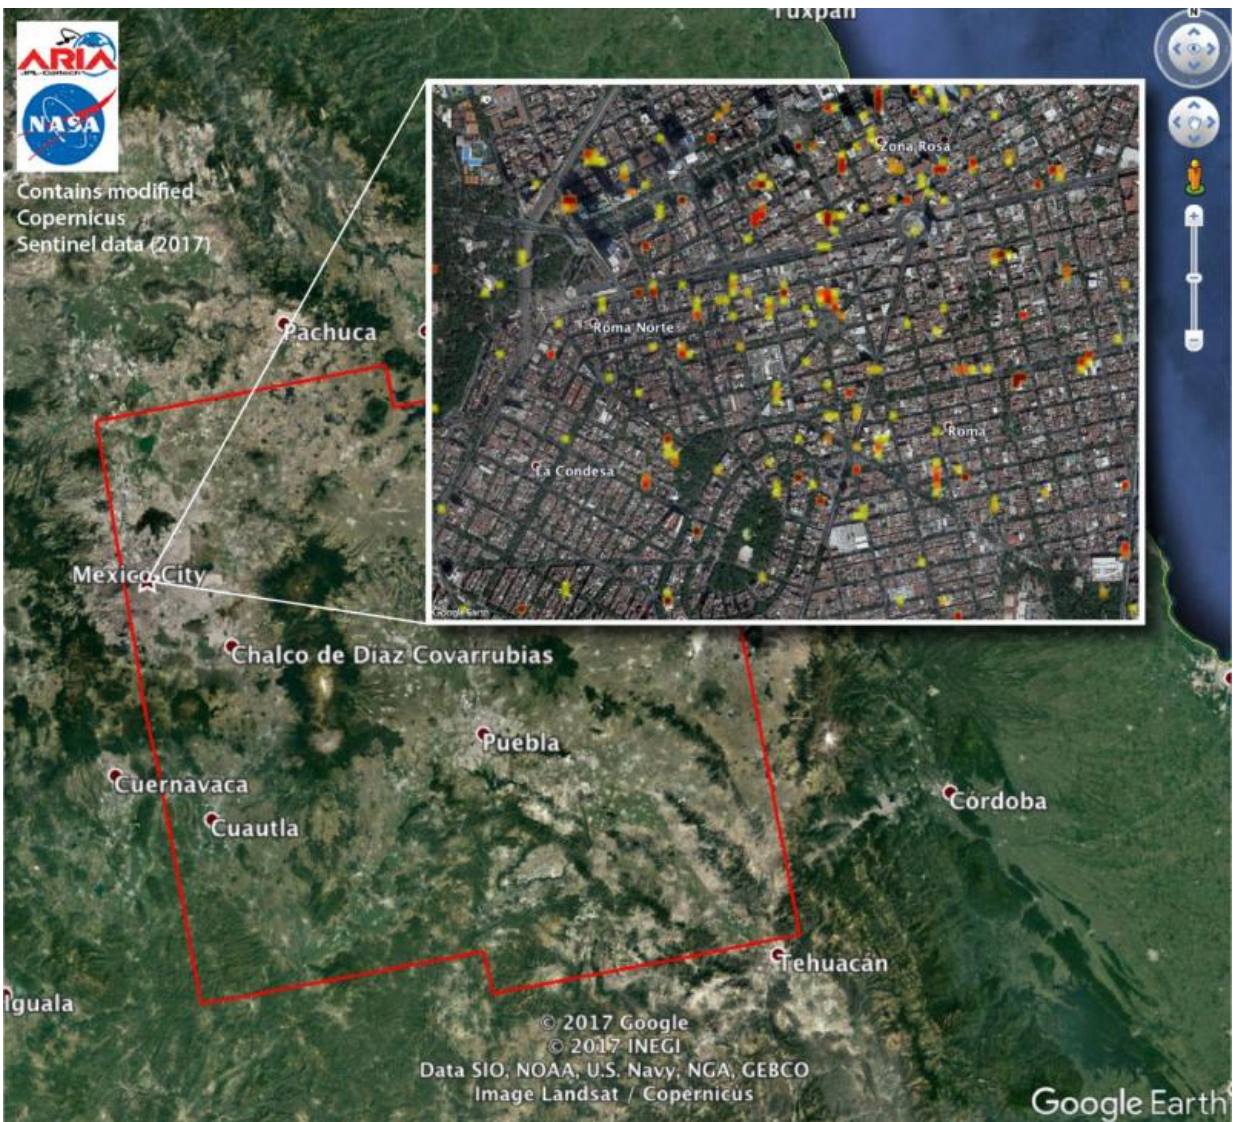
NASA/JPL-Caltech-produced map of damage in and around Mexico City from the Sept. 19, 2017, magnitude 7.1 Raboso earthquake, based on ground and

building surface changes detected by ESA satellites. Color variations from yellow to red indicate increasingly more significant ground surface change. Credit: NASA-JPL/Caltech/ESA/Copernicus/Google

The views indicate the extent of damage caused by the earthquake and subsequent aftershocks, based on changes to the ground surface detected

by radar. The color variations from yellow to red indicate increasingly more significant ground and building surface change. The map should be used as guidance to identify damaged areas, and may be less reliable over vegetated areas. It covers an area of 109 by 106 miles (175 by 170 kilometers). Each pixel measures about 33 yards (30 meters) across.

Preliminary validation of the Raboso quake Damage Proxy Map was done by comparing it to a [crowd-sourced Google Map](#). Sentinel-1 data were accessed through the Copernicus Open Access Hub. The image contains modified Copernicus Sentinel data (2017), processed by ESA and analyzed by the NASA-JPL/Caltech ARIA team.
