# NASA confirms re-discovered IMAGE satellite

January 31 2018

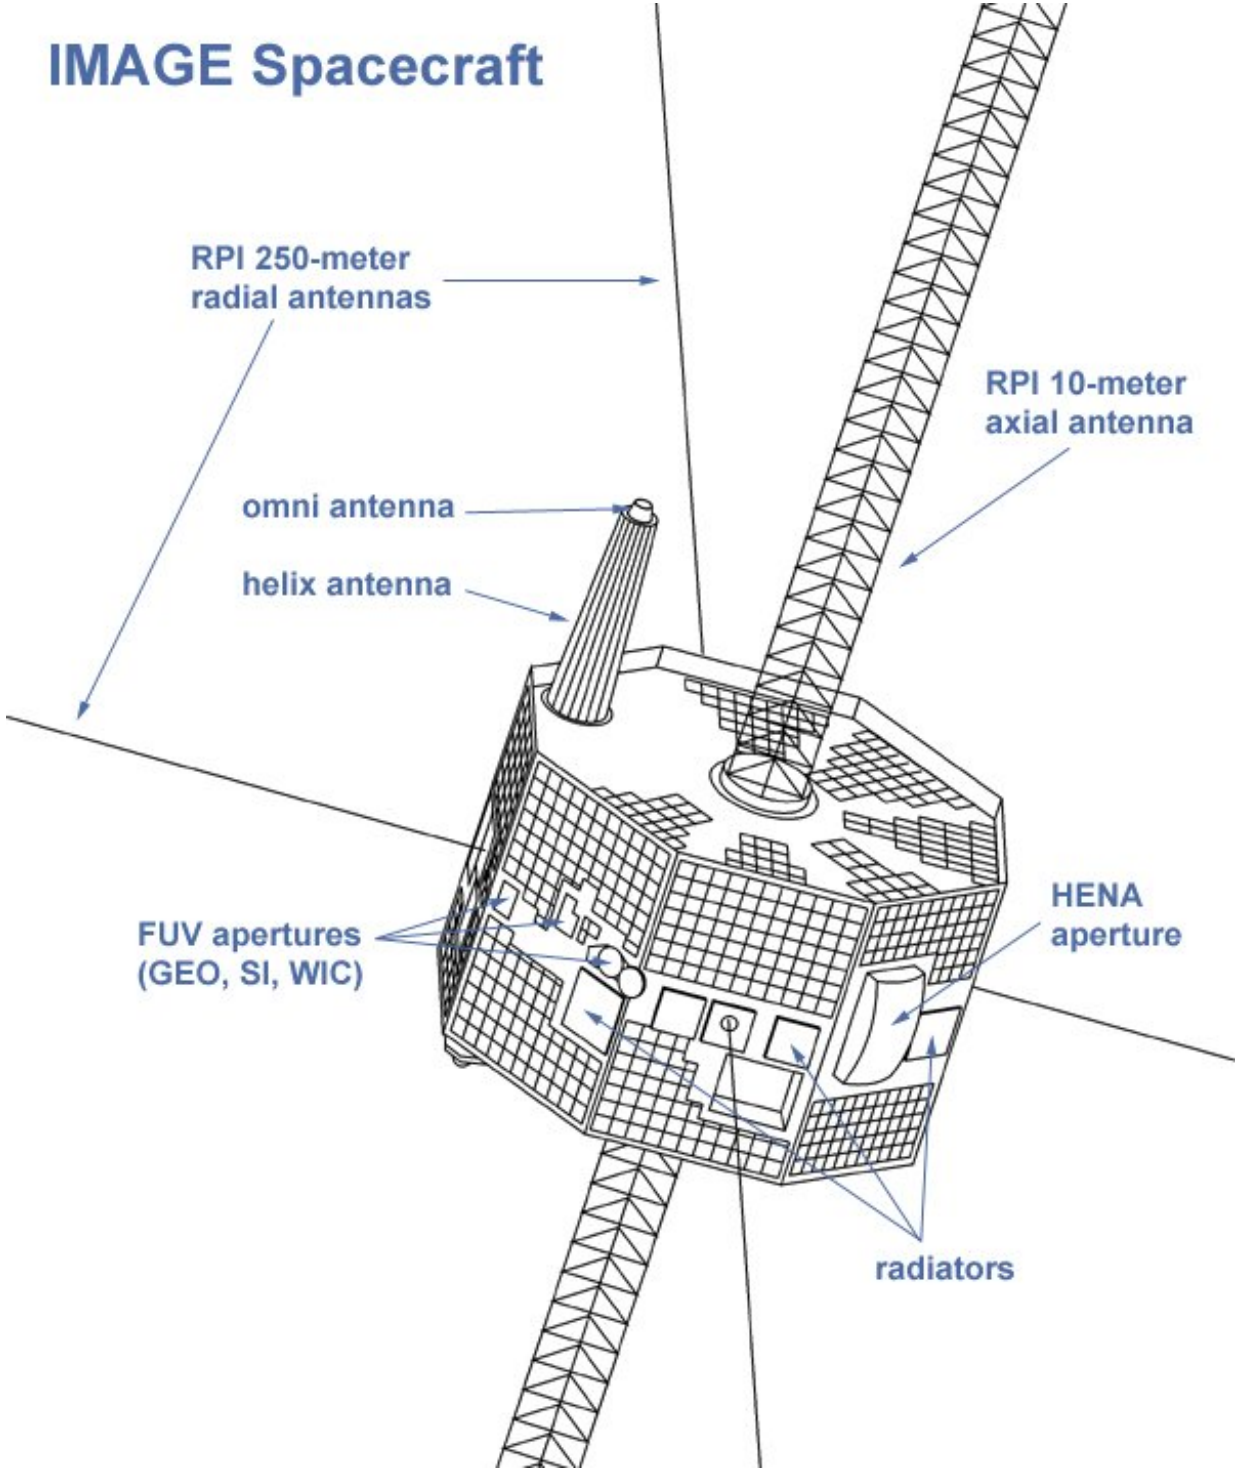
Diagram of NASA's IMAGE spacecraft. Credit: NASA

IMAGE was designed to image Earth's magnetosphere and produce the first comprehensive global images of the plasma populations in this region. After successfully completing and extending its initial two-year mission in 2002, the [satellite](#) unexpectedly failed to make contact on a routine pass on Dec. 18, 2005. After a 2007 eclipse failed to induce a reboot, the mission was declared over.
