# **Updates on recovery attempts for NASA IMAGE mission**

January 29 2018

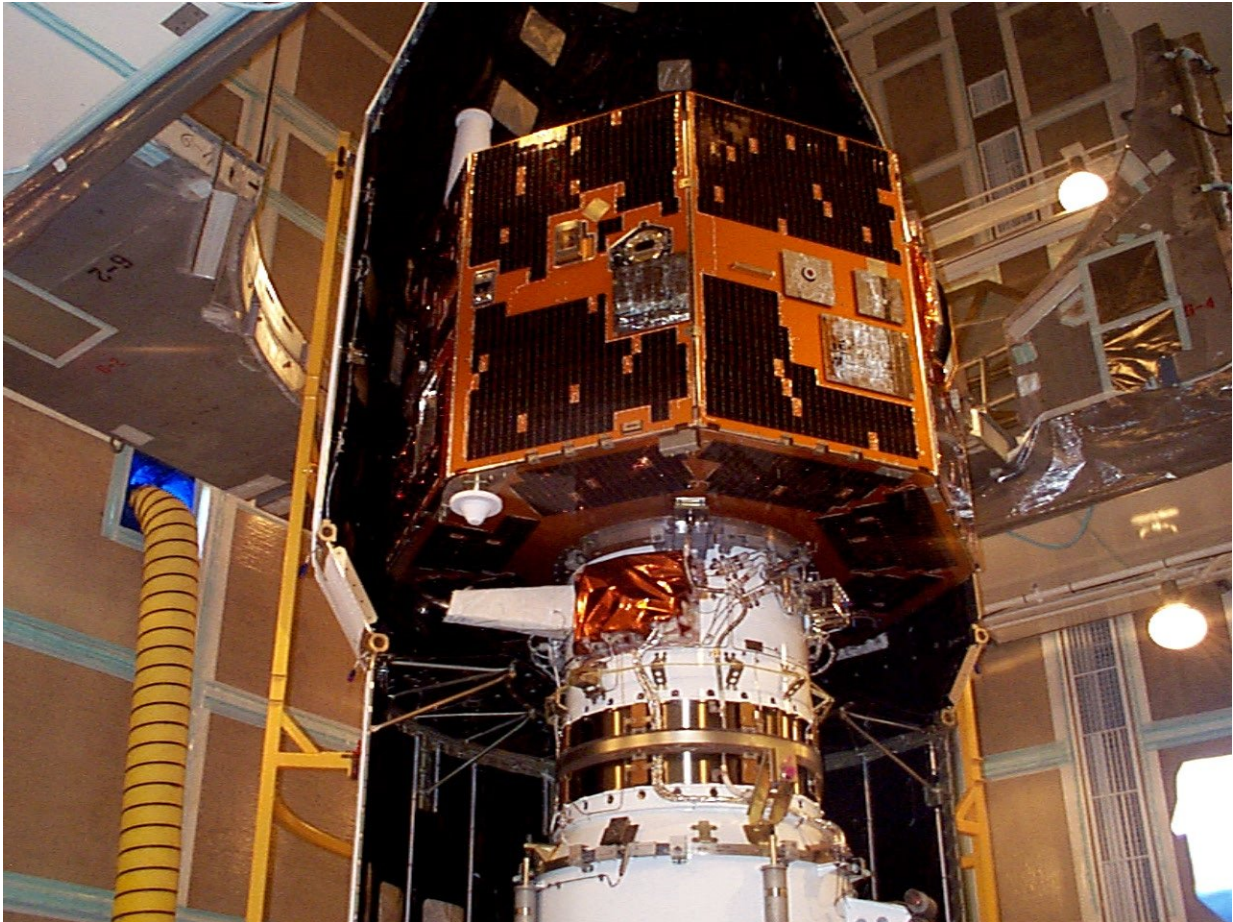
The IMAGE spacecraft undergoing launch preparations in early 2000. Credit: NASA
